CASE STUDY: IMPACT OF STORMS AND HIGH TIDES IN SEFTON

Storm Ciara swept across the UK on 8th and 9th February 2020, bringing widespread gusts of between 70-80 mph and heavy rain. This extreme onshore wind combined with high spring tides caused devastation to parts of the Sefton coast.

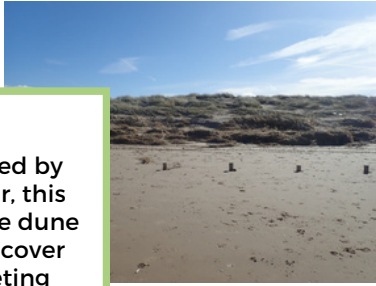
Ainsdale Dunes

The dunes at Ainsdale eroded by an average of 8.1m. However, this erosion was mainly from the dune toe which should in time recover and return back to an accreting coastal section.

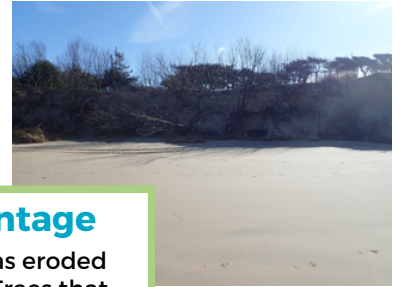
Golf Course Frontage

Golf Course frontage was eroded by an average of 5.9m. Trees that were previously behind the dune face are now starting to fall onto the beach.

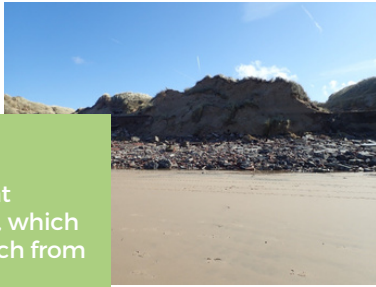
National Trust

The National trust frontage at Formby was eroded by 7.6m, which left lots of rubble on the beach from the old carpark site.

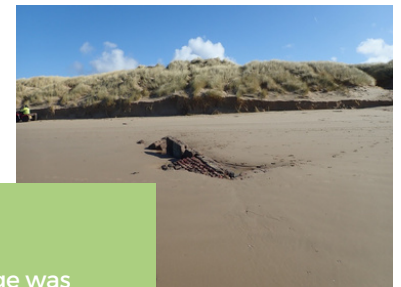
Lifeboat Rd dune frontage was eroded by an average of 2.8m.

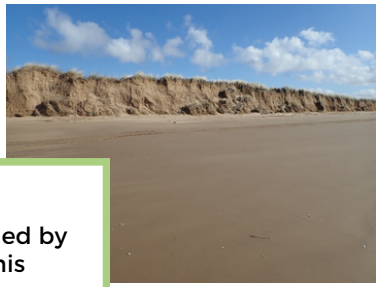
Altcar Rifle Range was eroded by 10.3m from the dune toe. This should recover back to an accreting coast line when wind-blown sand re-enters the system.

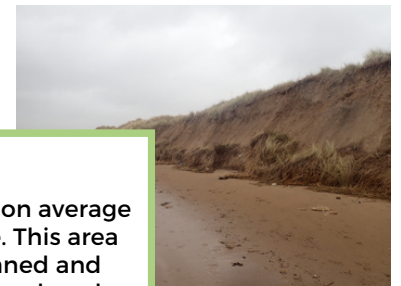
Hightown frontage lost on average 6.8m from the dune toe. This area has also been laser scanned and volumetric data regarding beach levels will be available once analysis has been completed.

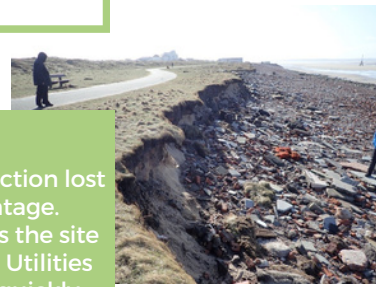
The Hightown Cliff rubble section lost on average 1.5m from its frontage. Some localised areas, such as the site closest to the MEPAS United Utilities pipe appear to have eroded quickly across this area. This may be due to the substrate making up the defence changing from rubble to sand as the rubble is eroded away.

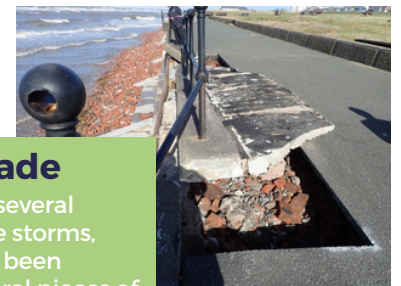
Crosby Promenade

Crosby promenade had several structural issues after the storms, mainly to areas that had been previously repaired. Several pieces of timber breastwork had been damaged with sections of the steel piling becoming slightly exposed due to upper beach levels dropping.

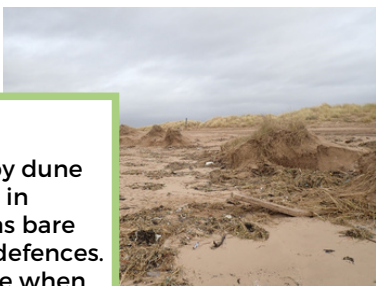
Crosby Dunes

After storm Ciara, the Crosby dune system was eroded by 7.7m in places, which left large areas bare leading up to the hard sea defences. This area will recover in time when wind blown sand enters the system.
