# CASE STUDY: IMPACT OF STORMS AND HIGH TIDES IN SEFTON

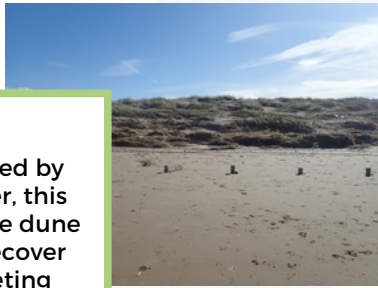
### Ainsdale Dunes

The dunes at Ainsdale eroded by an average of 8.1m. However, this erosion was mainly from the dune toe which should in time recover and return back to an accreting coastal section.

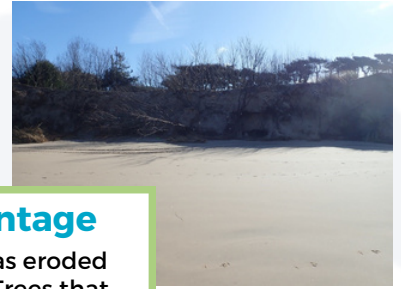
### Golf Course Frontage

Golf Course frontage was eroded by an average of 5.9m. Trees that were previously behind the dune face are now starting to fall onto the beach.

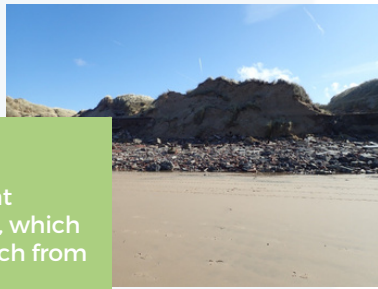
### National Trust

The National trust frontage at Formby was eroded by 7.6m, which left lots of rubble on the beach from the old carpark site.

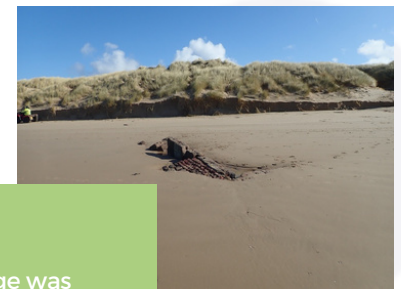
### Lifeboat Rd

Lifeboat Rd dune frontage was eroded by an average of 2.8m.

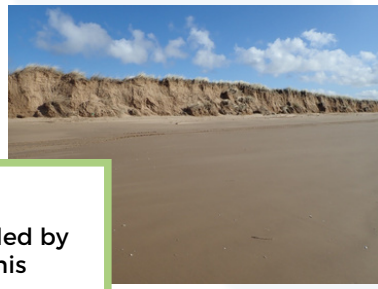
### Altcar Rifle Range

Altcar Rifle Range was eroded by 10.3m from the dune toe. This should recover back to an accreting coast line when wind-blown sand re-enters the system.

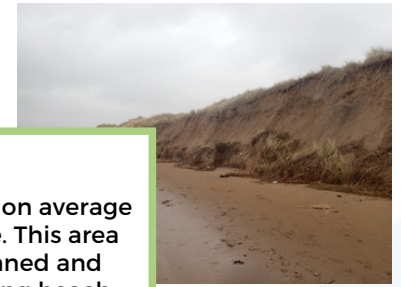
### Hightown

Hightown frontage lost on average 6.8m from the dune toe. This area has also been laser scanned and volumetric data regarding beach levels will be available once analysis has been completed.

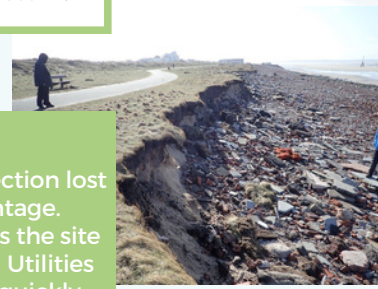
### Hightown Cliff

The Hightown Cliff rubble section lost on average 1.5m from its frontage. Some localised areas, such as the site closest to the MEPAS United Utilities pipe appear to have eroded quickly across this area. This may be due to the substrate making up the defence changing from rubble to sand as the rubble is eroded away.

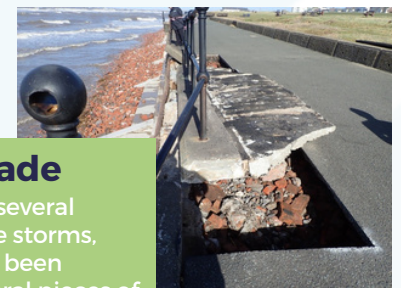
### Crosby Promenade

Crosby promenade had several structural issues after the storms, mainly to areas that had been previously repaired. Several pieces of timber breastwork had been damaged with sections of the steel piling becoming slightly exposed due to upper beach levels dropping.

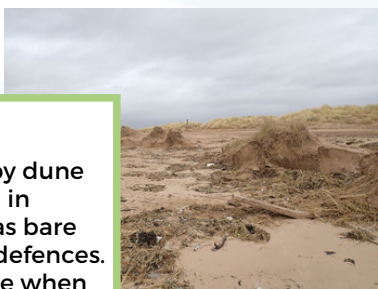
### Crosby Dunes

After storm Ciara, the Crosby dune system was eroded by 7.7m in places, which left large areas bare leading up to the hard sea defences. This area will recover in time when wind blown sand enters the system.
