# CASE STUDY: LIVERPOOL - EGREMONT LAWN, WOODLANDS ESTATE

## OVERVIEW

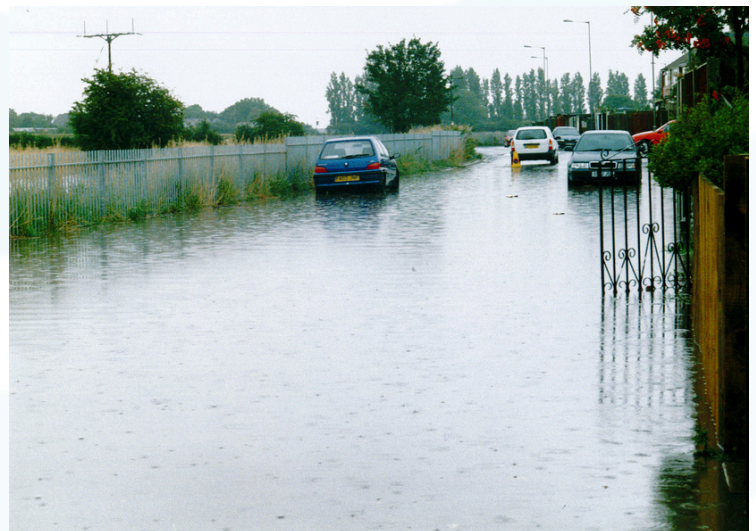
Image: Liverpool City Council

The area experienced considerable rainfall from around 18:00 on the 23rd September and continued over night. The rain gauge at Fazakerley recorded over 82mm in 48 hours and nearly 90mm in 60 hours. This amount of rainfall has a probability of occurring approximately every 30 to 35 years. The properties flooded initially from the front and later from the rear (Winsters Drive) as a pond of water accumulated on the road and into the gardens of the properties.

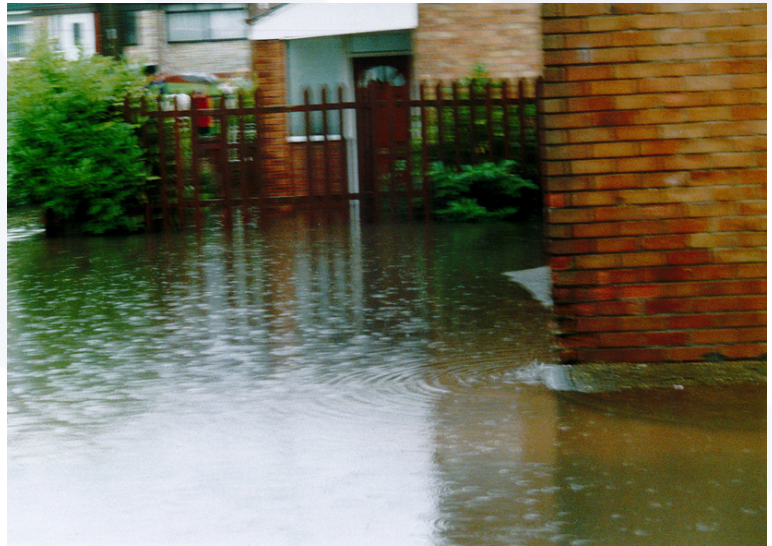
Image: Liverpool City Council

Water later came in through the rear of the houses, not helped by the wash caused by cars travelling down Winster Drive. Residents blocked off the road with their cars. The Environment Agency issued a Flood Alert for the River Ditton catchment that includes Netherley Brook at 15:50 on 24th September 2012, although this alert was not for surface water flooding. United Utilities were contacted on the 24th September and offered to supply sandbags. They confirmed their assets were in order after attending the site on the 25th. Enterprise Liverpool attended the site on the 25th and used a suction wagon to inspect and clear the gullies. The water had drained away by 06:00 on the 26th September according to a resident.

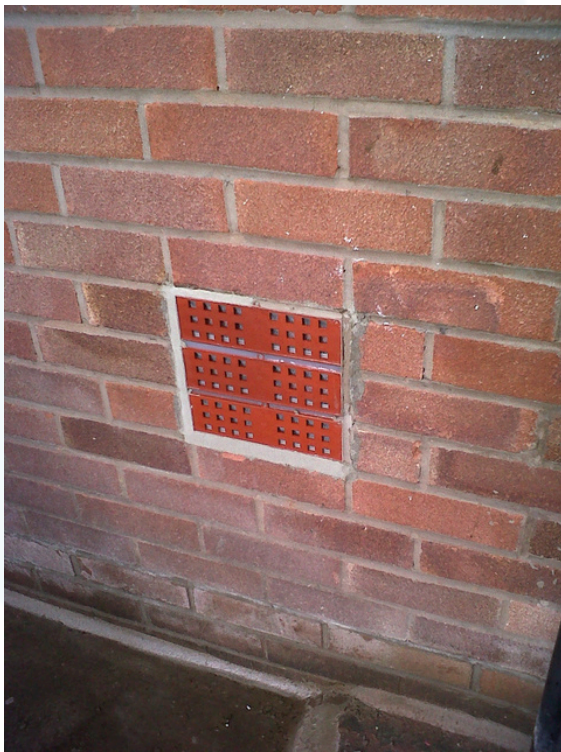
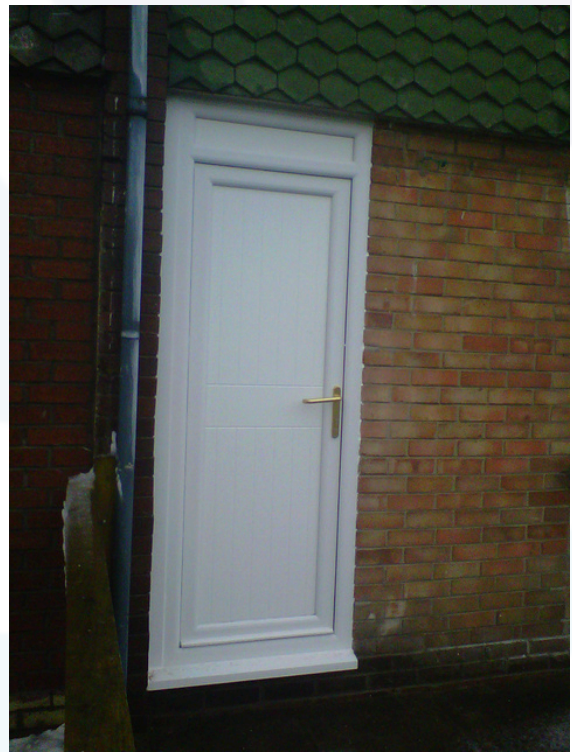
Six of the most at risk properties received Property Level Protection from Environment Agency grant monies. This included fitting flood doors, flood airbricks, re-pointing and spraying sealant on the house bricks to 1 metre.
