Property Flood Resilience

Stories from homes and businesses who have made adaptations to help them recover more quickly after a flood

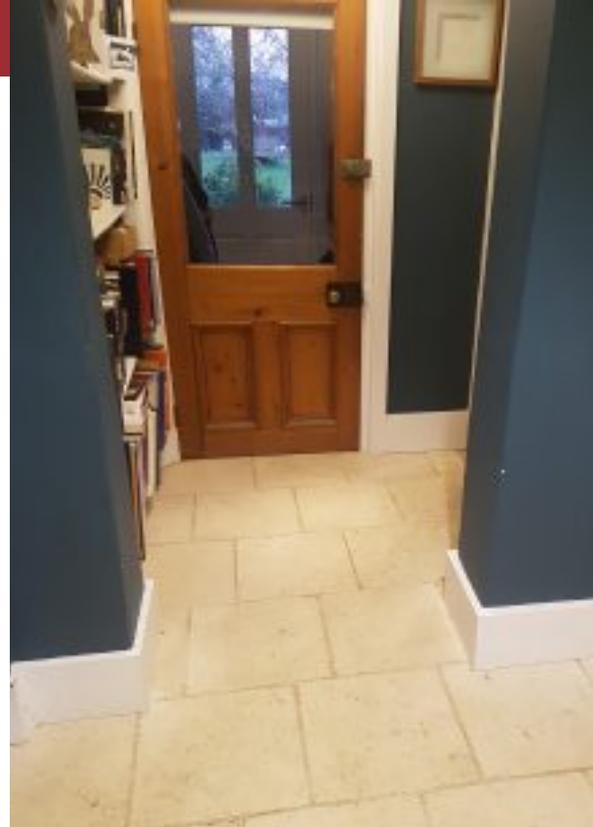
All the items shown here have survived one or more floods.

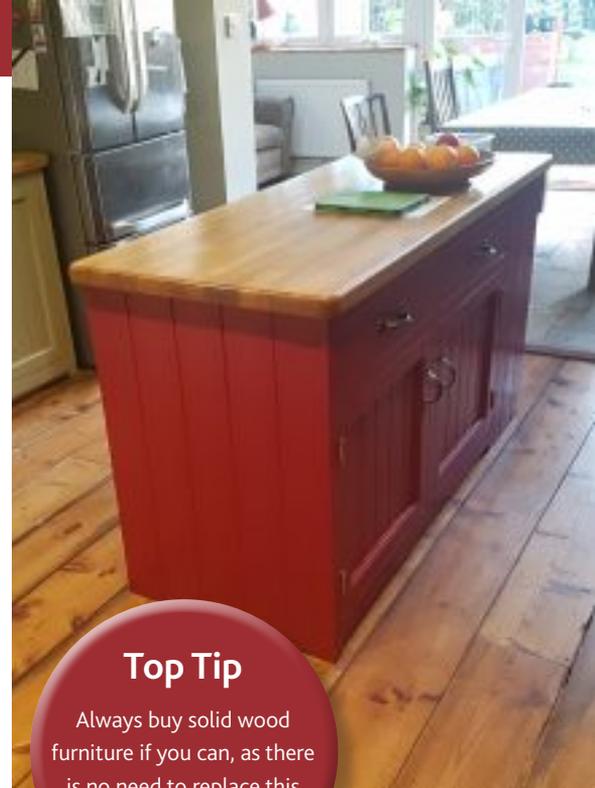
Solid wood kitchen, easily washed down, and all parts are free-standing so moveable.

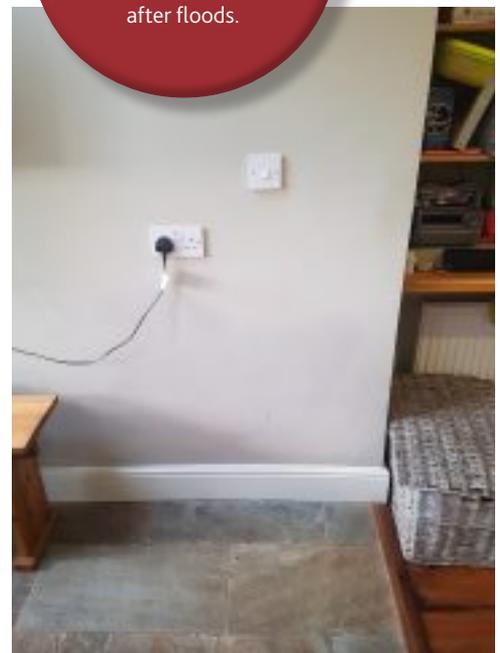
All electric service points are raised above flood level.

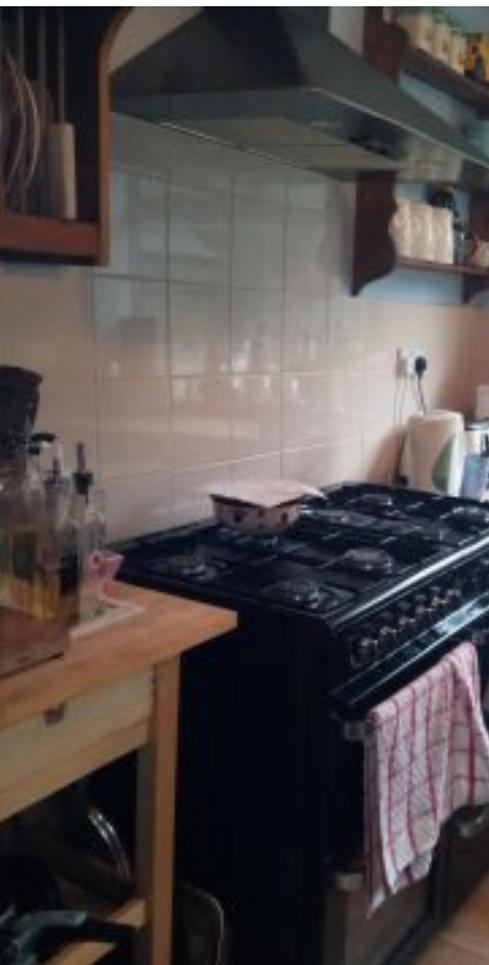
Solid wood kitchen units are freestanding so can easily be removed.

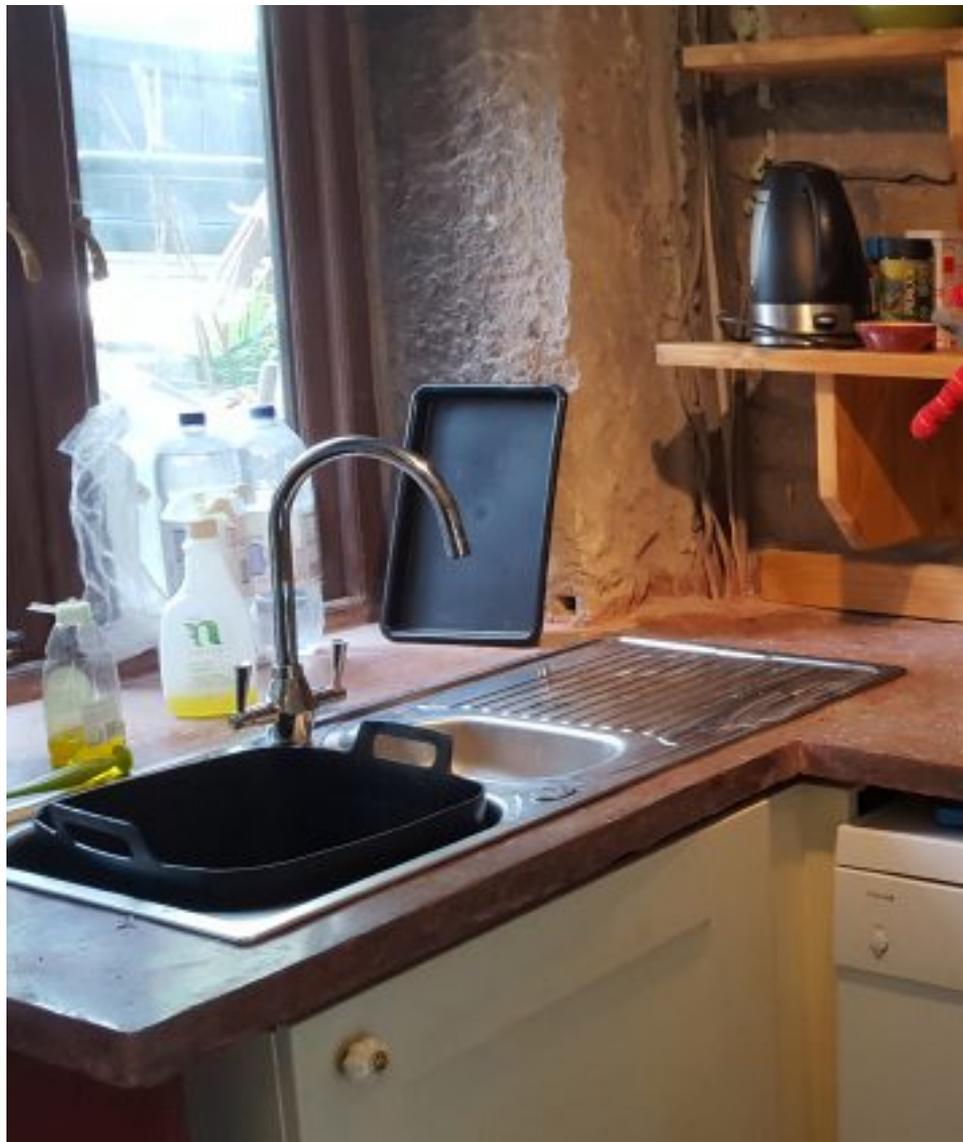
The kitchen worktop is polished concrete and was saved in the flood

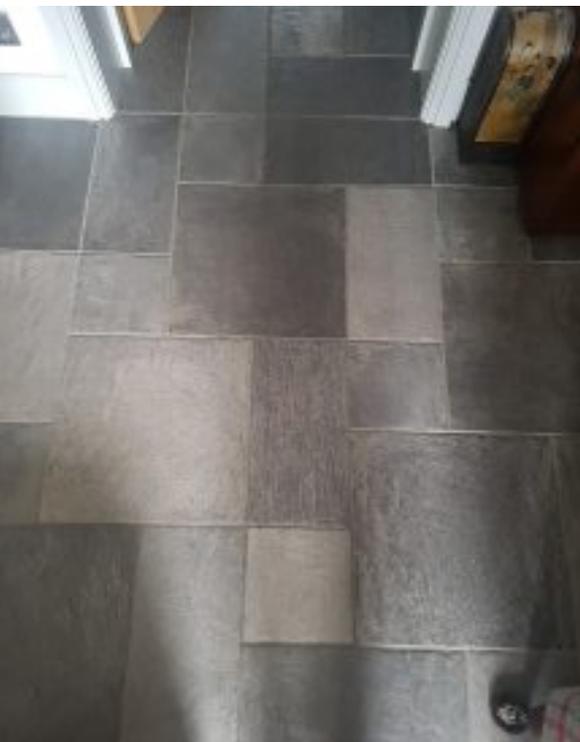
Tiling in the ground floor above insulation and underfloor heating.

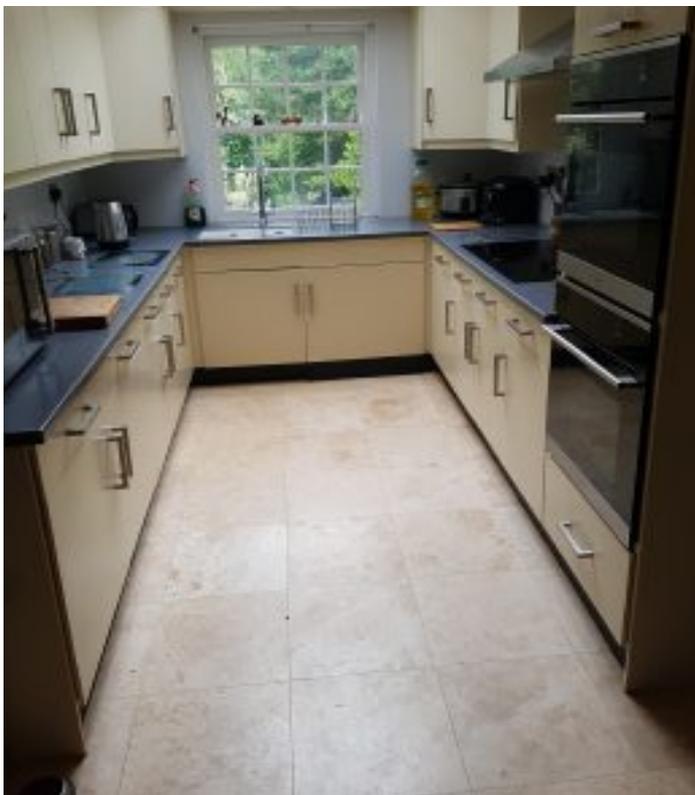
A Corian plastic kitchen was fitted.

He decided that because the kitchen was the most expensive item to replace, he would have a Corian plastic kitchen fitted. It appears that the company is no longer in existence, but a quick web search showed that Corian and laminated Aquoline kitchens are still available. He has stone tiled floors that survived the floods and now also has waterproof plaster on the walls.

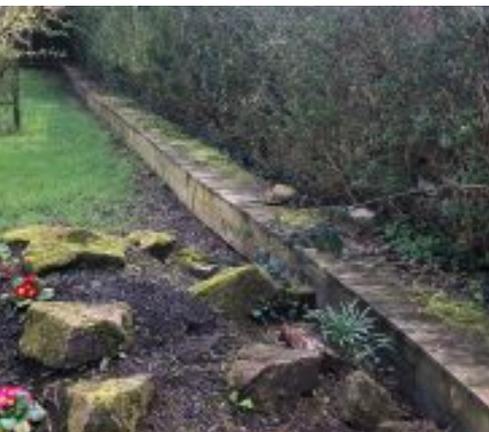
Wall with substantial foundations in the garden.

- Rob has built a wall with substantial foundations in the garden.
- They have non-return valves fitted to the sewers.
- White goods are raised up on plinths.

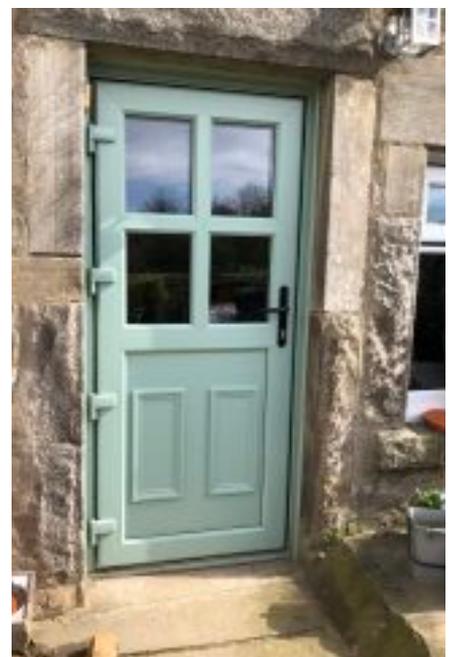
Flood door fitted.

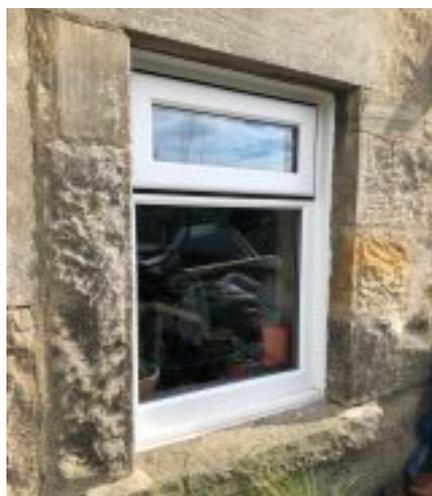
Original window replaced with a flood proof window.

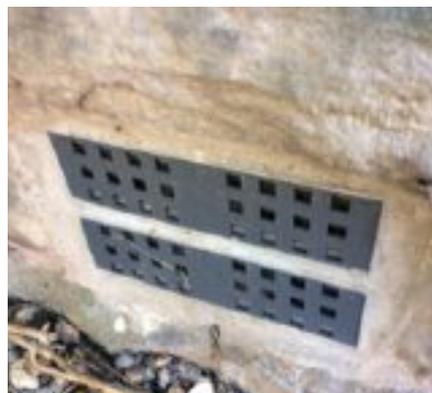
Self-closing airbricks.

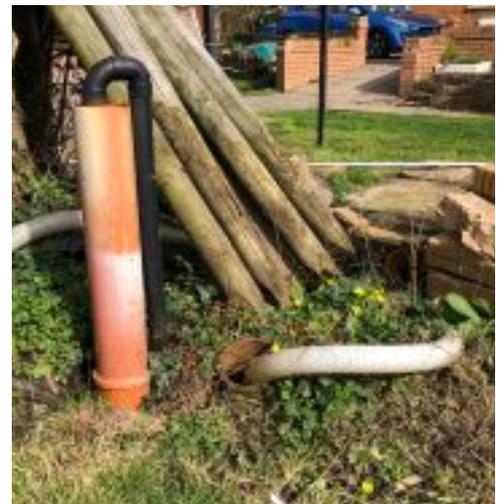
Rainwater runs through a series of French drains into a large sump into which a strong pump is fitted which pumps the water outside the garden boundaries.

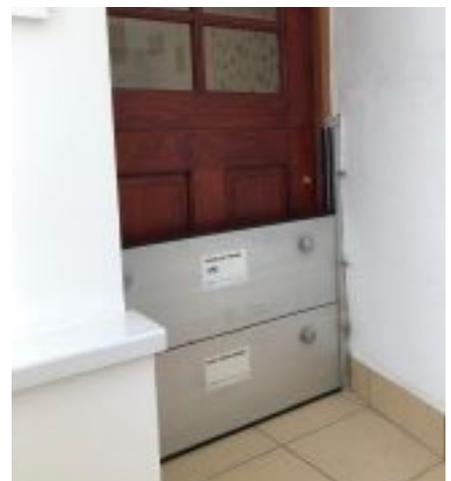
Flood barriers to all external doors and tiled floors.

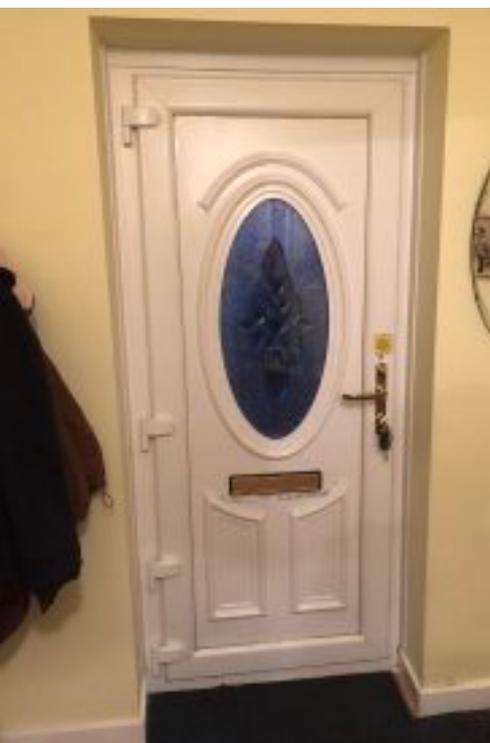
Flood resilient front door has been installed.

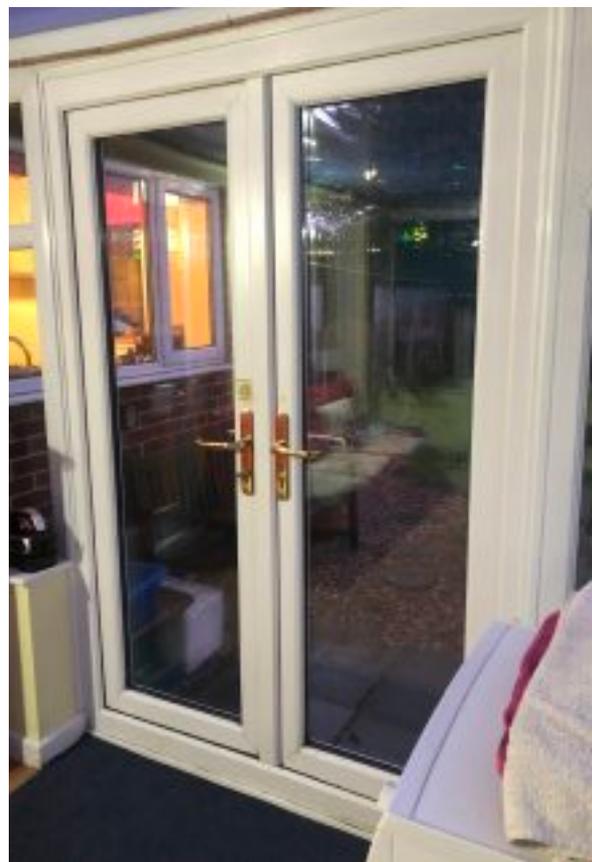
Flood resilient patio doors have been installed.

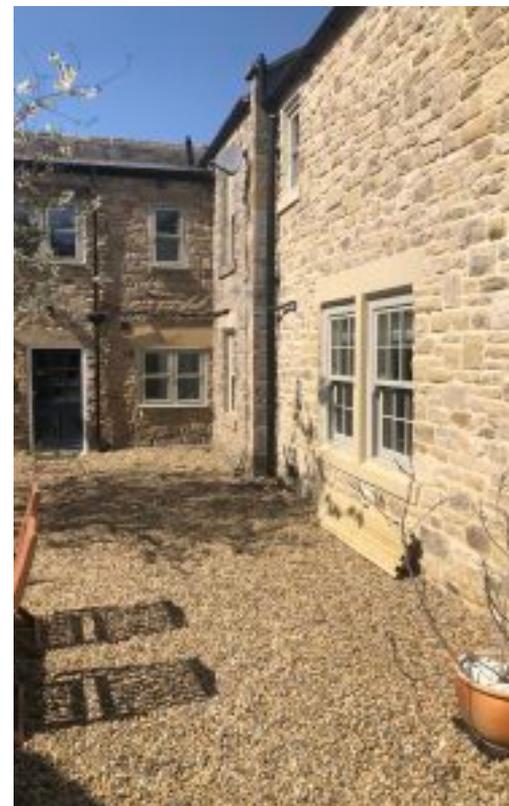
Permeable patio areas surround most of the house.

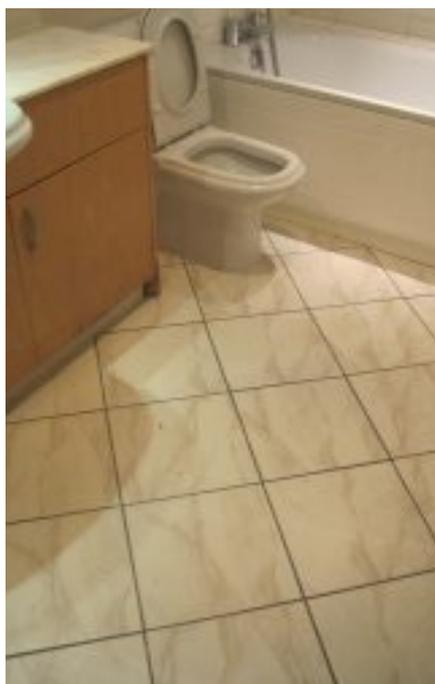
Ceramic tiled bathroom floor.

- A flood resilient front door has been installed.
- Carpets and laminate flooring replaced with ceramic tiles, bonded to the concrete floor with waterproof adhesive. The only exception was the three bedrooms, where cheap 'sacrificial' carpet was chosen.
- All replacement woodwork including skirting boards, internal doors and built-in wardrobes are made from solid wood, which has been varnished.
- Solid wood kitchen.
- NRVs have been added to all the pipe work.
- Toilet bungs for each of the bathrooms.

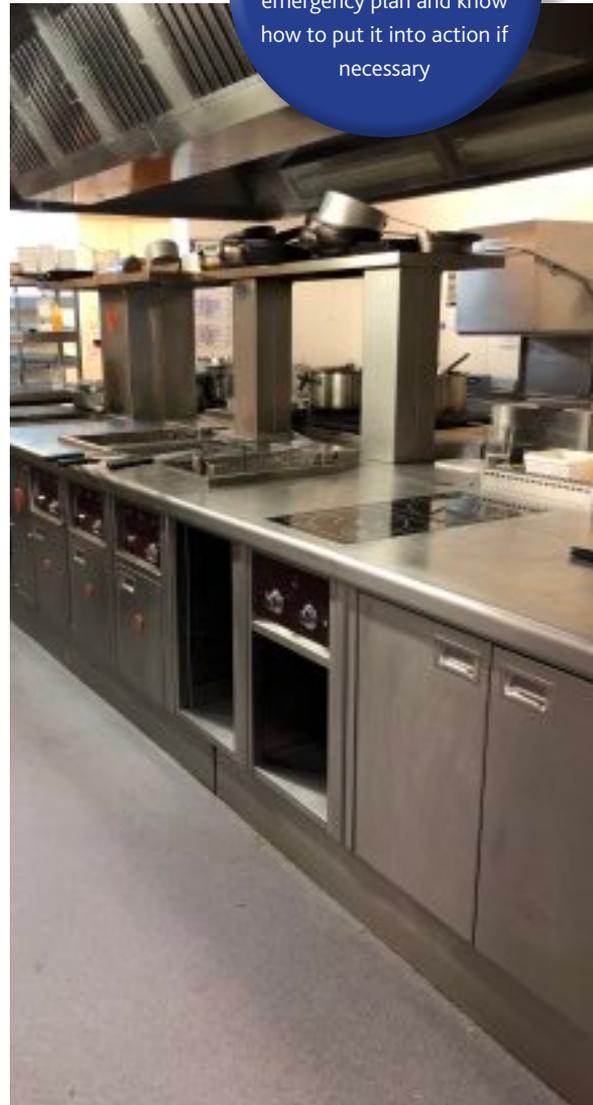
The motor can be removed from the stainless-steel kitchen 'Chave block' (cooking area).

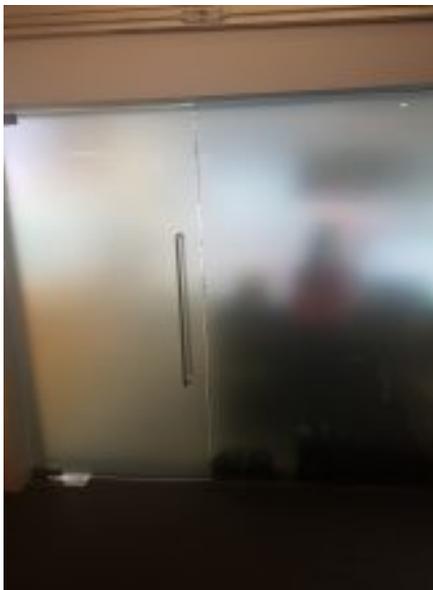
Interior doors are now 'Rainscreen' panels, mounted on stainless steel supports.

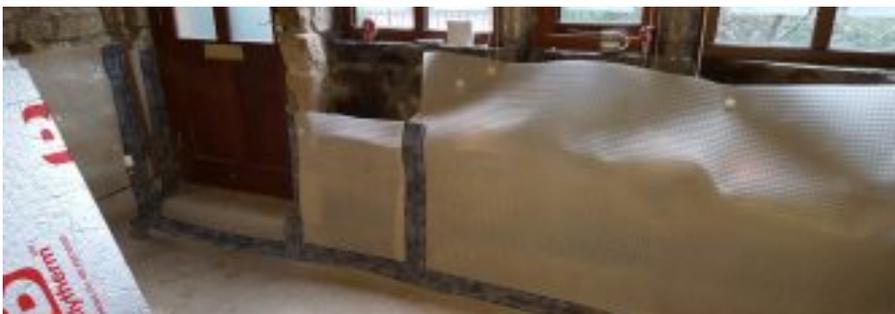
Waterproof membrane during installation.

- All floors are now solid concrete with a membrane underneath, and sealed to allow it to be wiped down.
- Walls - membrane extends from under the floor to one metre up the wall, then concrete coated and painted to resemble tiles.
- All the work surfaces, bar and serving counter are concrete.
- Kitchen is stainless steel and can be hosed down.
- Kitchen floor has tiles, affixed with waterproof adhesive and finished with waterproof grouting.
- Electrical sockets have been raised.
- Window replaced with a new one, with concrete below it.

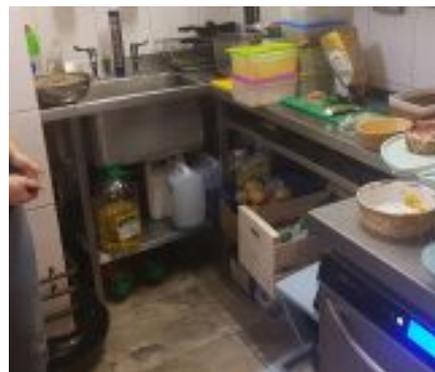
Kitchen is stainless steel and can be hosed down.

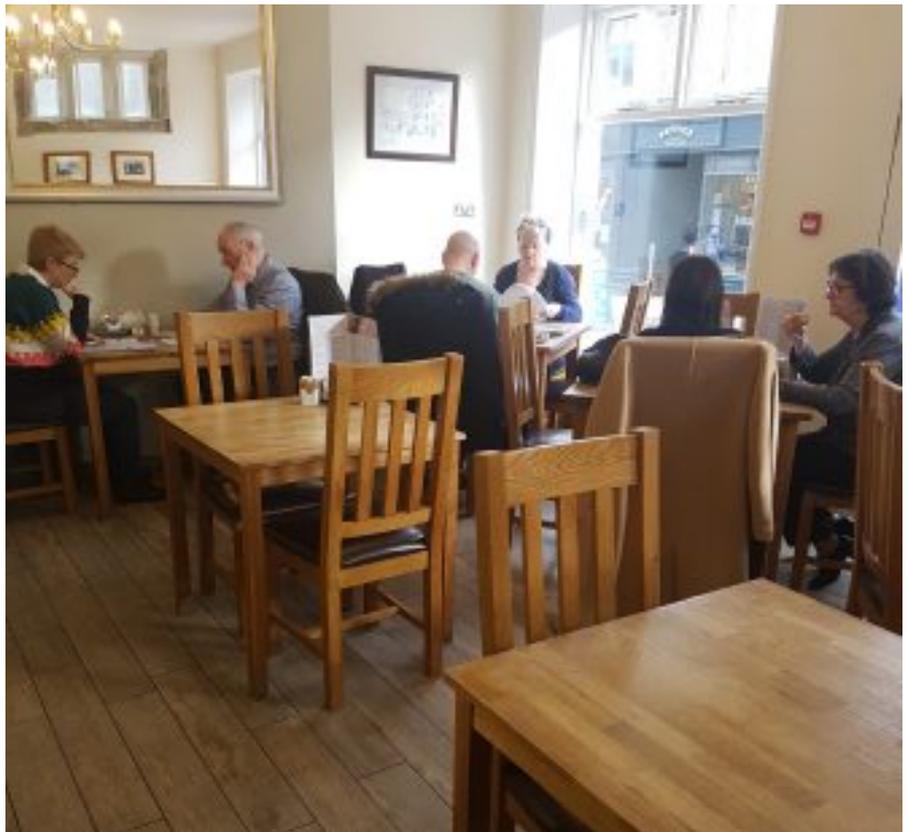
Ground floor was concreted and tiled with wood effect ceramic tiles.
