## **Installation of Natural Flood Management measures and habitat improvements at Pott Shrigley**

### **Final Report**

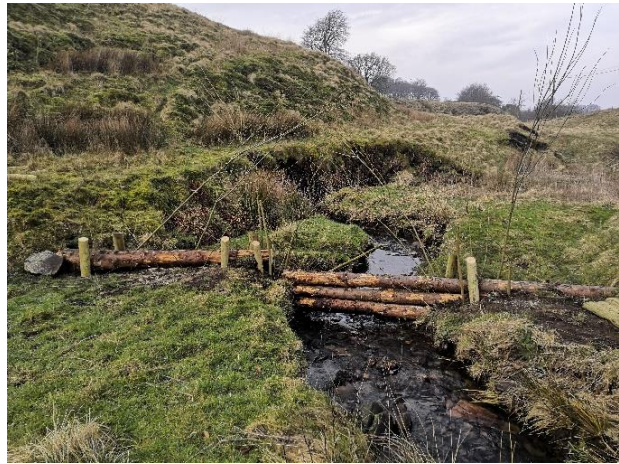
#### **Section 1:**

The first 6 leaky dams were built on the parcel of land immediately upstream of the industrial estate which has previously flooded. Locally grown osier willow (*Salix viminalis*) was chosen as there were no trees in this area. A mixture of sizes of willow were planted to provide variety of shapes and sizes and ensure protection from grazing.

A deflector was built next to Dam 5 (pictured) to protect the downstream area from erosion and redirect water towards the leaky dam during high river levels.

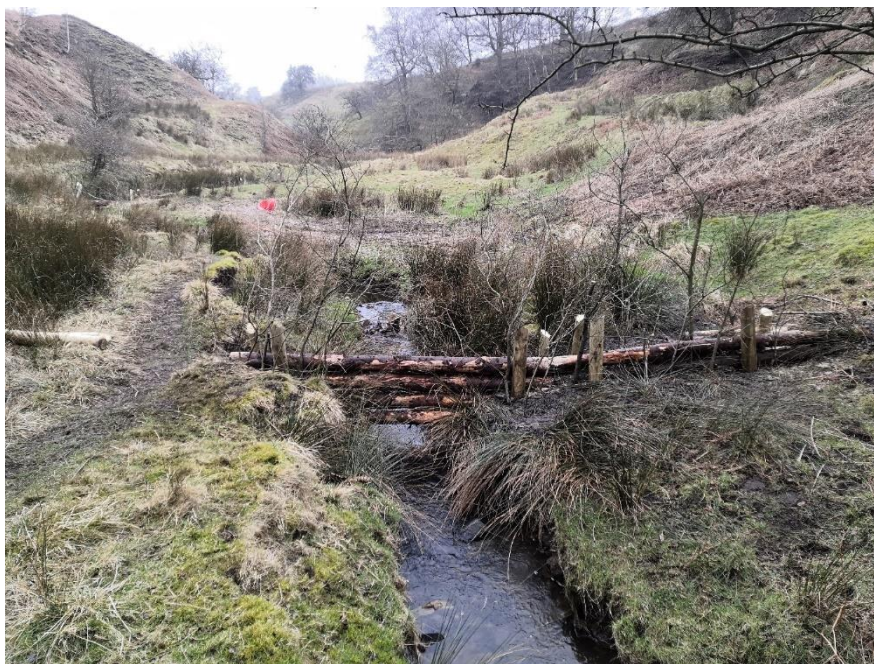
### **Section 2:**

10 Leaky dams were built to hold water in the flat wet parts of this section. All dams were planted with goat willow (*Salix caprea*) harvested from this section. Site 17 was going to be the site of a leaky dam but a tree had fallen down a steep slope into the watercourse where it is effectively slowing the flow of water and, due to the position of the tree, it would not have been safe to try and reposition it. As such, its effect is being noted and it will be monitored to make sure it does not shift and interfere with the nearest structure.

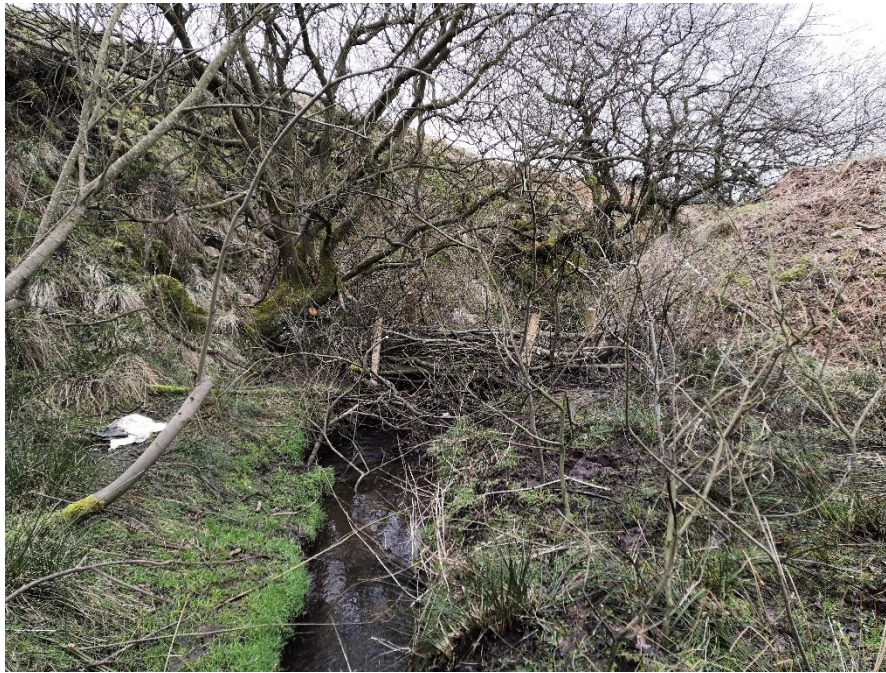
### **Section 3:**

Six leaky dams planted with goat willow harvested from this section. The large bowl formed by a bank which formed an old track and bridge foundations was planted with an extra 400 goat willow cuttings.

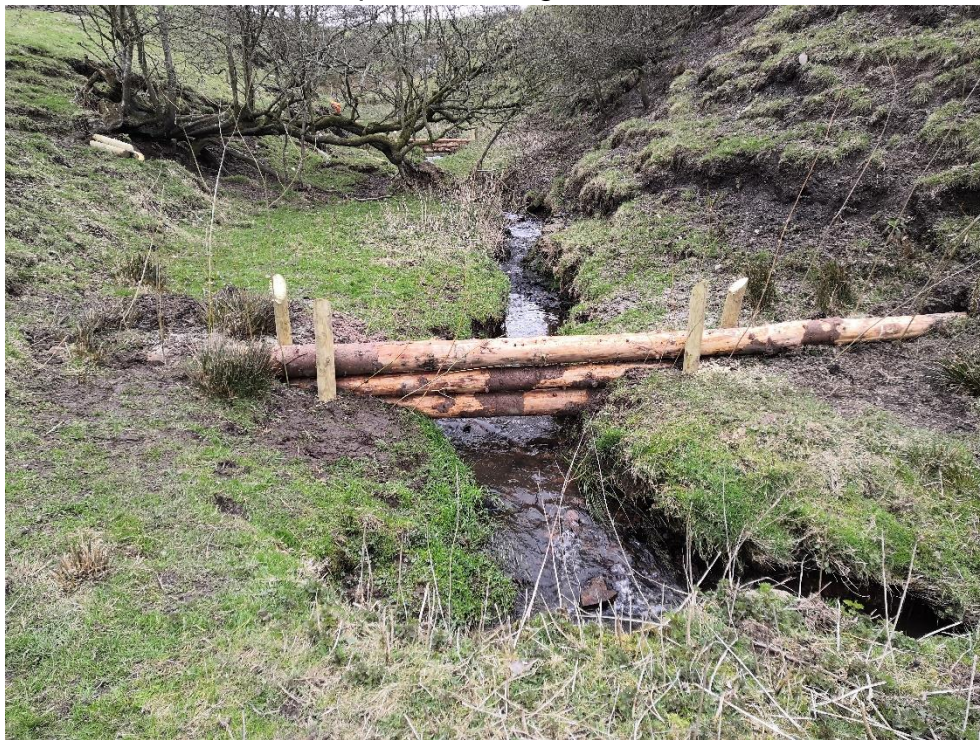
**Section 4:**

4 leaky dams were installed and planted with goat willow harvested from Section 3.

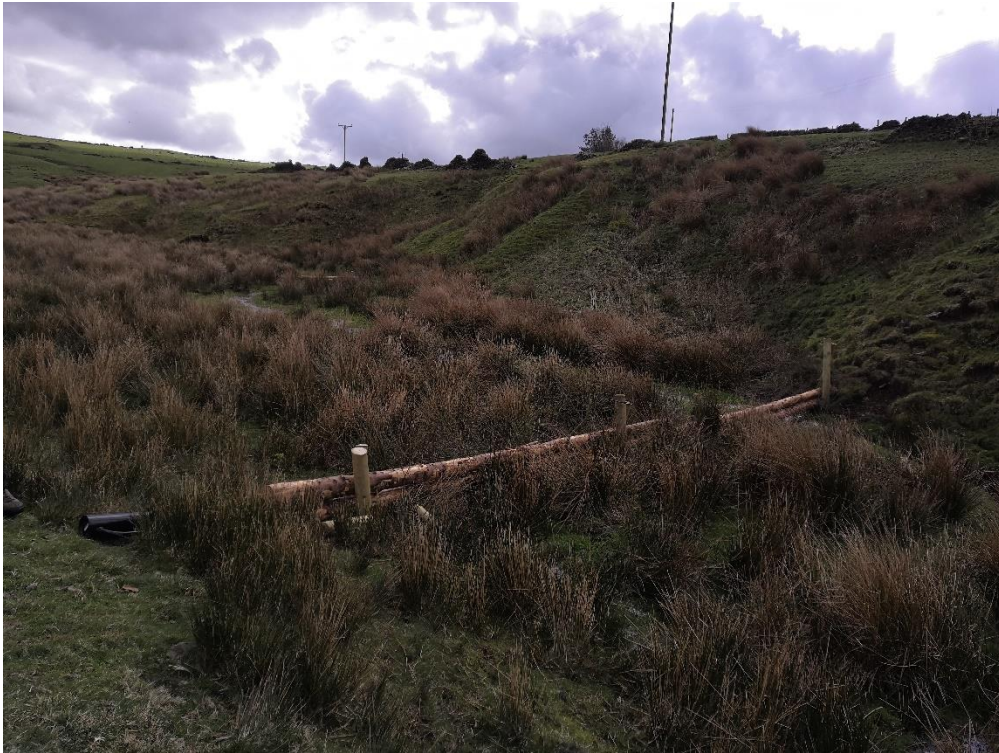
**Section 5:**

12 leaky dams were installed and planted with goat willow harvested from this section. Larger dams were built to cover the flat, wetter sections of the valley.

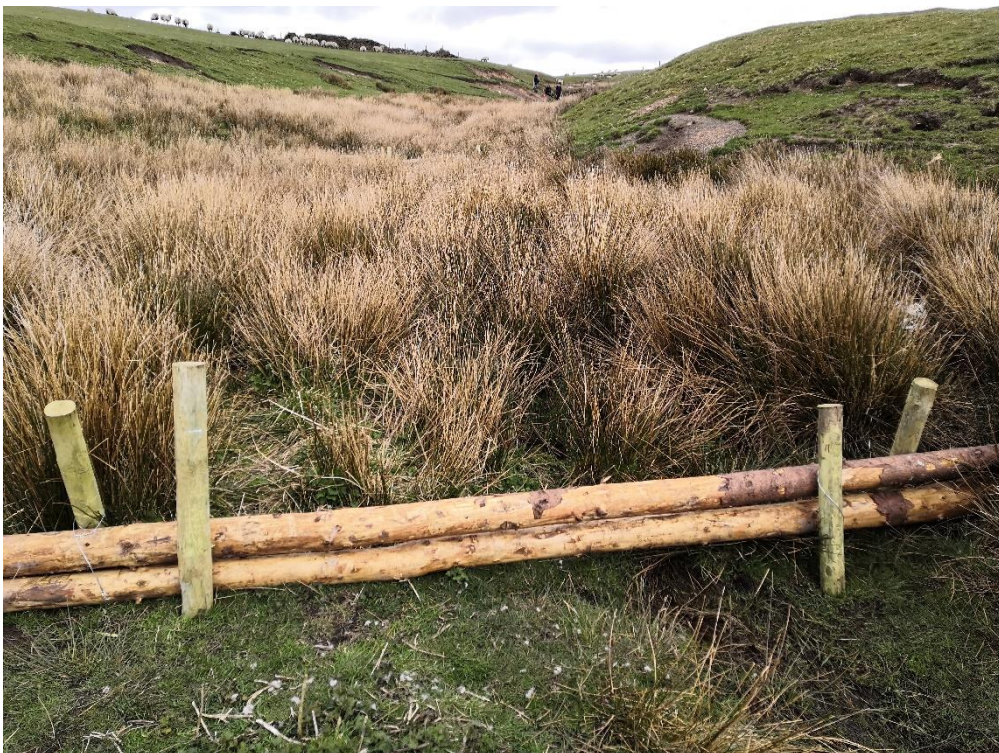
**Section 6:**

9 leaky dams were built and planted with a mixture of goat and osier willow.

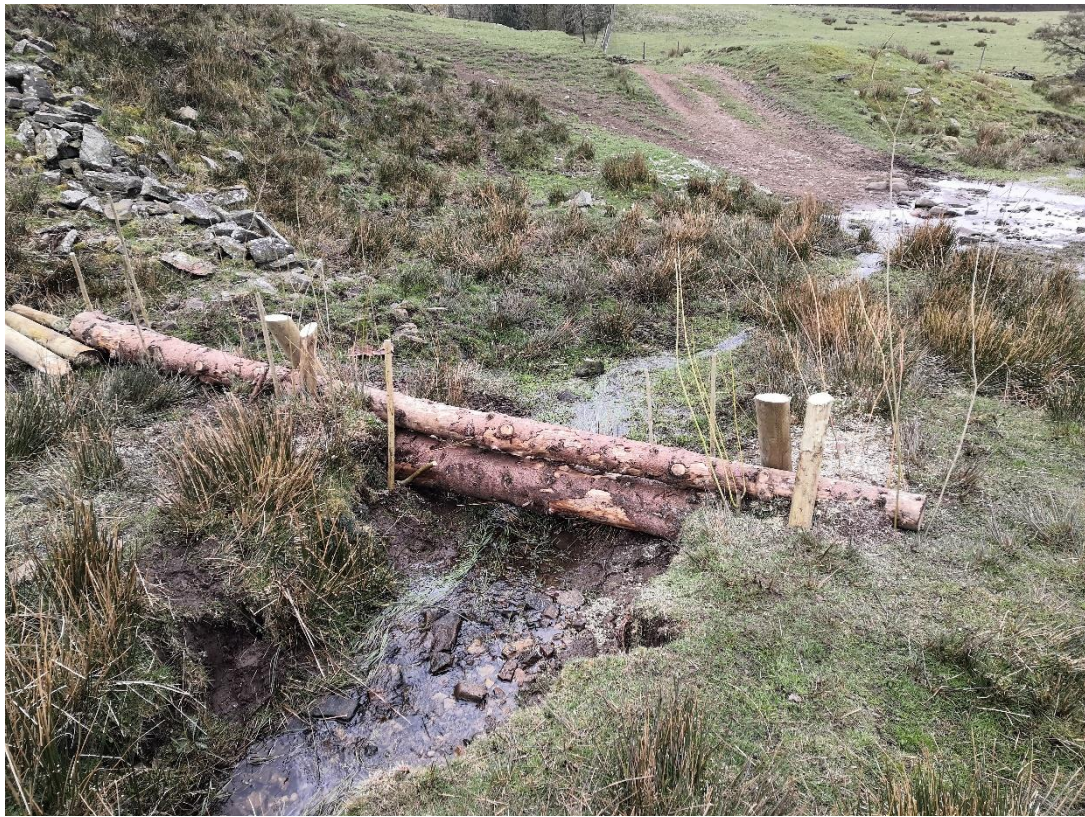
**Section 7:**

12 leaky dams were built and planted with osier willow.

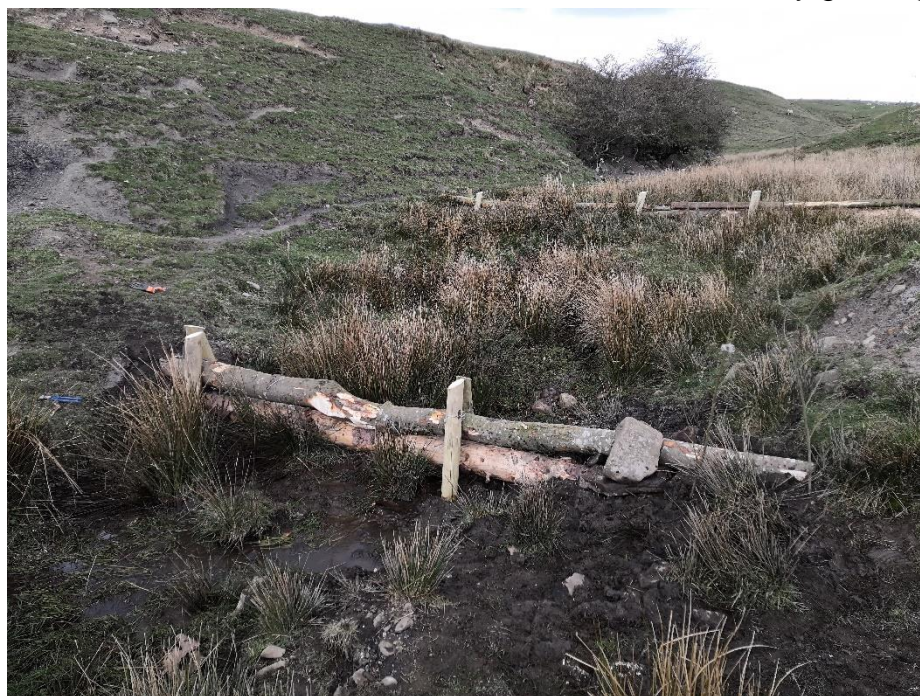
**Section 8:**

8 leaky dams were built and planted with osier willow. This area included very wide, wet sections so larger dams were built to capture water in the full width of the valley and to spread water out over the dense reeds which were naturally growing there.

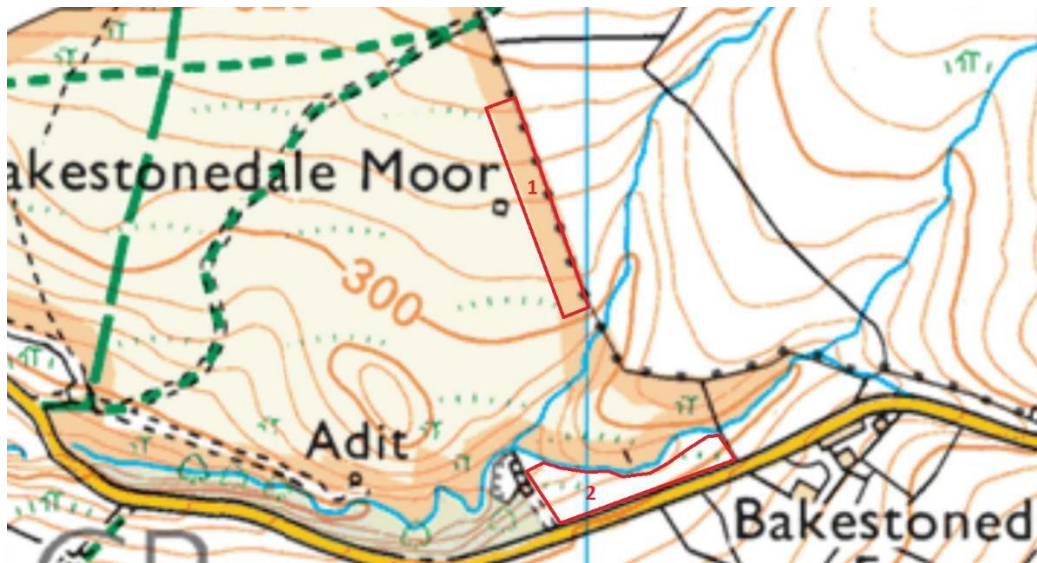
The planting of 4,000 trees and formation of two new shelter belts totalling 2ha in area on previously grazed land will reduce water run-off from heavily-grazed upland and provide habitat and food sources for invertebrates, birds and mammals. The areas which have been fenced contain no bracken and the fencing will protect the area from stock, allowing ground flora and shrubs to grow between the new trees. Due to the high grazing density on the upper moor there is very little natural regeneration of the few existing trees, so these trees will add significantly to the biodiversity of the upland.

The areas of tree planting are shown in the maps below.
