Castle Community Centre Rain Garden

2. Description

The excavated rain garden at Age UK's Castle Community Centre was designed as a retro-fit project suitable for installation by volunteers. Its primary purpose is to divert all rainfall landing on the Centres' roof away from the local combined sewer network, into which it had always drained. This helps reduce the risk of river pollution from Combined Sewer Overflows (CSOs) at times of peak rainfall. Much of the sewer network in older districts of Northwich is of the 'Combined' type and CSO events are an important source of pollutants in the River Weaver and River Dane within the town.

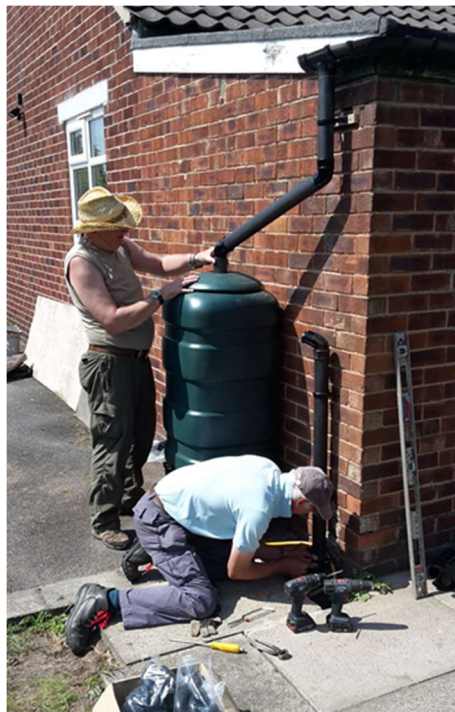
1. Crewe Conservation Volunteers install the water butts

The first part of the system to be installed was a series of four water-butts; one at each of the downpipes from the guttering around the roof of the single storey community centre building. These enable collection of rainwater for use in watering the centre's developing garden, and when full, overflows into a buried pipe network, which carries water to the excavated raingarden.

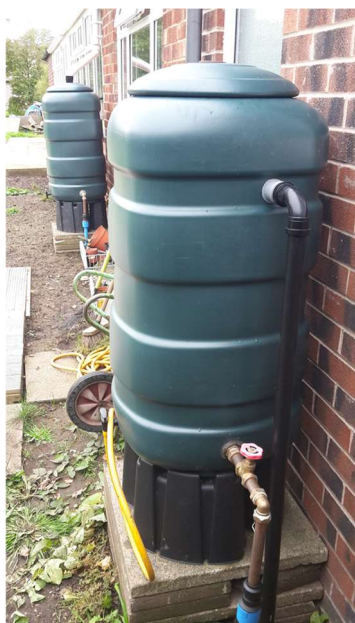
2. Water butts showing isolation valves and overflow pipe to raingarden

Three of the water butts are connected together by buried pipework and isolating valves, which enable these to be drained down individually or as a single unit providing a greater head of water and increased water pressure for use via hosepipes around the garden.

- Silt is also prevented from entering the system at the earliest stage as the waterbutts themselves act as effective silt traps, with water overflowing into the system only from the top of the waterbutt, while any silt will safely accumulate at the bottom.

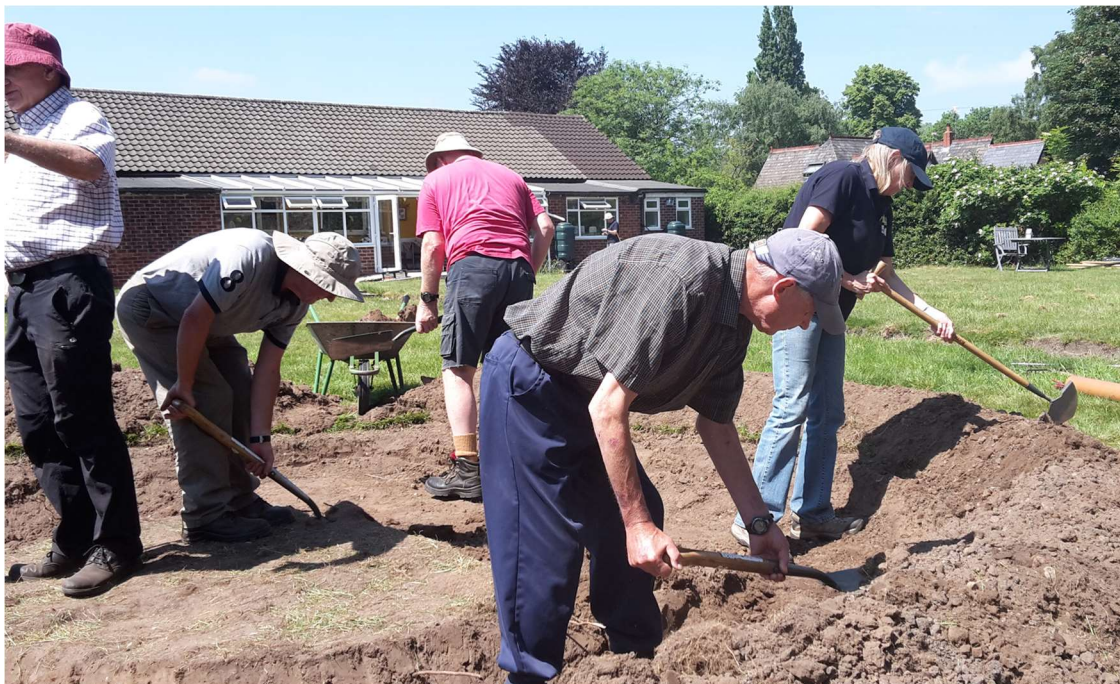
3. Vale Royal Conservation Volunteers excavate the rain garden

The raingarden was excavated by hand in free draining sandy subsoil to a depth of approximately 60cm. A bund approx. 20cm high was created around rim of the excavation to provide extra capacity and avoid flooding of surrounding areas in periods of extreme rainfall.

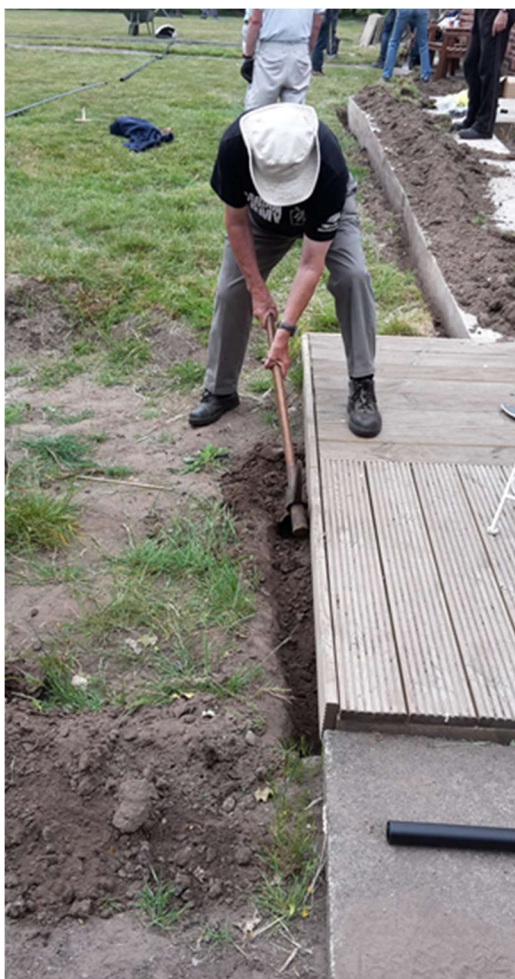
4. Vale Royal Conservation Volunteers excavate the pipe trenches

Prior to backfilling, trenches were dug and pipework installed, using easy-to-install black plastic 40mm waste pipe with pushfit connectors.

- A surveyors optical level and ranging pole were used to ensure that a fall of 1:100 was maintained along the length of the pipework to ensure sufficient flow to prevent siltation.

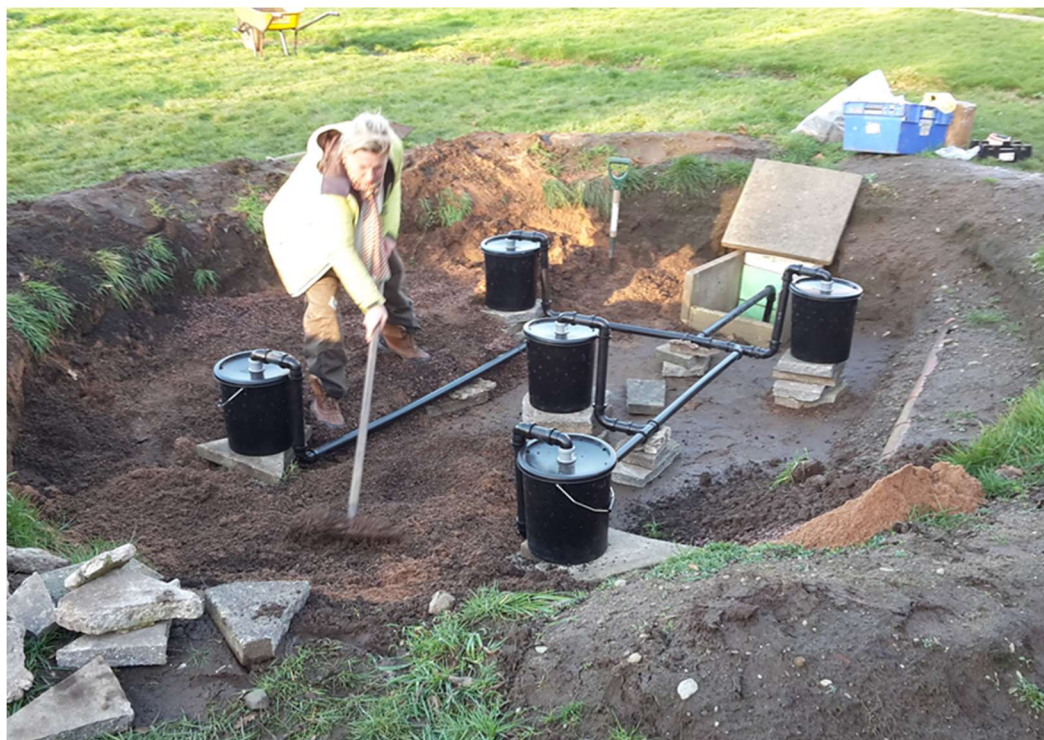
5. Love My River Volunteers installing five-point outfall and silt-trap buckets

- As it enters the raingarden, the pipe carrying rainwater from the waterbutts passes through an inspection chamber which allows for dismantling of the pipework at its lowest point, enabling flushing and de-silting if required.

- From this point the pipe divides into five branches, each branch having its own outfall. This also enables water to be more evenly distributed around the excavation. Each outfall empties into a bucket which has a series of drainage holes drilled into the sides of the buckets at regular spacings between the top and half way down. This enables any silt entering through either the outfall pipe or the drainage holes to settle at the bottom of the bucket.

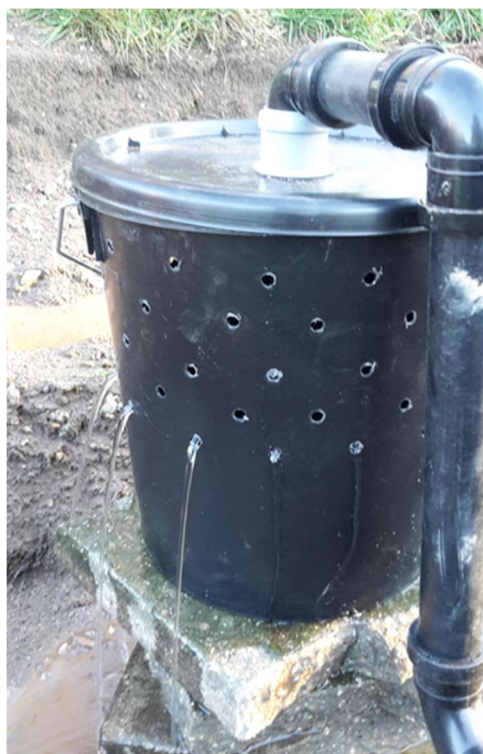
6. Testing silt-trap buckets being for water-flow

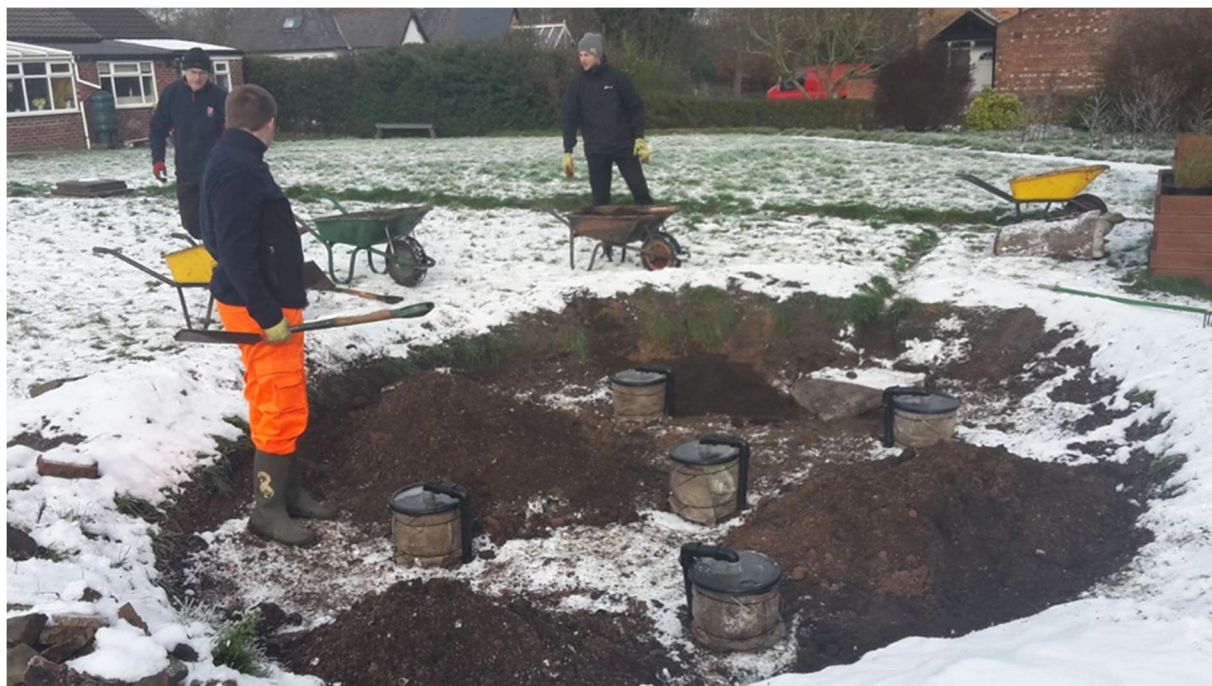
7. Grozone volunteers wrap buckets with geotextile and complete rain garden back-fill

Back fill material for the rain garden consisted of a combination of sand, compost and subsoil, to create a free draining substrate containing enough organic matter to hold in moisture around plant roots during dry spells. Final planting included a range of native wetland and marginal plants, together with some annual wildflower seed for early colour. The bund around the excavation was seeded with an amenity grass seed mix.

- Before final back-filling, the buckets were wrapped with a geotextile material cable tied into place to reduce the likelihood of silt entering through the drainage holes.

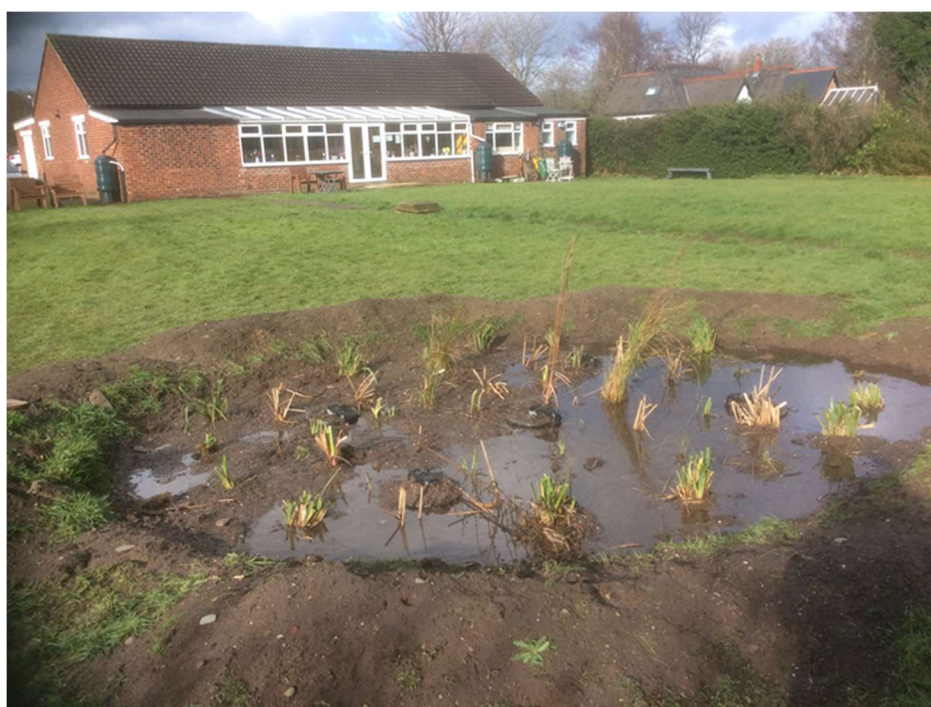
8. Completed rain garden shown soon after planting, the day after a night of heavy rain.

The completed rain garden now acts as an effective soakaway for the rainwater from the community centre roof and has been observed functioning well during periods of extreme rainfall. At the same time, the raingarden provides valuable seasonally wet habitat for wildlife, including pollinating insects.
