# WEST CUMBRIA RIVERS TRUST NATURAL FLOOD MANAGEMENT (NFM) CASE STUDY: HEDGE RESTORATION AND LEAKY DAMS AT MOOR FARM, KESWICK

## ABOUT THE PROJECT

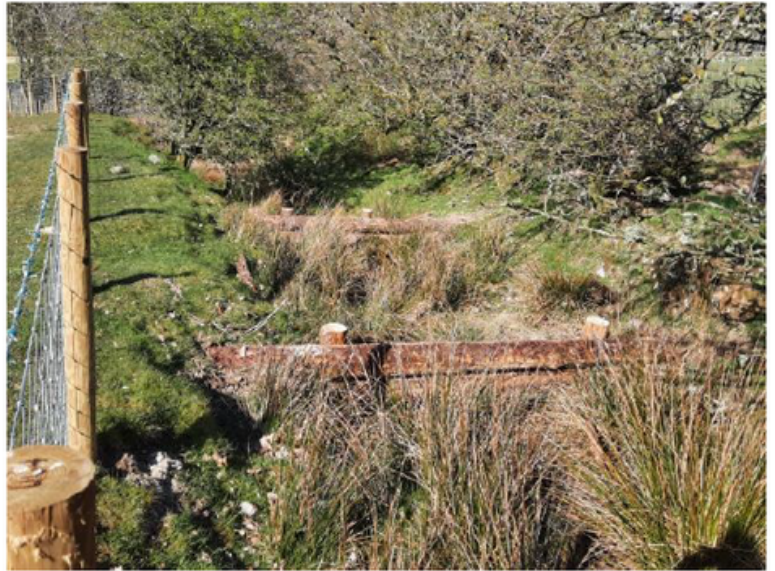
Photo 1 -Leaky dams in 2m wide ditch above main A591, flowing into Keswick.

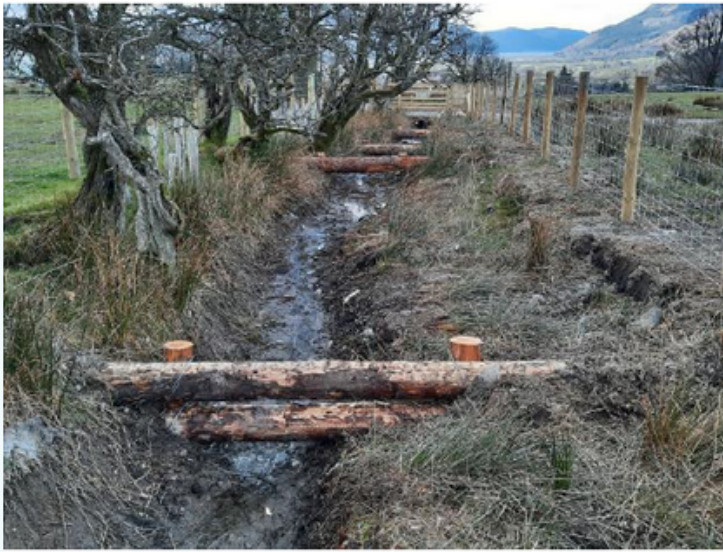
Photo 2 - Leaky dams and hedge restoration in ditch flowing directly down into Keswick.  
Image: West Cumbria Rivers Trust

The dams have been constructed to be very leaky and made using locally sourced larch, which were knocked in using larch posts for longevity and to give a more natural look. The vegetation in the ditches is now long so that the dams are less visible from the roads.

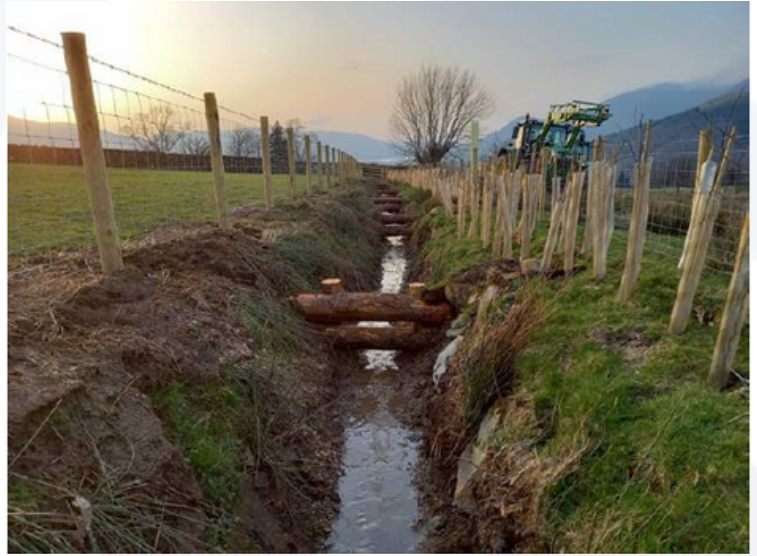
Photo 3 - Another photo of restored hedge and leaky dams above Keswick.  
Image: West Cumbria Rivers Trust
