WEST CUMBRIA RIVERS TRUST NATURAL FLOOD MANAGEMENT (NFM) CASE STUDY: LONSCALE GULLY EROSION STABILISATION PROJECT

BACKGROUND INFORMATION

This project was delivered by West Cumbria Rivers Trust as part of their DEFRA funded Glenderamackin Natural Flood Management (NFM) Project, in partnership with the Environment Agency and landowners.

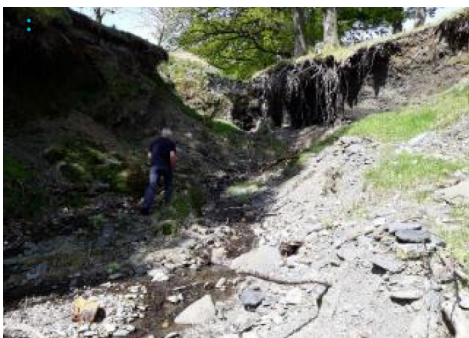
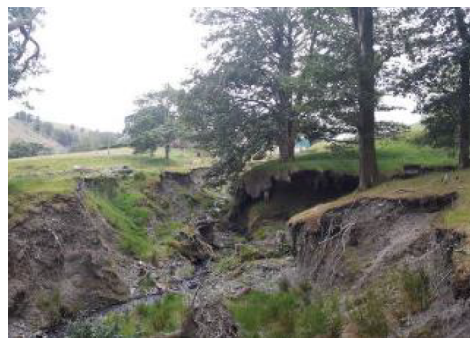
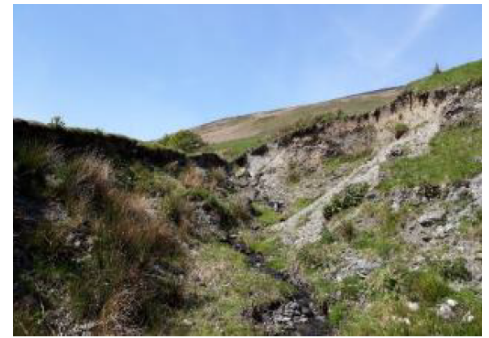
The project involved stabilising two large gullies on an upland farm. These are upstream migrating knickpoints which are actively eroding which resulted in the release of large volumes of sediment downstream during the floods of 2009 and 2015. The sediment was deposited in the main river downstream effectively reducing channel capacity and increasing flood risk. It also led to the loss of agricultural farmland and poses a potential future risk to the farm buildings.

The bed of both gullies is composed of highly erodible fluvial and glacial sediments. Stabilisation was carried out using gravels from a culvert upgrade project elsewhere on the farm (to improve fish passage and enable a more natural sediment transfer regime, funded through the Water Environment Grant).

Before - Photos showing the before photos in the gully. Images: West Cumbria Rivers Trust

Local sourced stone and woody material were knocked into the culvert to create a series of bed check weirs. Large woody debris features were added to facilitate stabilisation and to create a less easily erodible gravel bed in the river, these were created from the coppicing of 3 – 4 dangerous oak trees overhanging the gully. Additional seeding, scrub planting and planting of willow stakes have also contributed to increased hydraulic roughness at the site. The gullies have also been fenced off from livestock to enable vegetation to establish. Stone from bed check weirs was sourced from a local quarry. No treated timber was used. Banks were regraded once the excavator had left site. The project also included the restoration of 135m of cross slope hedge.

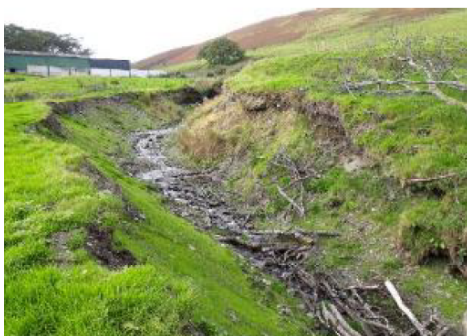
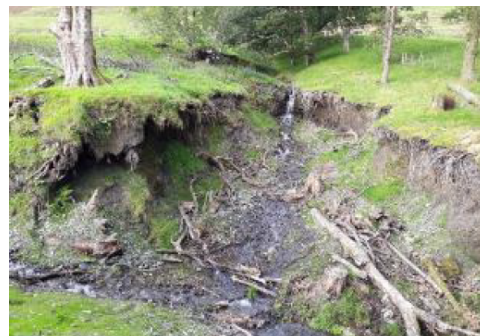
After - Photos showing the gullies afterwards with trees installed, bed check weirs, large woody debris features and them fenced off from livestock and seeded. Images: West Cumbria Rivers Trust
