WEST CUMBRIA RIVERS TRUST NATURAL FLOOD MANAGEMENT (NFM) CASE STUDY: THRELKELD HALL FARM FLOODPLAIN BUND

Threlkeld Hall Farm schematic – NFM Project

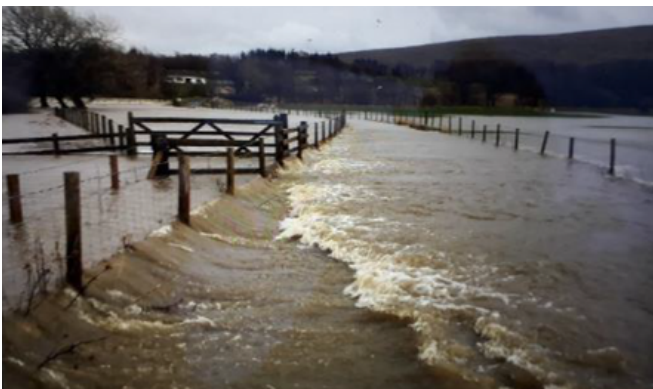
Flooding on golf course access road, February 2020 (Photo below taken by farmer at Threlkeld Hall Farm).

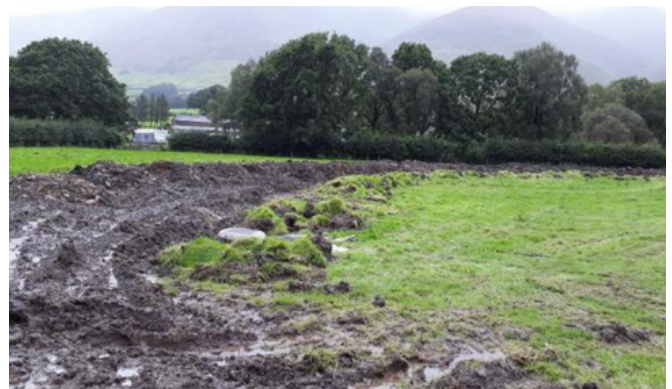
Photo of bund during construction.

Floodplain bund: A topographical survey was carried out by an external company and the floodplain bund was designed by a contractor and project officer using a laser level to determine the optimum height of the bund on the floodplain (and therefore estimating water storage behind bund before it drains through an existing concrete culvert). The final height of the bund was determined by how much material could be generated through creating and restoring two ponds in the woodland nearby. The stone for the leaky dams was from a nearby quarry (see photos below).

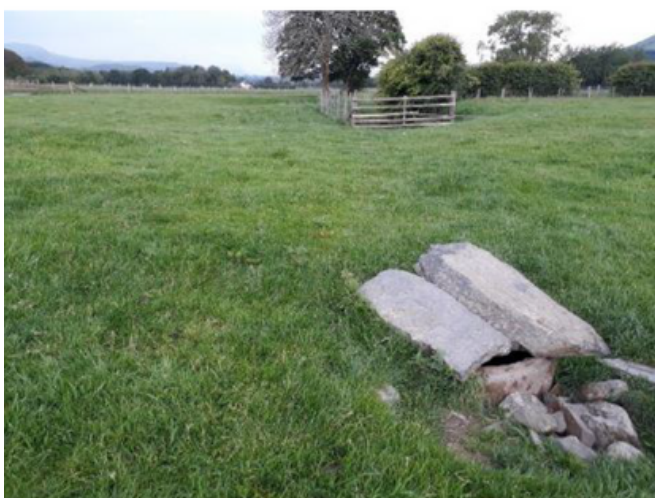
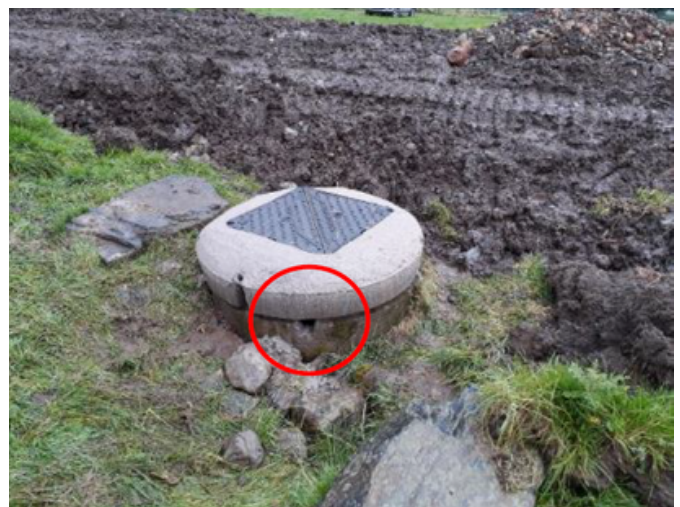
Photo of culvert before and after restriction placed on it (the outlet, as circled in red on the second image, can be amended following monitoring).

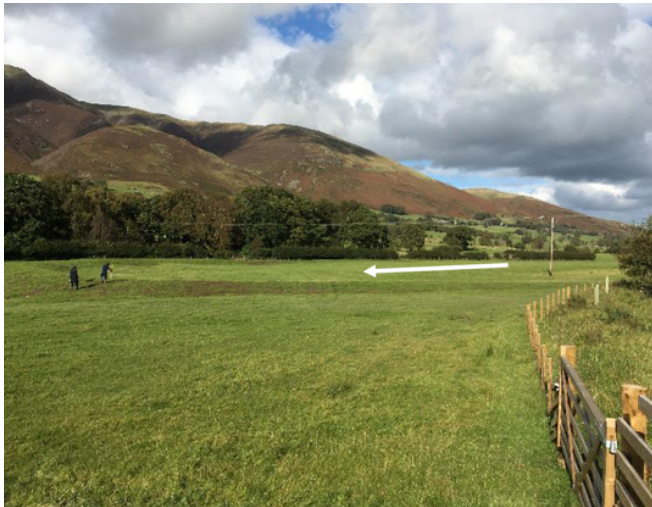
Photo of finished floodplain bund (white arrow shows direction of flow of floodwater).

The volume of water stored behind the floodplain bund is 4300m³ and the effectiveness of the project is monitored through anecdotal evidence for the landowner, water level loggers and time lapse cameras for the small-scale pond and floodplain bund.

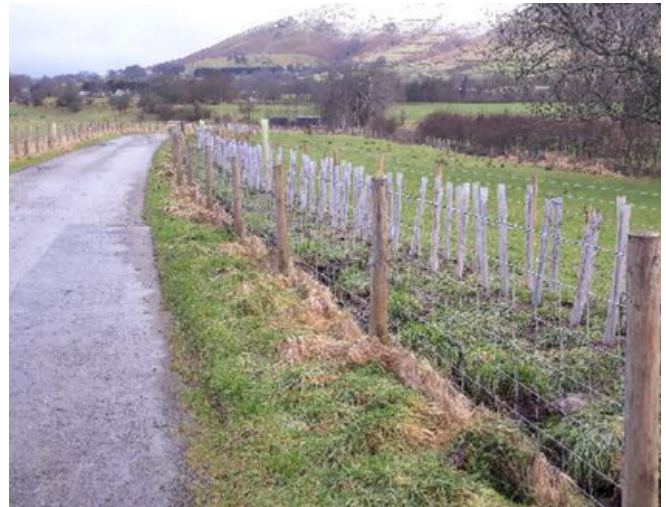
Photo of kested hedge.
