Low Crosby

Location, development and flood history

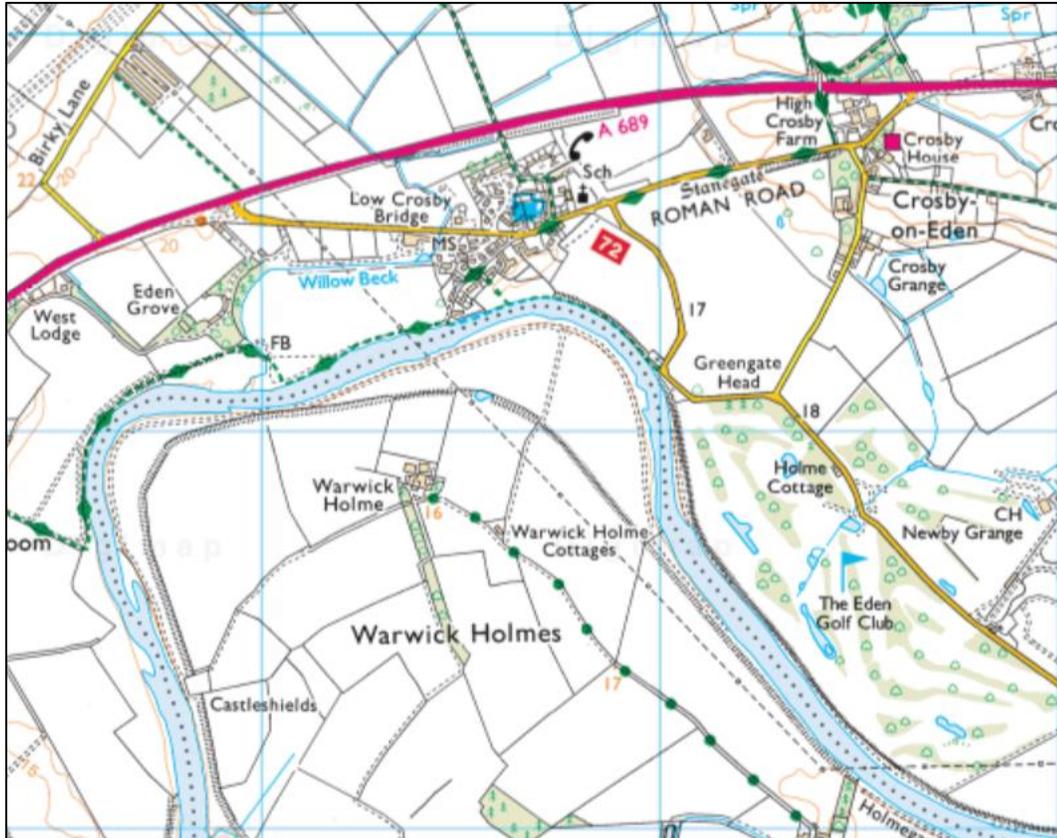
- Notice that the village is situated on flat ground on the north bank of a river meander.
- There is a small stream, Willow Beck, that drains land north of Low Crosby and discharges into the River Eden, west of Low Crosby.
- Willow Beck skirts the north and western sides of the village.
- Low Crosby is a residential village with no large commercial enterprises.

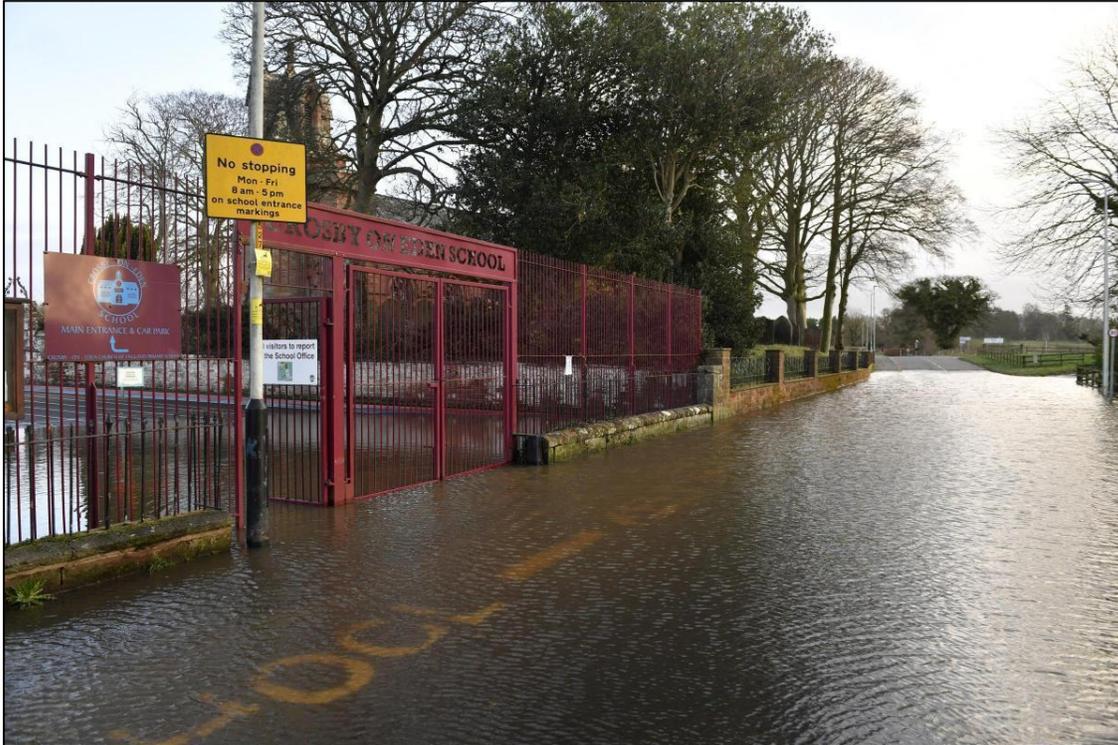
Low Crosby - flood history

- There are 110 residential properties in Low Crosby.
- Low lying and situated on the banks of the River Eden, the village is prone to flooding.
- In recent decades, Low Crosby has suffered serious flooding in 1968, 1995, 2005 and 2009.
- In 2015, Storm Desmond caused severe flooding. Most recently, Storm Ciara caused flooding in 2020.

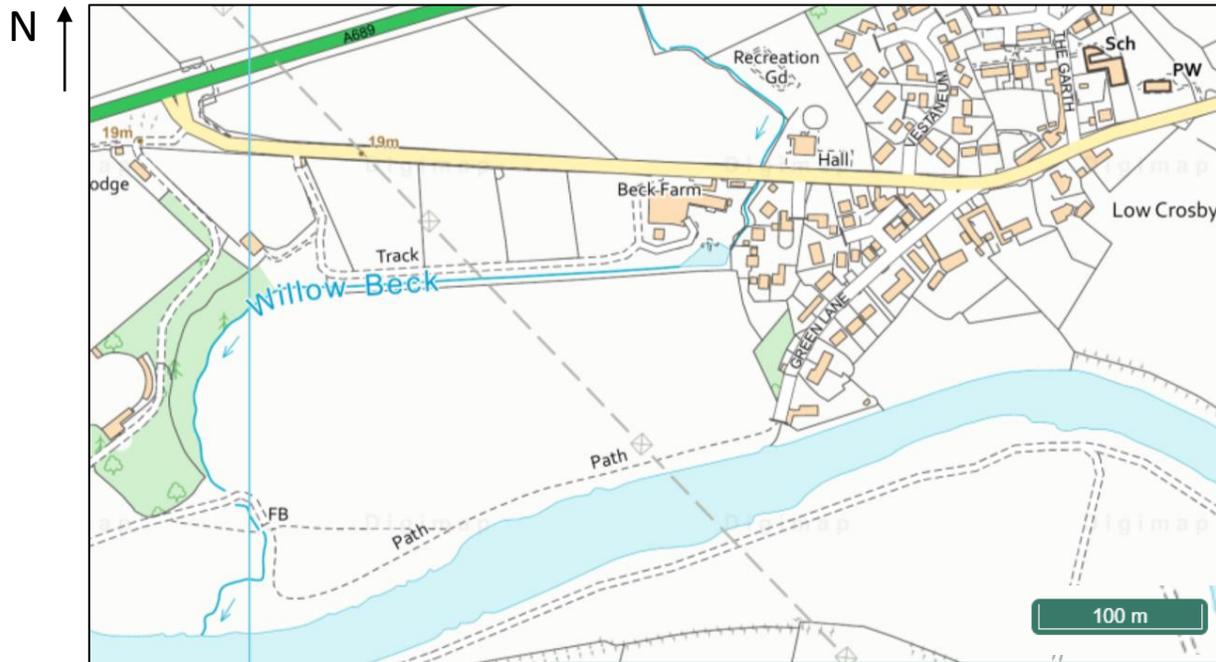
There are three main reasons why Low Crosby is prone to flooding

1. The River Eden overtops its banks during periods of exceptionally high flow (due to high rainfall/snowmelt).
2. During high flow, water from the River Eden flows up the Willow Beck causing the village to flood.
3. Surface water flooding following an intense storm or period of heavy rain.

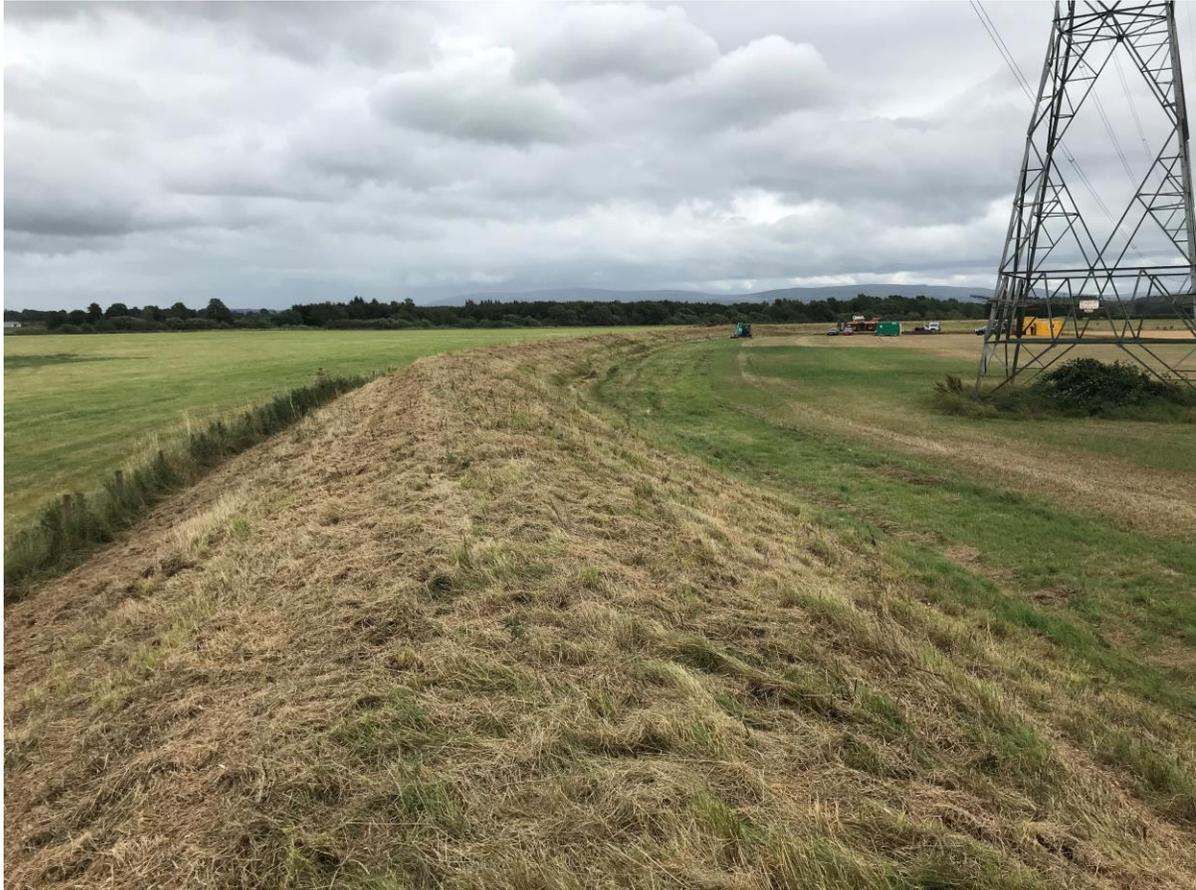
- Following the floods of 2005, a new defence scheme was constructed in 2009-11 to reduce flood risk.
- A 380m long earth embankment was constructed to the east of Low Crosby.
- This scheme included a sump chamber designed to accommodate a temporary pump. This is because the surface water drainage systems cannot discharge freely, so a pump is required.
