The River Irwell at Kearsley Flood Risk Management Scheme

20th September 2023- Comm

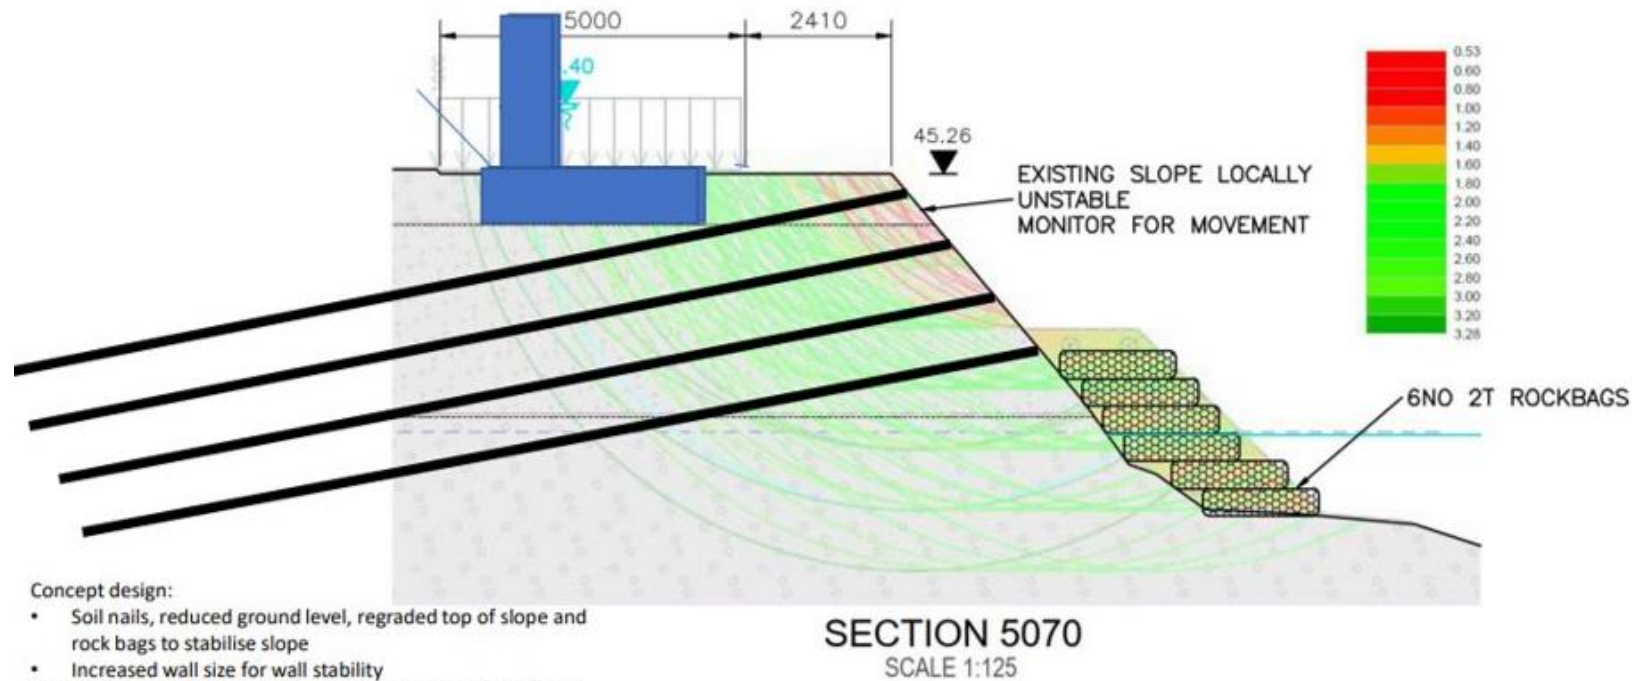
Conceptual design - Flood Wall, soil nails and rock bags

Concept design:

- Soil nails, reduced ground level, regraded top of slope and rock bags to stabilise slope

- Increased wall size for wall stability

1. Lower ground level
2. Install rock bags
3. Regrade slope
4. Soil nail
5. Build wall

This option includes a combination of methods. Soil nails and rock bags provide stability to the riverbank to allow the construction of a flood wall at the top of bank.

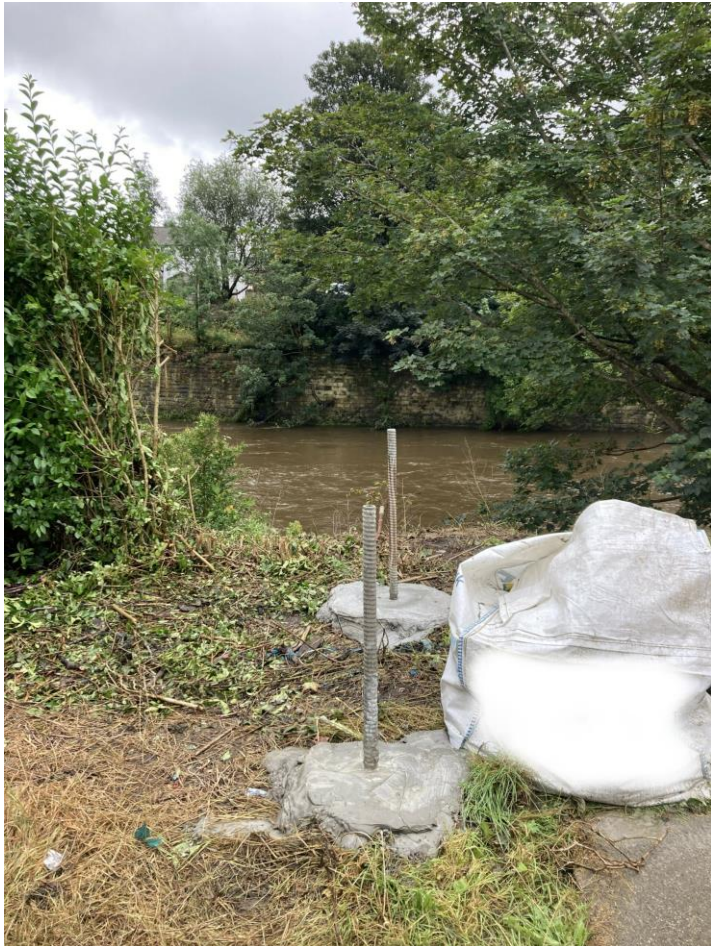
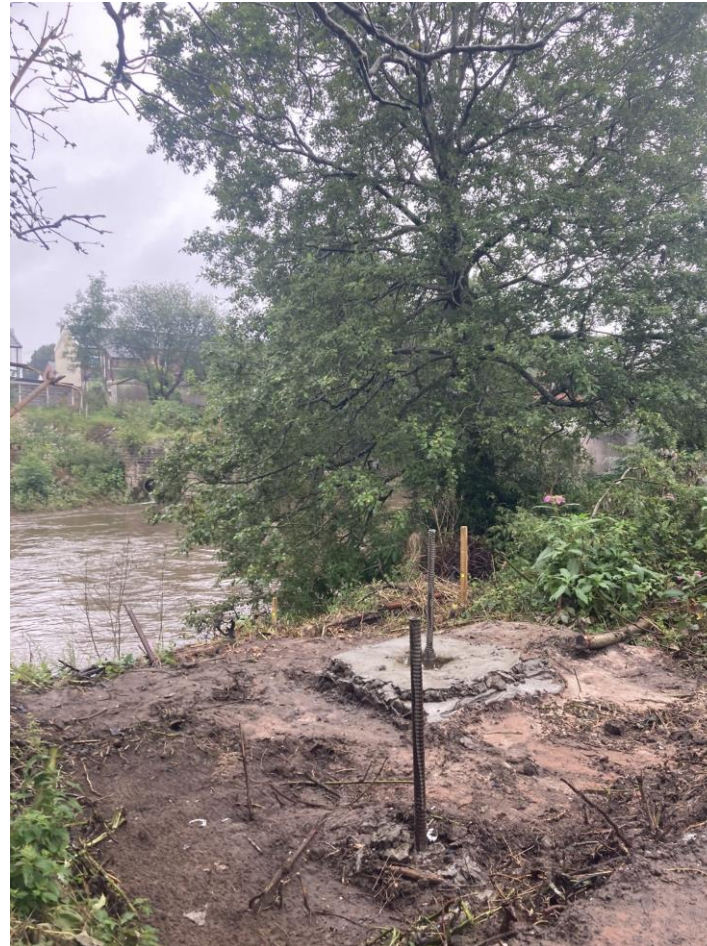
Investigations July 2023

Over the summer ground investigations and soil nail tests were carried out on the riverbank to identify if this intervention is appropriate in this location.

Results from the 'pull out tests' showed that there is a possibility that this option may provide the required bank stability however there are still challenges with the design that need to be addressed before we have full confidence in the scheme.

Difficult ground condition: All soil nails refused to penetrate below 6m due to hard strata which was unexpected. The design requires the soil nails to penetrate below 6m. Consultants and contractors will be investigating alternative drilling techniques and different machinery to determine if the soil nails can penetrate below 6m.

Grout Loss: After installation of the soil nails, the contractors pumped grout around the nails in order to seal them in place. It was found that in some locations more grout was being pumped to fill this void than expected, this raised concerns around grout loss/seepage. Consultants and contractors are looking at different methods to contain the grout, such as casing, to ensure there are no environmental impacts.
