CASE STUDY: LIVERPOOL - EGREMONT LAWN, WOODLANDS ESTATE

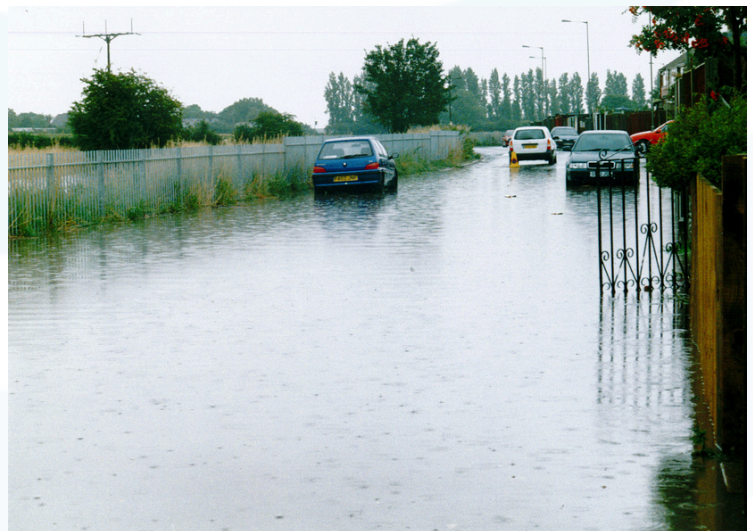
The area experienced considerable rainfall from around 18:00 on the 23rd September and continued over night. The rain gauge at Fazakerley recorded over 82mm in 48 hours and nearly 90mm in 60 hours. This amount of rainfall has a probability of occurring approximately every 30 to 35 years. The properties flooded initially from the front and later from the rear (Winsters Drive) as a pond of water accumulated on the road and into the gardens of the properties.

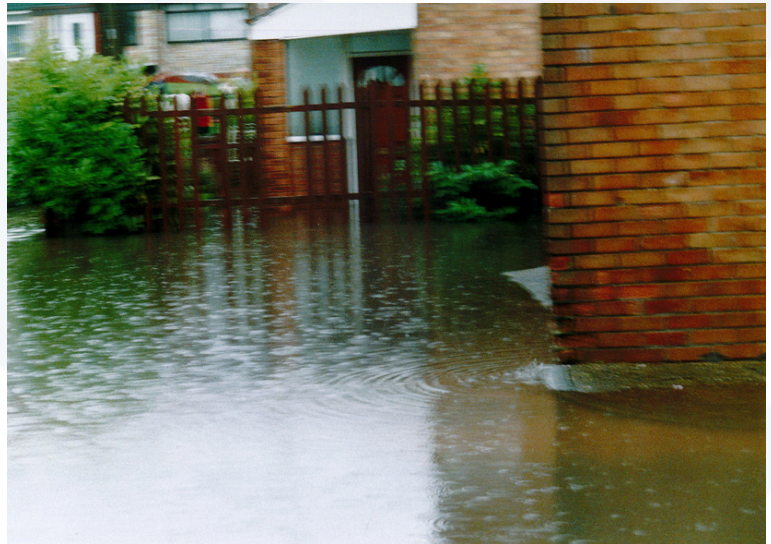
Water later came in through the rear of the houses, not helped by the wash caused by cars travelling down Winster Drive. Residents blocked off the road with their cars. The Environment Agency issued a Flood Alert for the River Ditton catchment that includes Netherley Brook at 15:50 on 24th September 2012, although this alert was not for surface water flooding. United Utilities were contacted on the 24th September and offered to supply sandbags. They confirmed their assets were in order after attending the site on the 25th. Enterprise Liverpool attended the site on the 25th and used a suction wagon to inspect and clear the gullies. The water had drained away by 06:00 on the 26th September according to a resident.

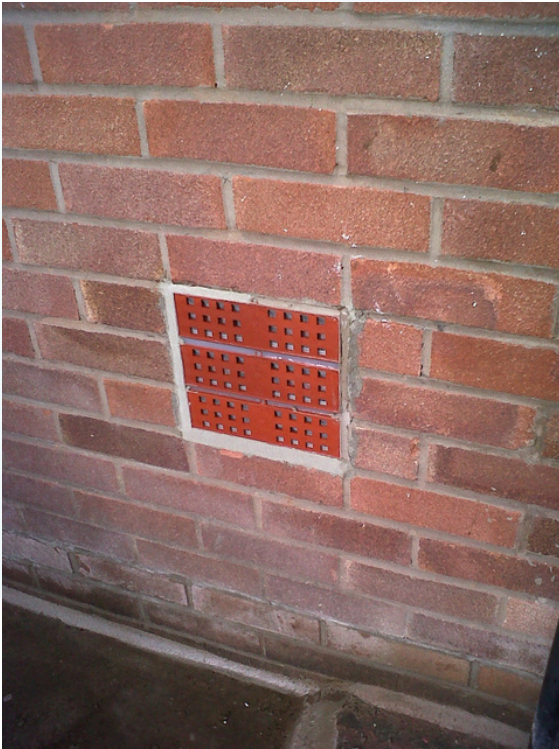
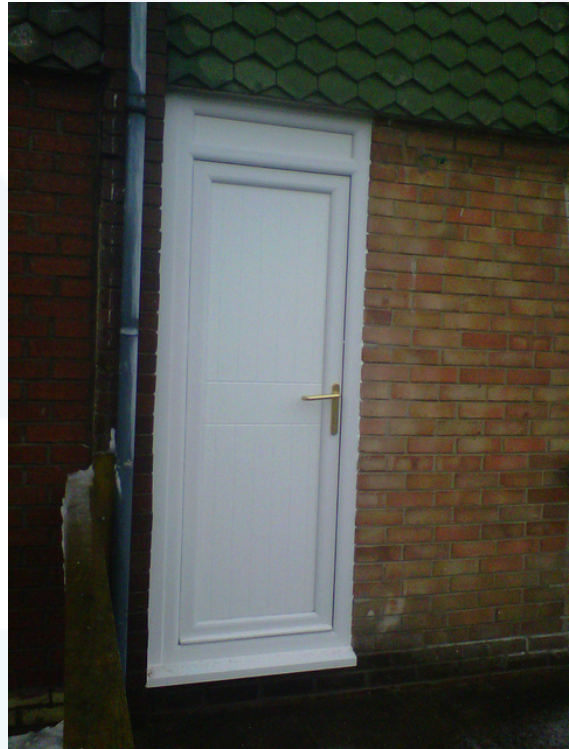
Six of the most at risk properties received Property Level Protection from Environment Agency grant monies. This included fitting flood doors, flood airbricks, re-pointing and spraying sealant on the house bricks to 1 metre.
