WEST CUMBRIA RIVERS TRUST NATURAL FLOOD MANAGEMENT (NFM) CASE STUDY: CHARLESGROUND LEAKY BARRIERS AND BUND

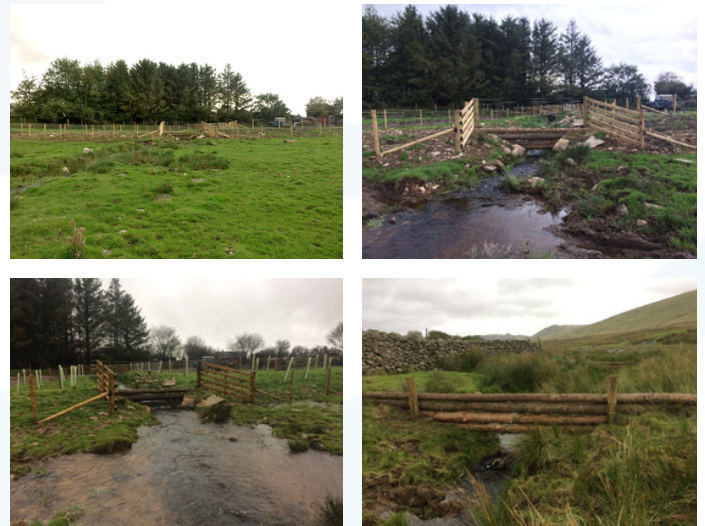
Images: West Cumbria Rivers Trust. Images of project area and leaky dams.

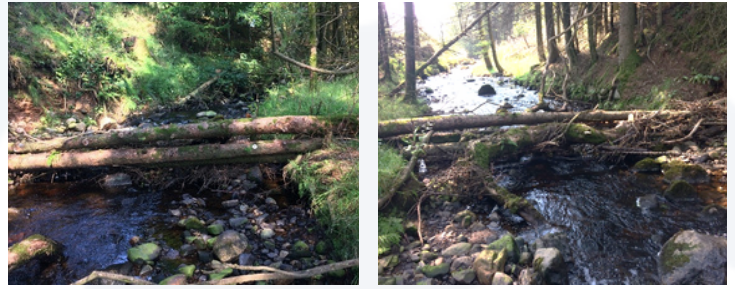
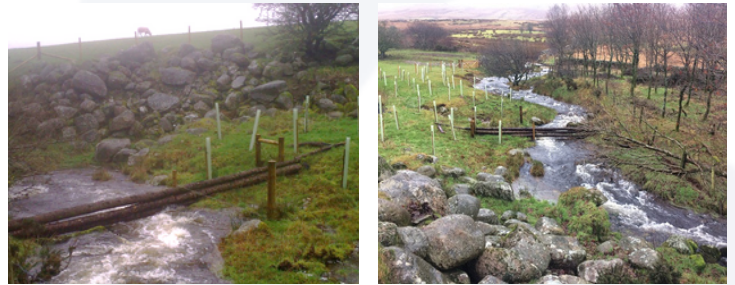
Larch was felled from a plantation next to the river and used in the construction of all the leaky dams. The bund was created from earth available on site. Logs were pinned together using metal bars and dug into the bank/bund. For the leaky dams on the main river, logs were also secured behind tree stumps on the bank.

Images: West Cumbria Rivers Trust. Images of leaky dams.

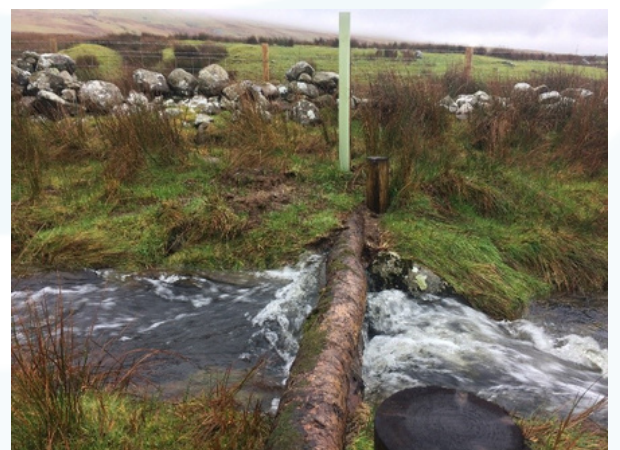
Image: West Cumbria Rivers Trust. Image of leaky dam
