WEST CUMBRIA RIVERS TRUST NATURAL FLOOD MANAGEMENT (NFM) CASE STUDY: LONSCALE GULLY EROSION STABILISATION PROJECT

BACKGROUND INFORMATION

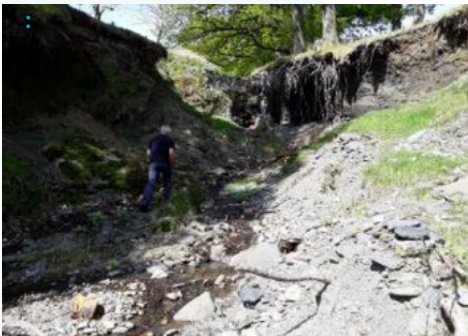
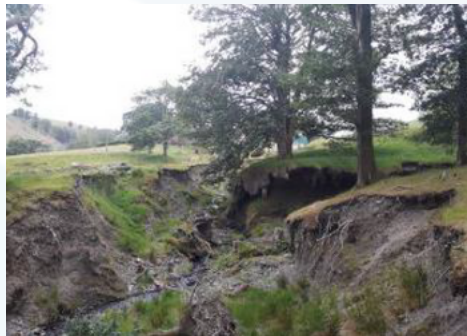
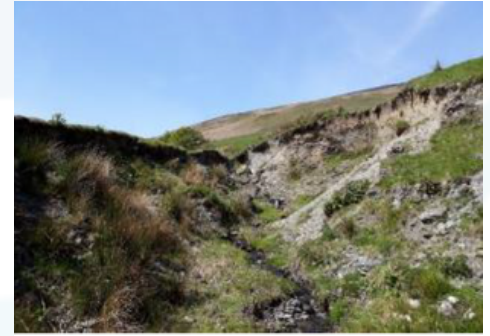
The project involved stabilising two large gullies on an upland farm. These are upstream migrating knickpoints which are actively eroding which resulted in the release of large volumes of sediment downstream during the floods of 2009 and 2015. The sediment was deposited in the main river downstream effectively reducing channel capacity and increasing flood risk. It also led to the loss of agricultural farmland and poses a potential future risk to the farm buildings.

The bed of both gullies is composed of highly erodible fluvial and glacial sediments. Stabilisation was carried out using gravels from a culvert upgrade project elsewhere on the farm (to improve fish passage and enable a more natural sediment transfer regime, funded through the Water Environment Grant).

Before - Photos showing the before photos in the gully. Images: West Cumbria Rivers Trust

Local sourced stone and woody material were knocked into the culvert to create a series of bed check weirs. Large woody debris features were added to facilitate stabilisation and to create a less easily erodible gravel bed in the river, these were created from the coppicing of 3 - 4 dangerous oak trees overhanging the gully. Additional seeding, scrub planting and planting of willow stakes have also contributed to increased hydraulic roughness at the site. The gullies have also been fenced off from livestock to enable vegetation to establish. Stone from bed check weirs was sourced from a local quarry. No treated timber was used. Banks were regraded once the excavator had left site. The project also included the restoration of 135m of cross slope hedge.

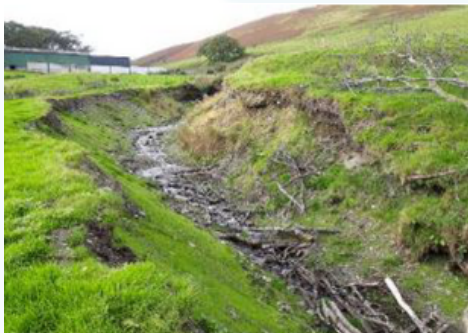
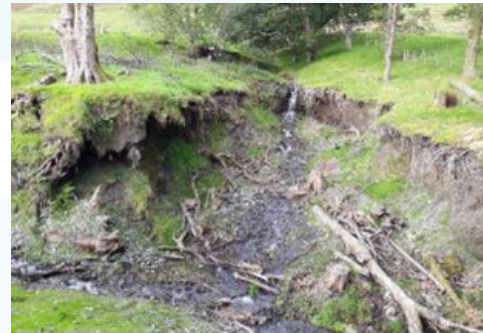
After - Photos showing the gullies afterwards with trees installed, bed check weirs, large woody debris features and them fenced off from livestock and seeded. Images: West Cumbria Rivers Trust
