CASE STUDY: WEST CUMBRIA RIVERS TRUST WATER STORAGE AREA

This project was delivered by West Cumbria Rivers Trust as part of their DEFRA funded Glenderamackin Natural Flood Management (NFM) Project, in partnership with the Environment Agency and landowners. The project includes a large, bunded pond situated above Naddle Beck's floodplain, to provide flood water storage, slow the flow of water and reduce flood risk downstream.

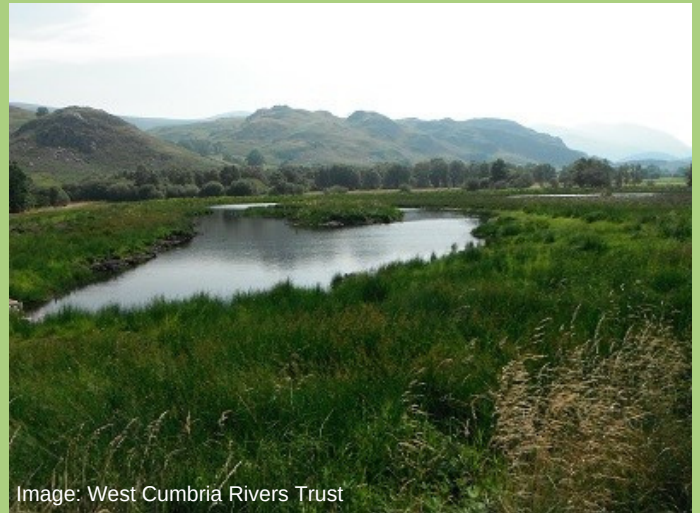
Image: West Cumbria Rivers Trust

A large, elongated pond was dug into the field, fed by high level over flow from an agricultural ditch. The base flow in this ditch will be maintained, with flows only above 15cm being directed into the pond/bunded area.

The final bund created is crescent shaped and extends up to the field boundary either side of the field. It is 370m long x 8-12m wide x 1m high with the outflow set so there is an additional 0.5m of freeboard. **The bund provides an estimated 3,500-4,000m³ of additional flood water storage.**

Outflow of the pond consists of a buried 4inch diameter pipe with a stone lined high level overflow on top. There is a 3inch metal 'T' piece outflow attached to the pipe to control the outflow of the pond during low flows and allow for maintenance access. This is an example of **buried engineering**.

- When creating the pond, once the vegetation layer was broken through, at least 6 foot of peat was found before boulder clay. The design was amended to make the bund wider and more stable.
- There were some access issues due to COVID-19 lockdown and risks during post-construction and monitoring.

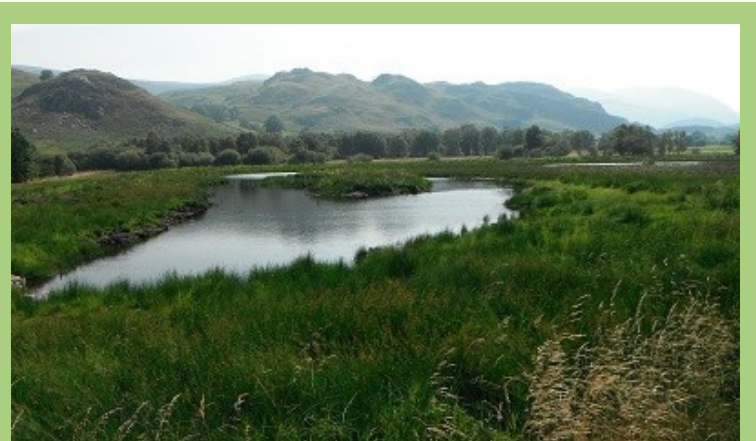
A large, elongated pond was dug into the field, fed by high level over flow from an agricultural ditch. The base flow in this ditch will be maintained, with flows only above 15cm being directed into the pond/bunded area.

The final bund created is crescent shaped and extends up to the field boundary either side of the field. It is 370m long x 8-12m wide x 1m high with the outflow set so there is an additional 0.5m of freeboard. **The bund provides an estimated 3,500-4,000m³ of additional flood water storage.**

Outflow of the pond consists of a buried 4inch diameter pipe with a stone lined high level overflow on top. There is a 3inch metal 'T' piece outflow attached to the pipe to control the outflow of the pond during low flows and allow for maintenance access. This is an example of **buried engineering**.

- When creating the pond, once the vegetation layer was broken through, at least 6 foot of peat was found before boulder clay. The design was amended to make the bund wider and more stable.
- Some access issues due to COVID-19 lockdown and risks during post-construction and monitoring.
