Kendal Flood Risk Management Scheme

Site Update: March Works Progress

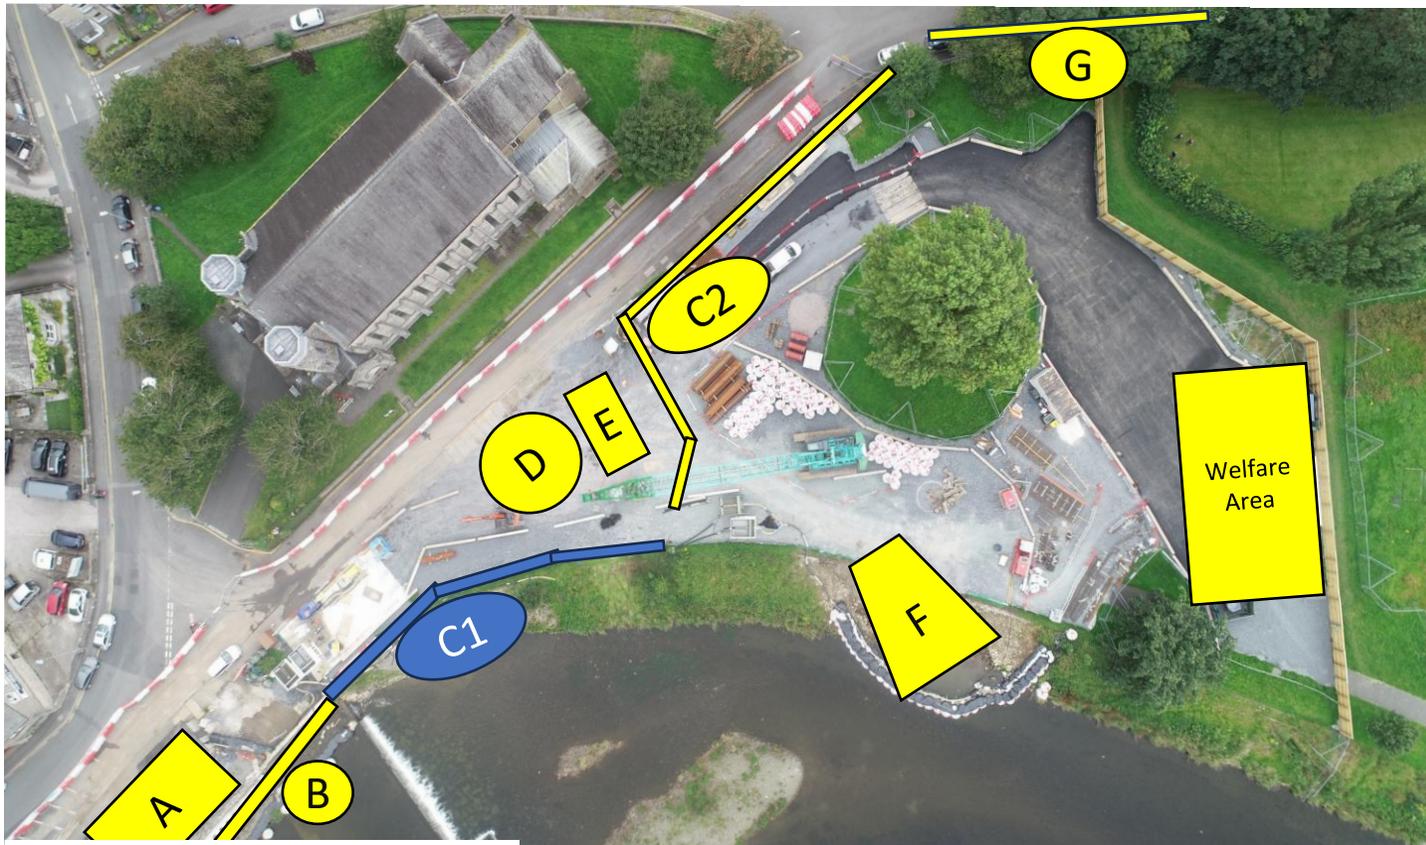
A – Motor Control Centre Building	95%
B – Glass Panel Flood Wall	COMPLETE
C1 – Flood Defence Wall	50%
C2 – Flood Defence Wall	50%
D – Wet Well Shaft	COMPLETE
E – Valve Chamber	COMPLETE
F – Outfall	95%
G – Kerbing Construction & Railings	COMPLETE

Overall completion -

86%

A – Motor Control Centre

Building (MCC)

This building will house all the electrical infrastructure that will power the stock beck pumps in flood conditions.

B – Glass panel flood wall

The glass panels will be partially uncovered with the remaining uncovered once the MCC building is completed

C1 & C2 – Flood wall construction

Constructed from a sheet pile foundation the concrete flood wall will be clad in local stone.

D – Wet Well Shaft

This is the underground structure which will house the pumps for stock beck designed to transfer water of Stock Beck from the Well to the Outfall (A).

E – Valve Chamber

This chamber will house the valves for the onward pumping of Stock Beck in flood conditions.

F – Outfall

The new Stock Beck outfall into the river Kent.

G – Railings & Footpath

Re-instatement of railings and footpath

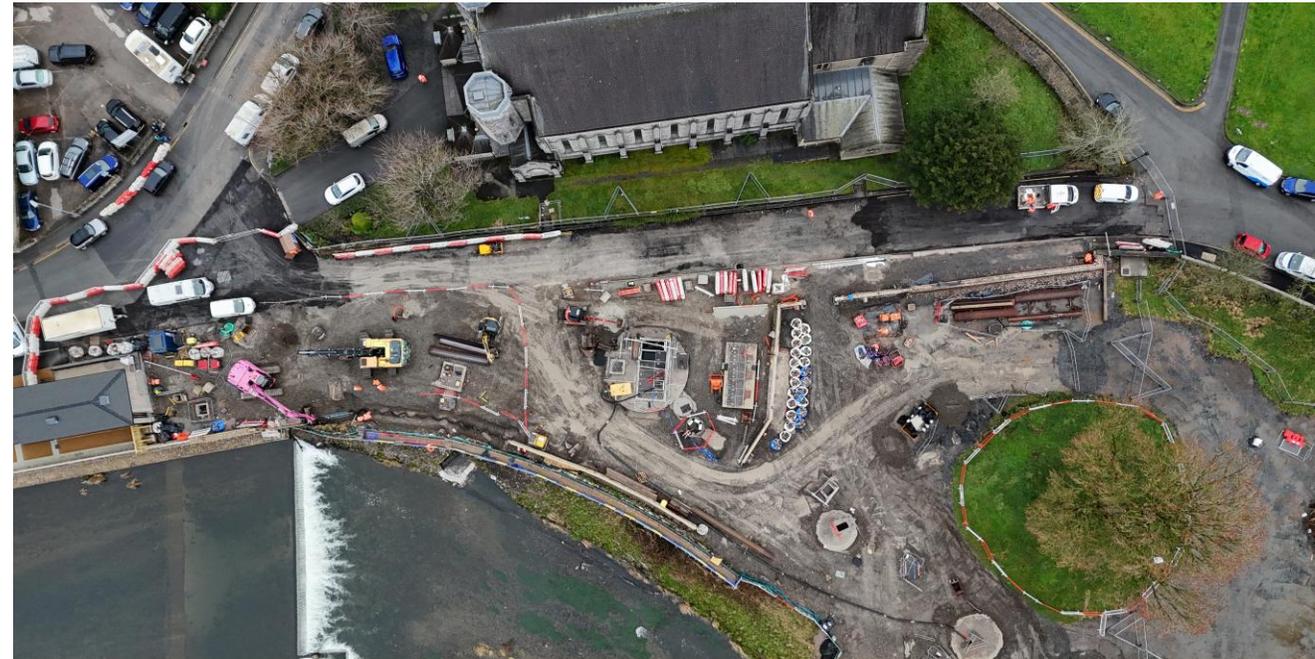
Aerial photograph's of Gooseholme working site following the planning of St Georges Walk

The top layers of tarmac on St Georges Walk have been removed. Kerbing, manholes and general levels are being prepared ahead of the new base layer being laid on Thursday 12th and Friday 13th March. We apologise for any inconvenience caused during these essential works and appreciate your patience as we work to reinstate and improve St Georges Walk.

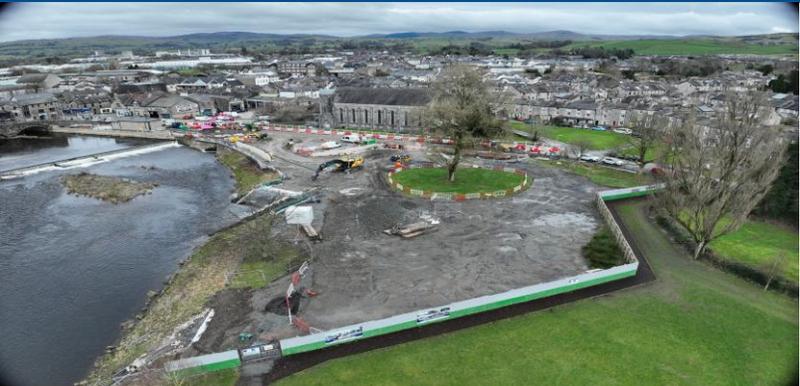
Aerial view of the common following the removal of the tarmac and staff welfare cabins

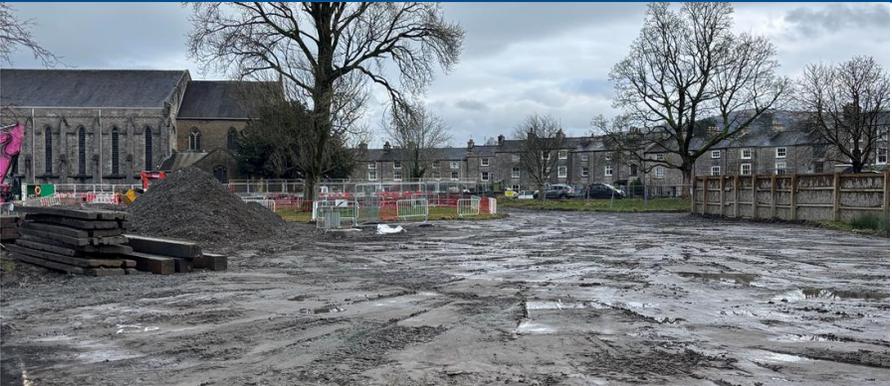
Preparation for the common reinstatement

The solid wooden fencing lining the bark path has been removed this week. The temporary bark path is now closed whilst reinstatement of the Common in this area starts. This closure allows us to carry out re-levelling, soiling and seeding works.

As part of the reinstatement, new planted beds will be created along the boundary of the Common, with several new trees being added to enhance the area.

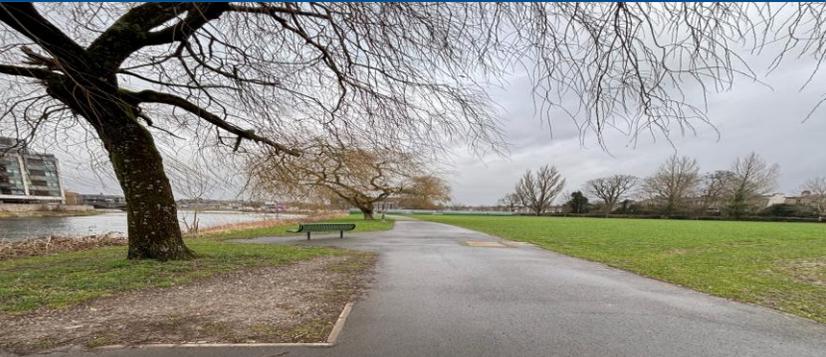
Riverside path in Gooseholme Common to have new ducting for street lighting and trees planted

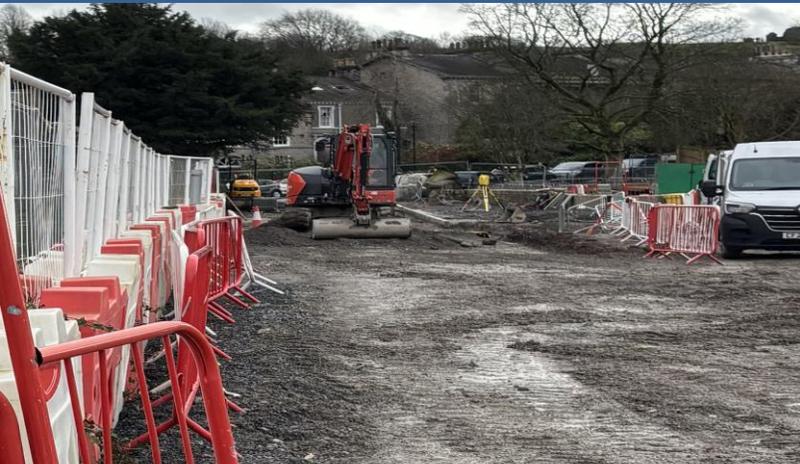
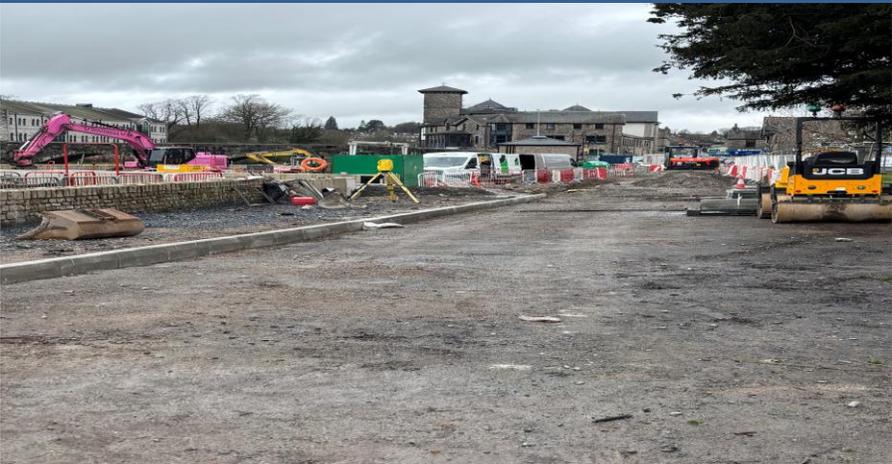
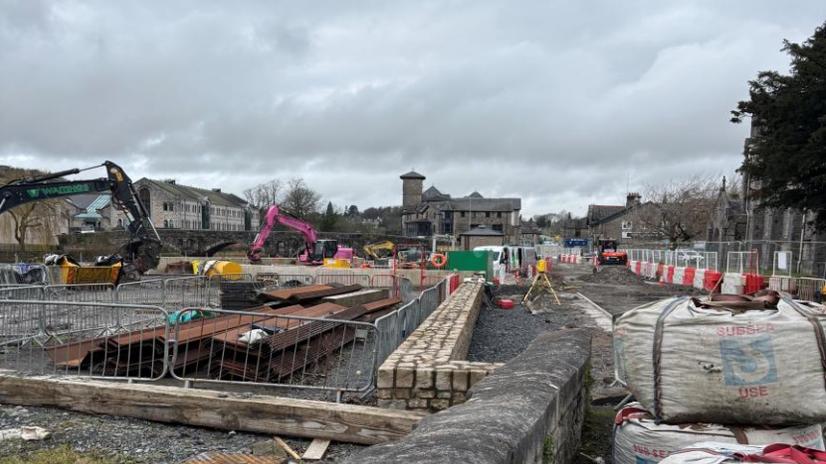
The re instatement has commenced on St George's Walk
