Kendal Flood Risk Management Scheme

Gooseholme Common update for Week Commencing Monday 16th March 2026

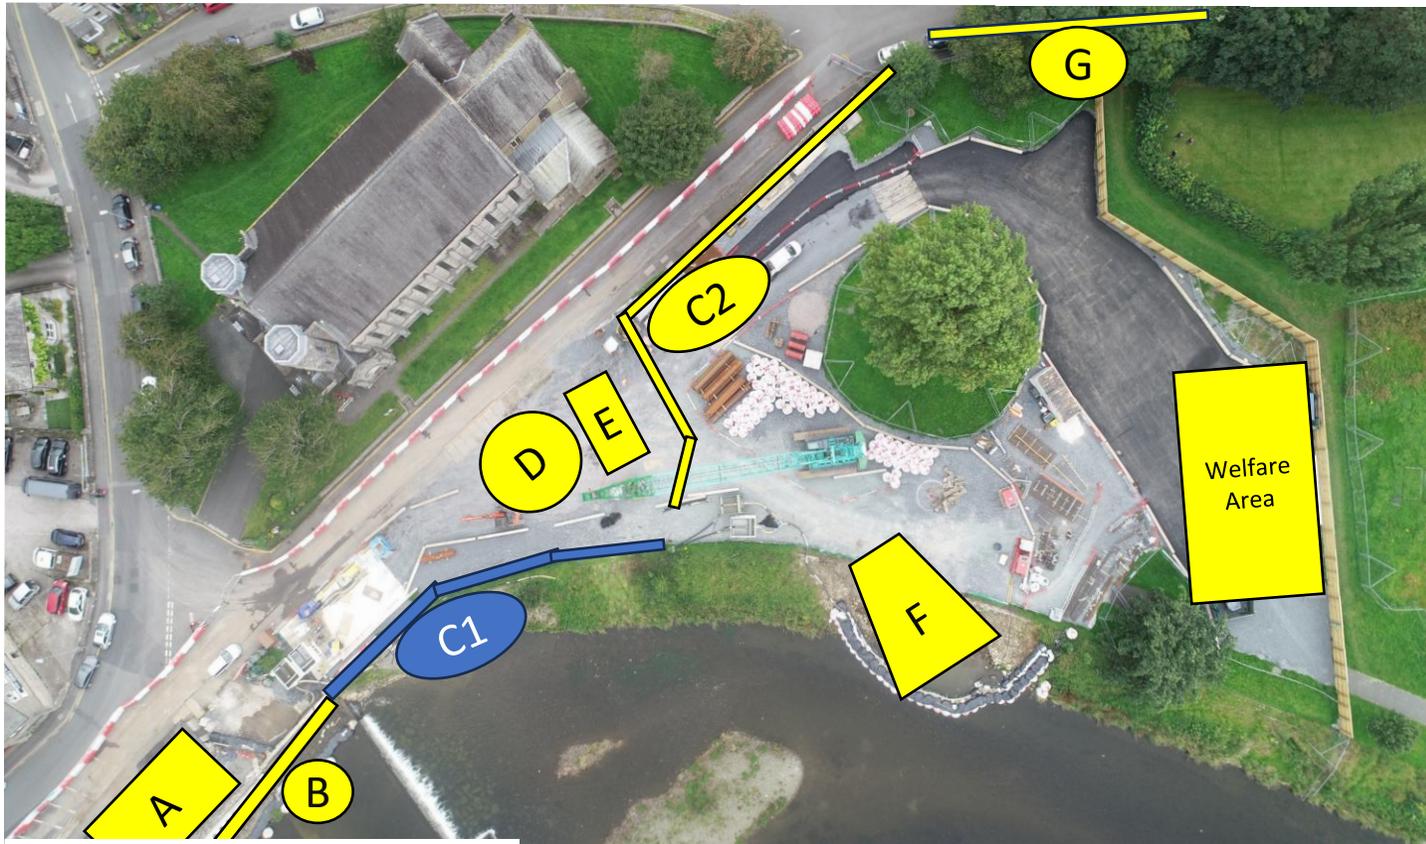
A – Motor Control Centre Building	98%
B – Glass Panel Flood Wall	COMPLETE
C1 – Flood Defence Wall	55%
C2 – Flood Defence Wall	75%
D – Wet Well Shaft	COMPLETE
E – Valve Chamber	COMPLETE
F – Outfall	95%
G – Kerbing Construction & Railings	COMPLETE

Overall completion -

90%

A – Motor Control Centre

Building (MCC)

This building will house all the electrical infrastructure that will power the stock beck pumps in flood conditions.

B – Glass panel flood wall

The glass panels will be partially uncovered with the remaining uncovered once the MCC building is completed

C1 & C2 – Flood wall construction

Constructed from a sheet pile foundation the concrete flood wall will be clad in local stone.

D – Wet Well Shaft

This is the underground structure which will house the pumps for stock beck designed to transfer water of Stock Beck from the Well to the Outfall (A).

E – Valve Chamber

This chamber will house the valves for the onward pumping of Stock Beck in flood conditions.

F – Outfall

The new Stock Beck outfall into the river Kent.

G – Railings & Footpath

Re-instatement of railings and footpath

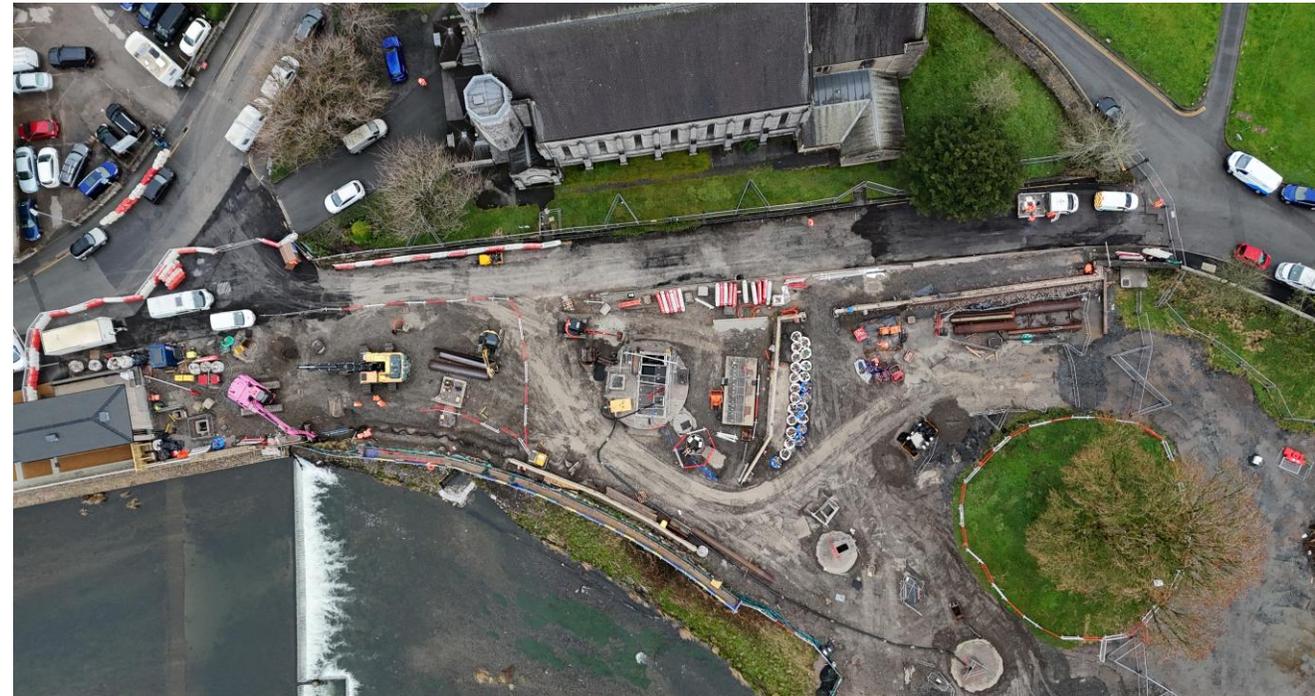
Aerial photograph's of Gooseholme working site following the planning of St Georges Walk

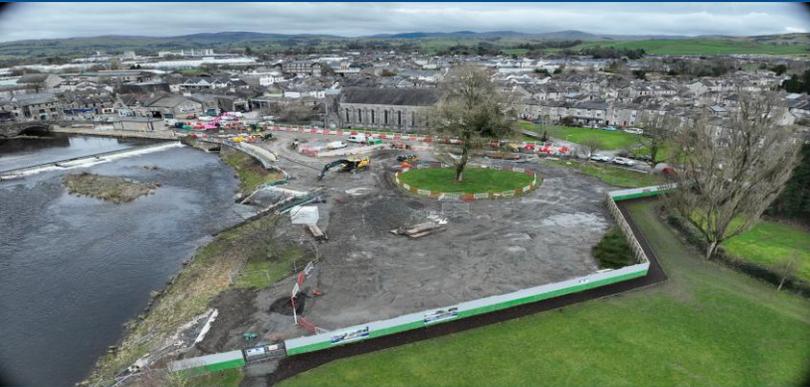
Aerial view of the common following the removal of the tarmac and staff welfare cabins

The solid wooden fencing along the temporary bark path has been removed, and the path is now closed to allow reinstatement of the Common. Works in this area will include re-levelling, soiling, and seeding. New planted beds will be established along the boundary of the Common, complemented by the addition of several new trees to enhance the local environment.

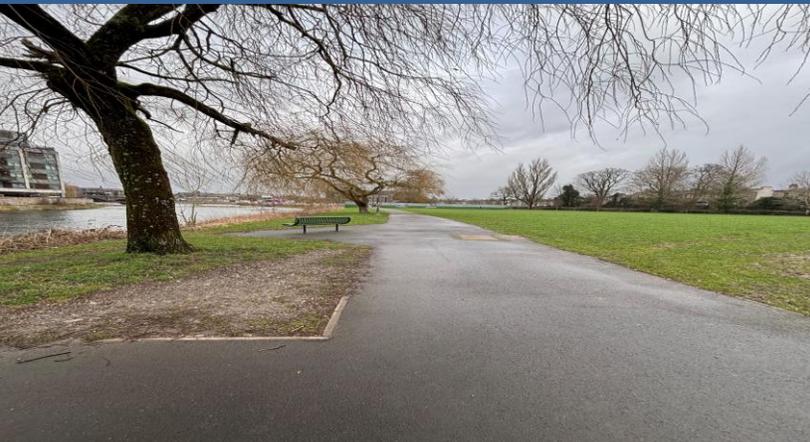
Riverside path in Gooseholme Common to have new ducting for street lighting and trees planted

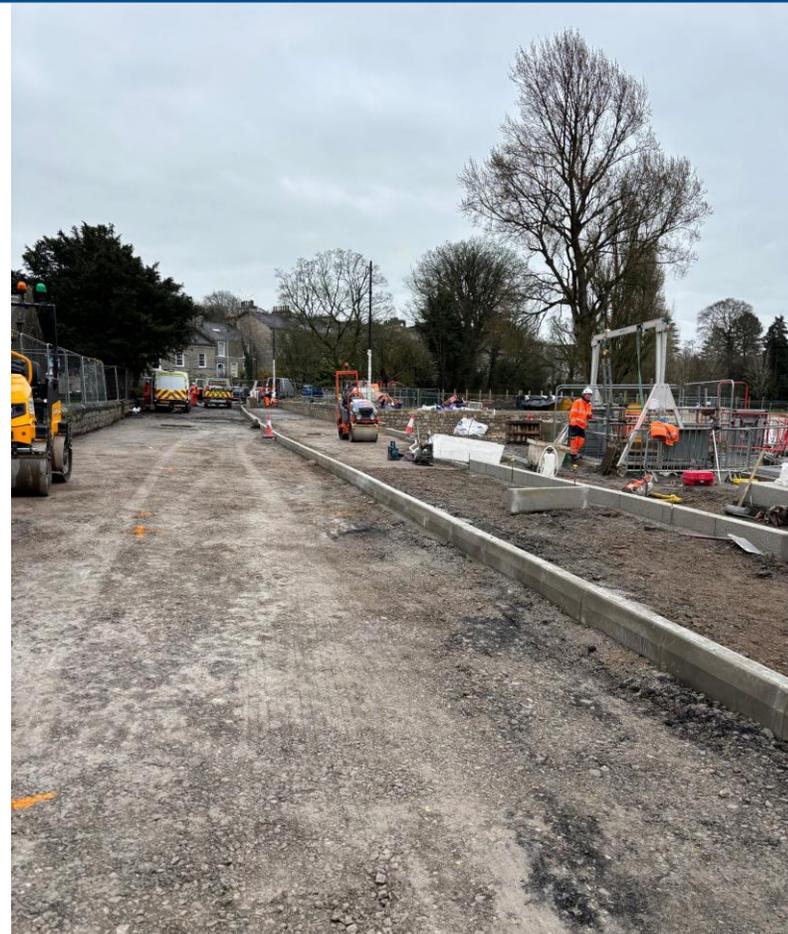
Reinstatement of STtGeorges Walk

Reinstatement works at St George's Walk are progressing well and hoping to be completed around the Easter period.

The base layer of tarmac was successfully laid despite the inclement weather on Thursday 12th, because of this weather the tarmacking of the footpath was cancelled and will be completed alongside the 'Blacktop' finish tarmac.

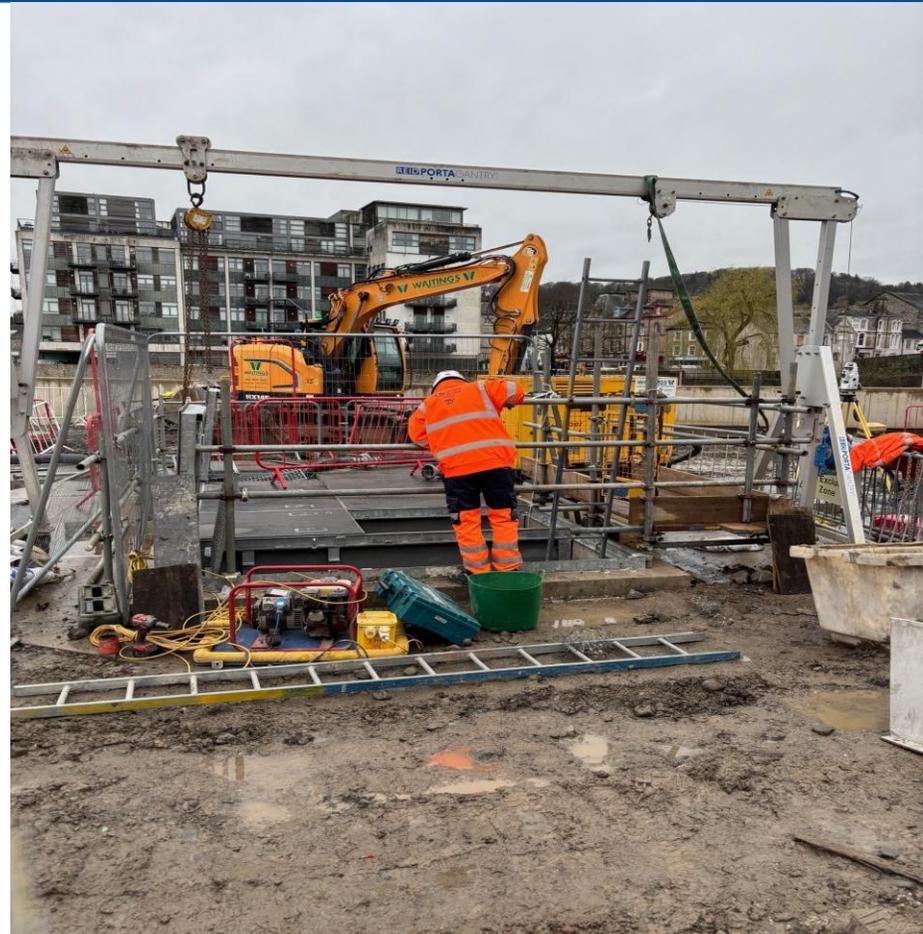
Preparation for fitting of the pumps

This week the covers and main beams over the wet well are being removed to facilitate the lowering and installation of the pumps. A crane is scheduled to arrive on Tuesday 17th March to support this operation.
