Cocker Tidal Channel and Cockerham Marsh SSSI Restoration Investigation

Task 1 - Desk-Based Review and Site Visit

Reference: PC7494-RHD-XX-XX-RP-X-0001

Date: 7 October 2025

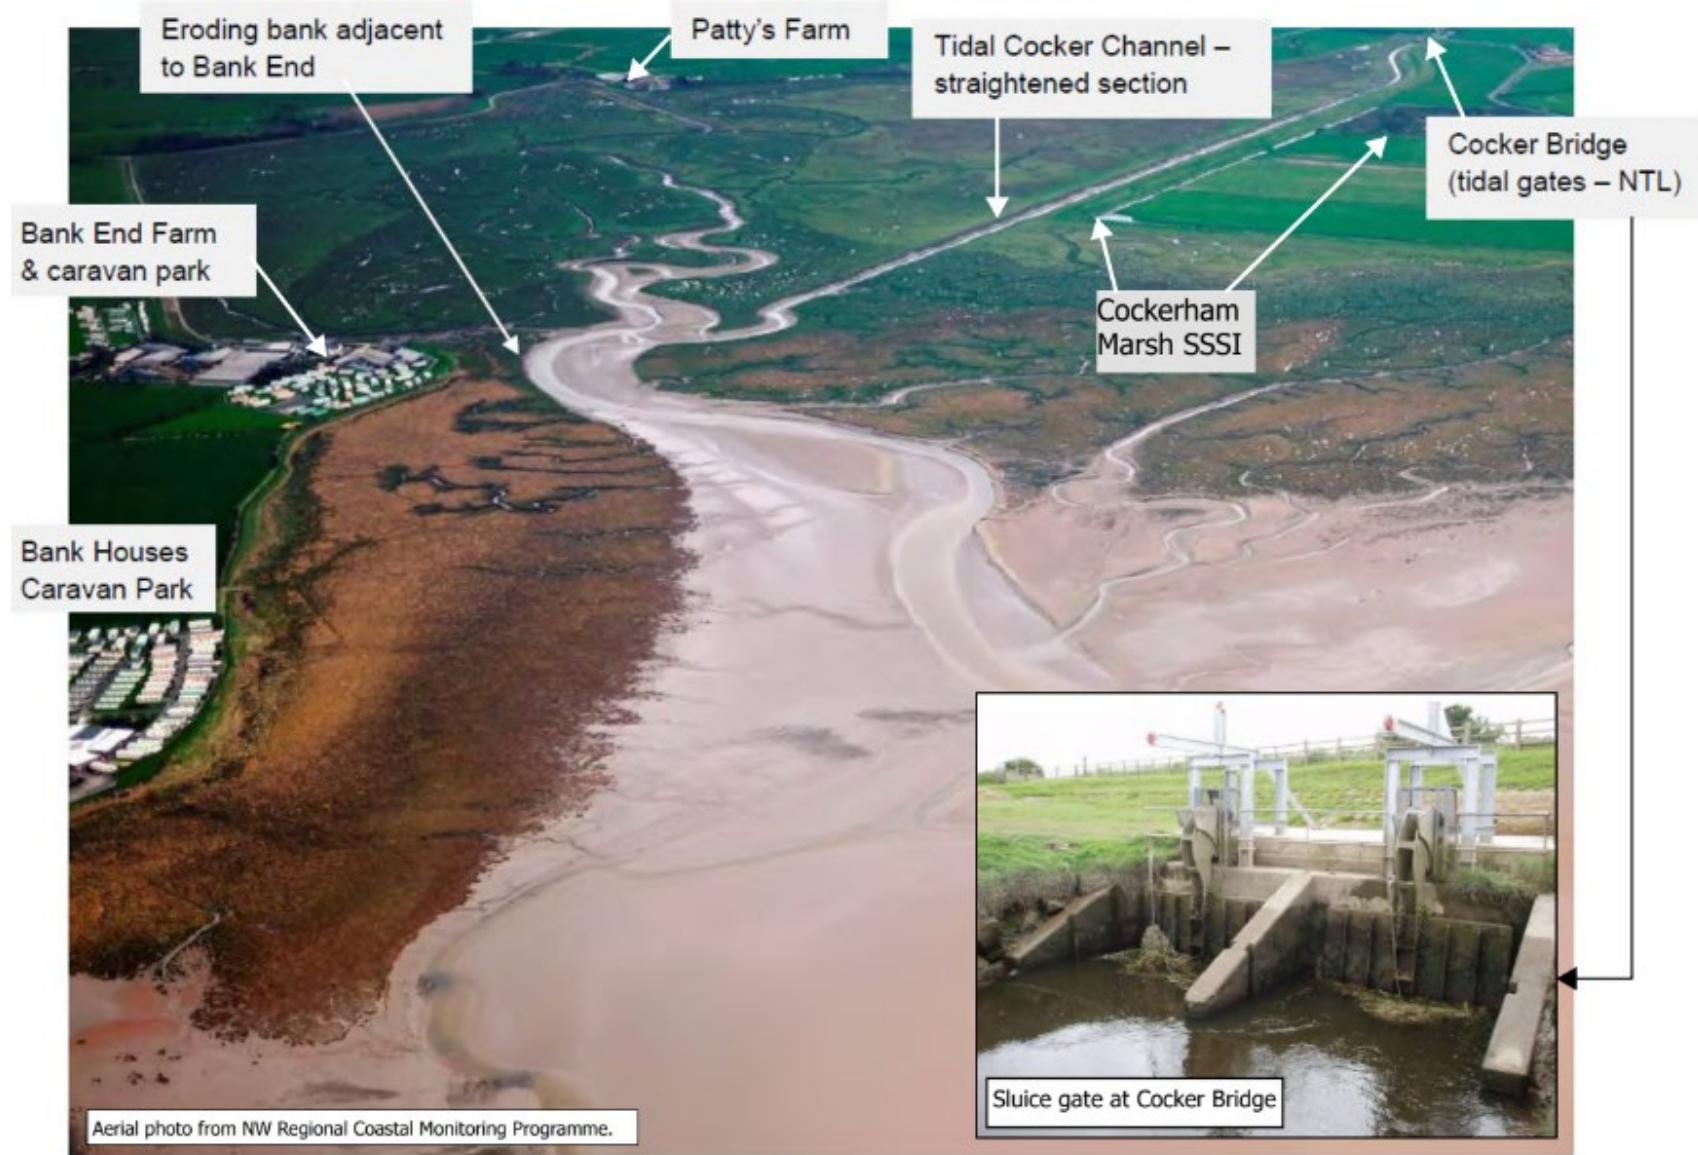
Figure 3 Key locations (reproduced from Swift, 2013)

- The **confluence** of the cut Cocker channel and Patty's Farm Creek contains a pronounced meander, and it is the deeper incision of this meander that caused erosion of the saltmarsh fronting Bank End Farm. The 2013 channel surveys commissioned by the Environment Agency showed shallower invert levels in the confluence than in the cut channel, suggesting some infilling in the confluence section.

- Saltmarsh erosion near Bank End is linked to changes in position of the tidal channel at the confluence. Continued bend migration is possible until a degree of dynamic equilibrium is reached. Existing defences could be vulnerable to toe scour and failure should channel bend migration incise further into the saltmarsh.

- Potential future management options for the saltmarsh erosion issues that were being noted at Bank End Farm in 2012 were:
 - Option 1 - Do nothing
 - Option 2a - Saltmarsh protection works to hold the channel at its existing bend position (e.g. bio-engineering works such as brushwood fascines or similar)

- The study recommended enhanced monitoring be undertaken, in combination with further assessment of the suitability of options to address the flood risk (whilst allowing the system to respond as naturally as possible to wider environmental forcing) by means of: (i) enhancing protection of the existing channel bank using bio-engineered brushwood mattresses (or similar); (ii) in-channel flow deflectors; and (iii) strengthening of the main flood embankment near Bank End Farm. The study also suggested that options to re-naturalise the tidal channel of the River Cocker could be considered if that too would alleviate erosion and associated flood risk pressure at Bank End Farm.

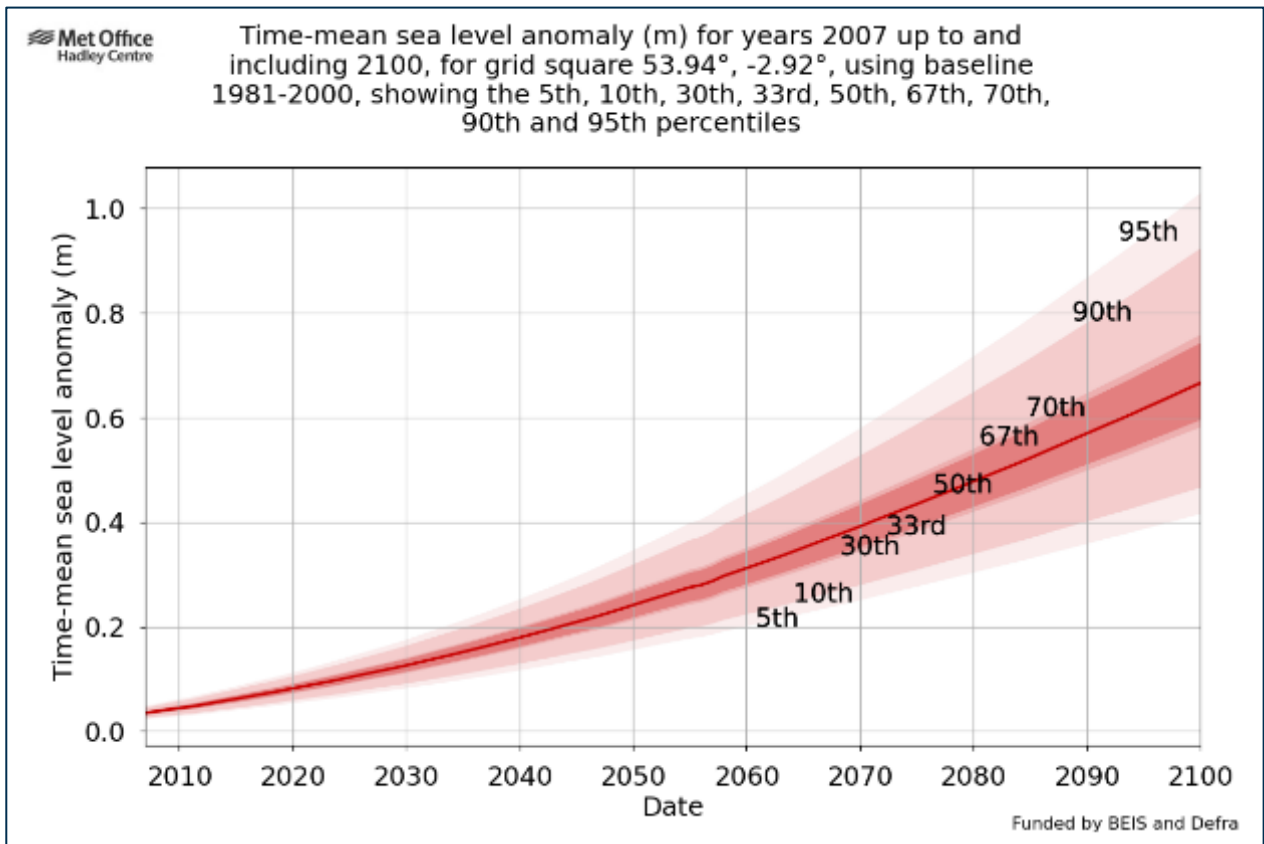
Figure 25 UKCP18 RCP8.5 Projections for Sea Level Rise (base date 2018)

The marine projections for a model grid cell covering Cockerham Sands (Figure 24) yields sea level rise projections as shown in Table 3 and Figure 25. The Environment Agency recommendation is to base projections on RCP8.5 and use the 70th percentile (higher central) as the design allowance and use the 95th percentile (upper end) allowance in planning for more severe climate impacts. It recommends adding the sea level rise allowance for a particular epoch (from a 2018 base date) to the extreme sea levels from the CFB project (which uses a 2018 base date) to yield extreme sea levels for future epochs.

Epoch	Sea Level Rise (m)	
	Higher Central (70 th percentile)	Upper End (95 th percentile)
2025	0.03	0.04
2050	0.19	0.24
2075	0.41	0.55
2100	0.68	0.93

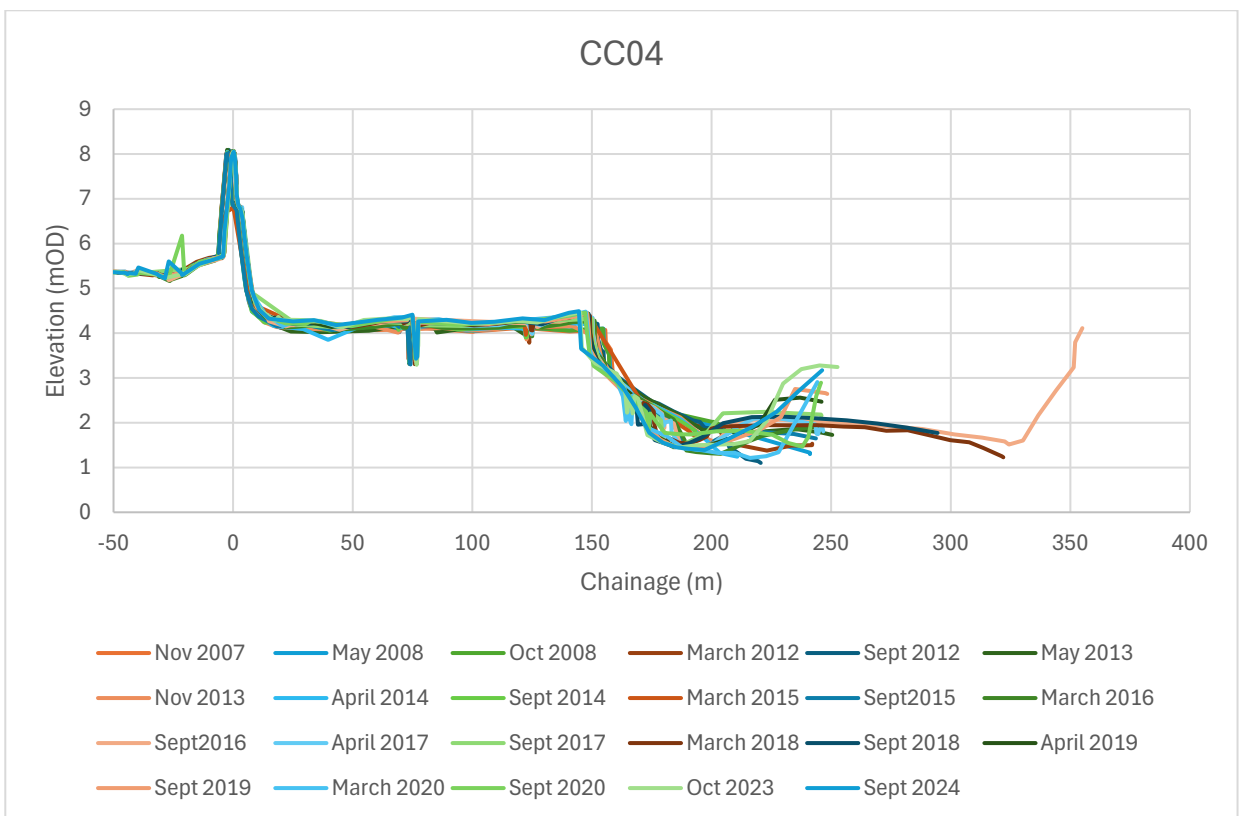
Figure 51 Profile transect CC04 (2007 – 2024)

At CC04 the channel just downstream of the confluence of the Cocker Channel and Patty's Farm Creek is a very pronounced and considerably dynamic feature of the survey. The retreat of the saltmarsh edge noted at this location is associated with the meander of the channel just downstream of the confluence of Cocker Channel and Patty's Farm Creek incising more sharply towards the shore. The movement of the channel centreline over the monitoring record has been of the order of 30m.

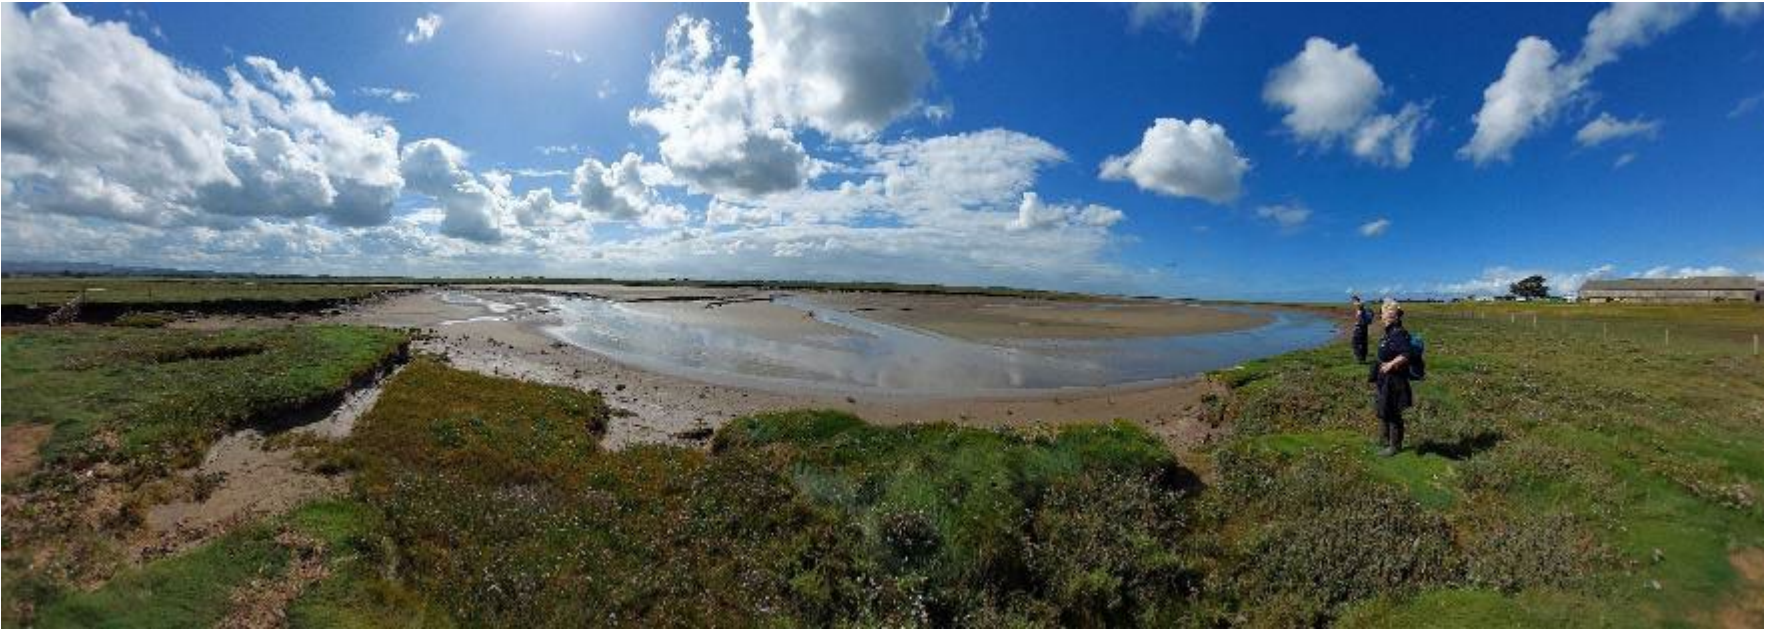
Cocker Tidal Channel – outer reach in vicinity of channel meander near to Bank End Farm

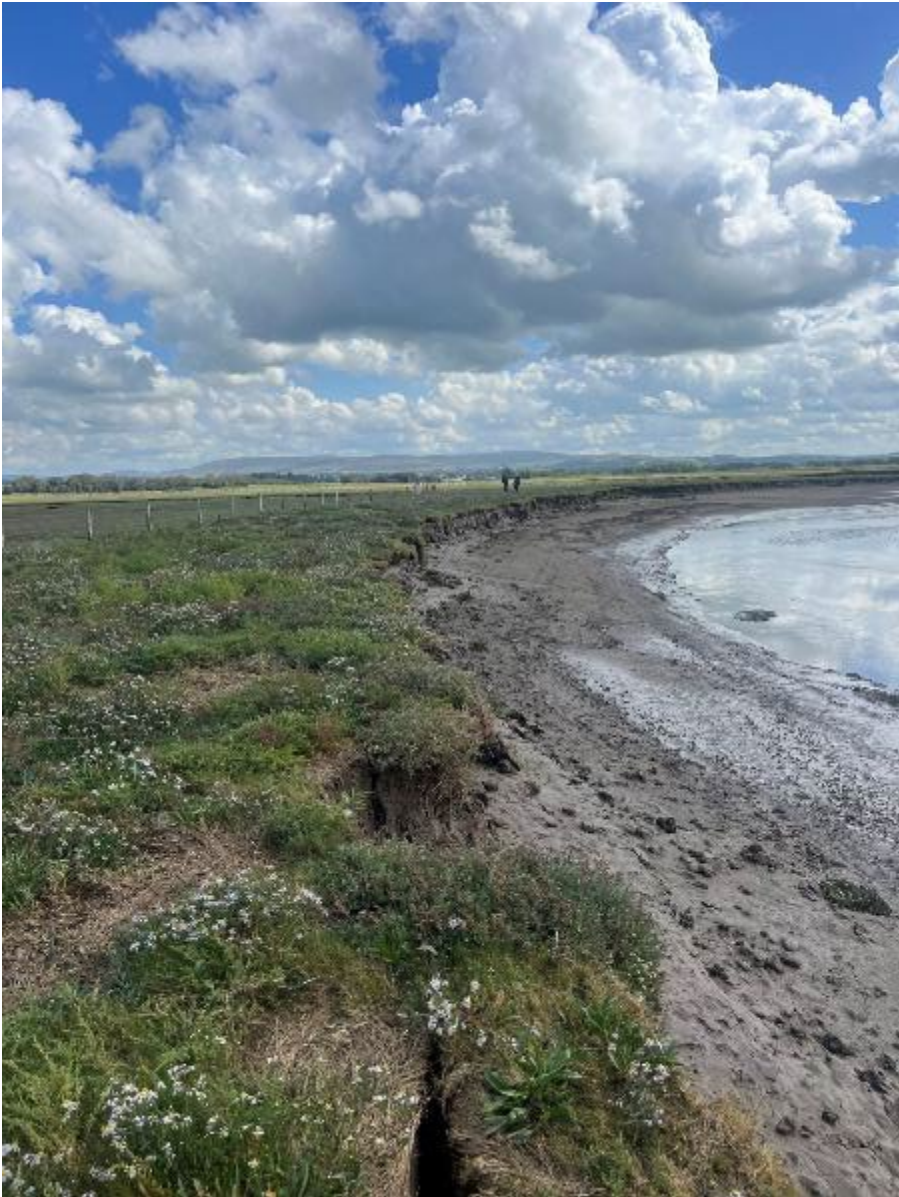
- The flood embankment last breached on 11th November 1977 causing flooding of the farmhouse and extensive areas of the Thurnham peninsula;
 - Since erection of a stock fence on saltmarsh immediately fronting Bank End Farm around 5 years ago, his view was that the saltmarsh width has not changed since (although this seems contradicted by evidence elsewhere within this Task 1 report and signs of ongoing erosion were clearly observed on the day of the visit, with areas adjacent to the pinch point showing signs of slumping and detachment from the main marsh); and

Cocker Tidal Channel - Slumping at saltmarsh margin at outer reach in vicinity of channel meander near to Bank End Farm

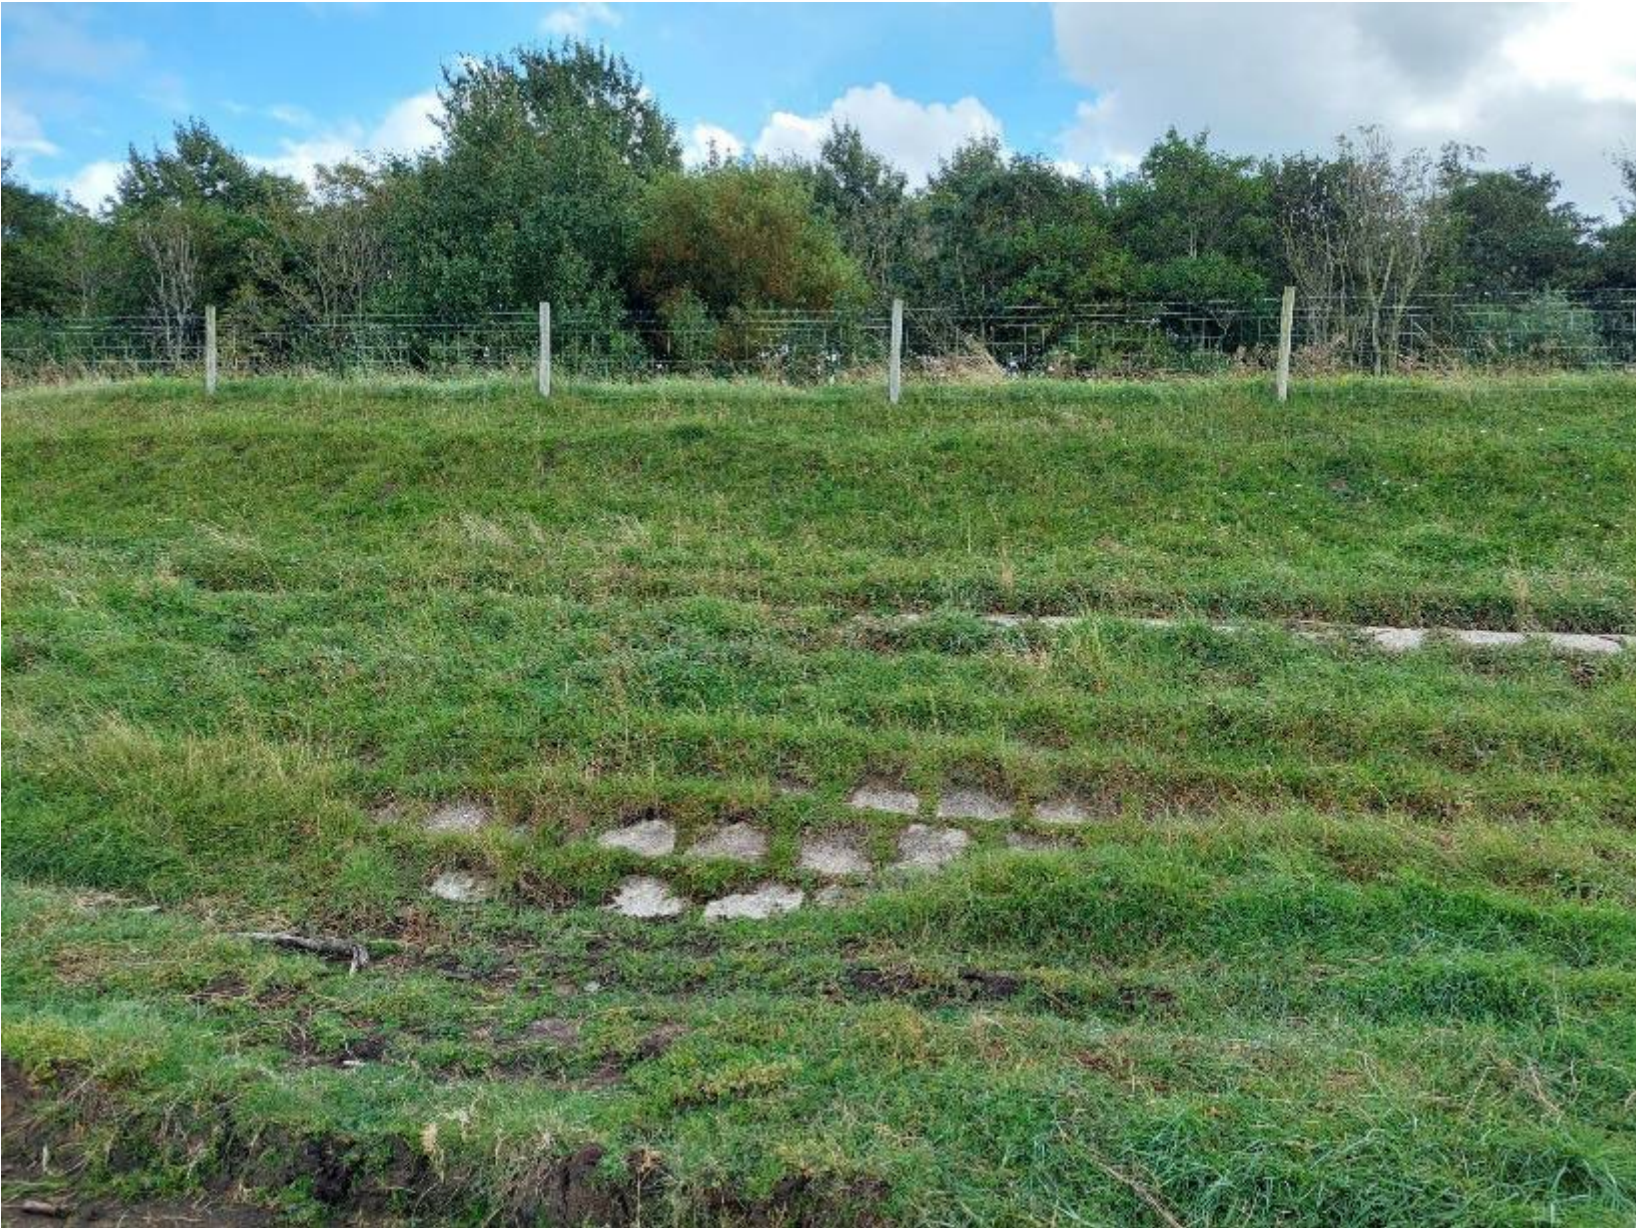
Flood embankment between Cocker Bridge and Patty's Farm

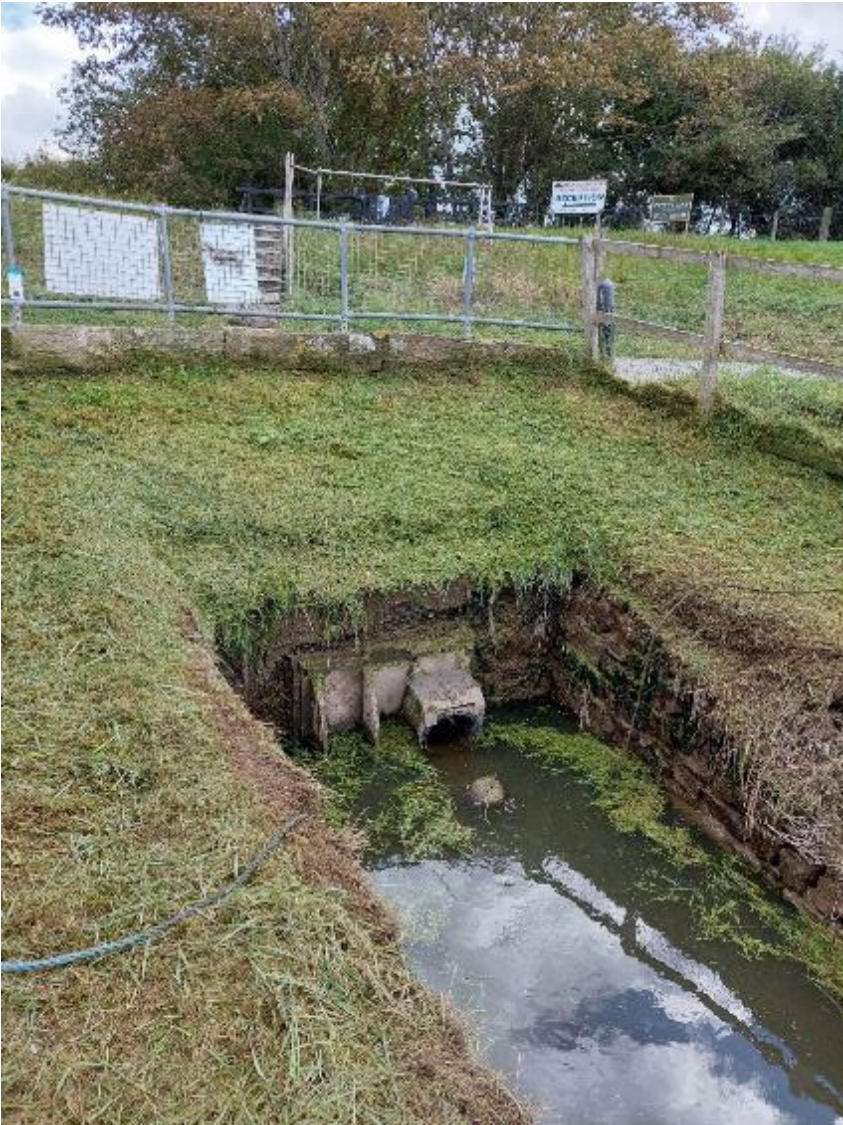
- It is understood that house recently built at Nateby has diverted water towards Pilling.
- Whilst the reclamation of Pilling to Cockerham saltmarsh was undertaken in 1981, further reclamation south of Pilling was in the late 1980s following flooding of that area.
- There has been flooding of the fields and path between Hillam Farm and Patty's Farm, thought to be caused by waters backing up from the flap valve sluice at Patty's Farm (named Hasty Beck Tidal Flap).

Hasty Beck Tidal Flap at Patty's Farm

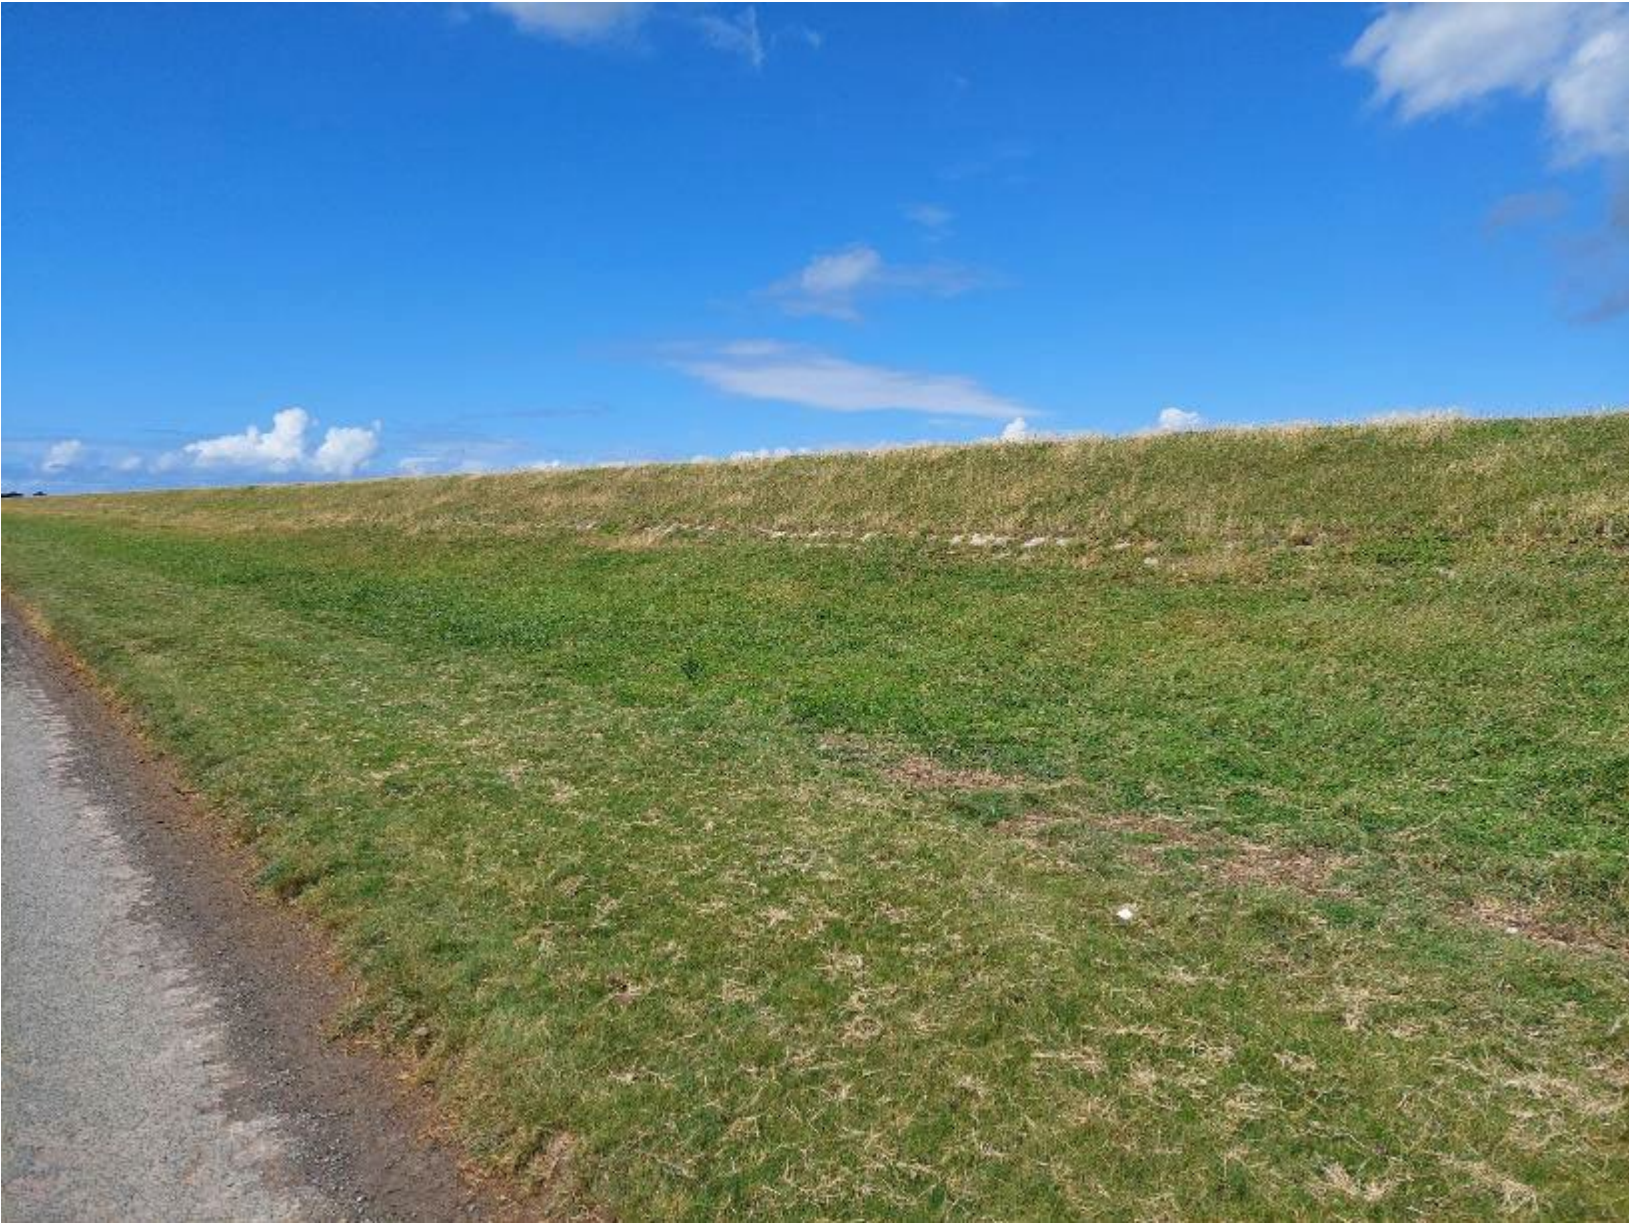
- The flood embankment to the rear of the tidal road approaching Bank End Farm is high, wide and protects an extensive low-lying hinterland (which was cattle-grazed at the time of the visit). It is armoured with concrete blocks on its seaward face and appears in good condition.

Flood embankment between Patty's Farm and Bank End Farm

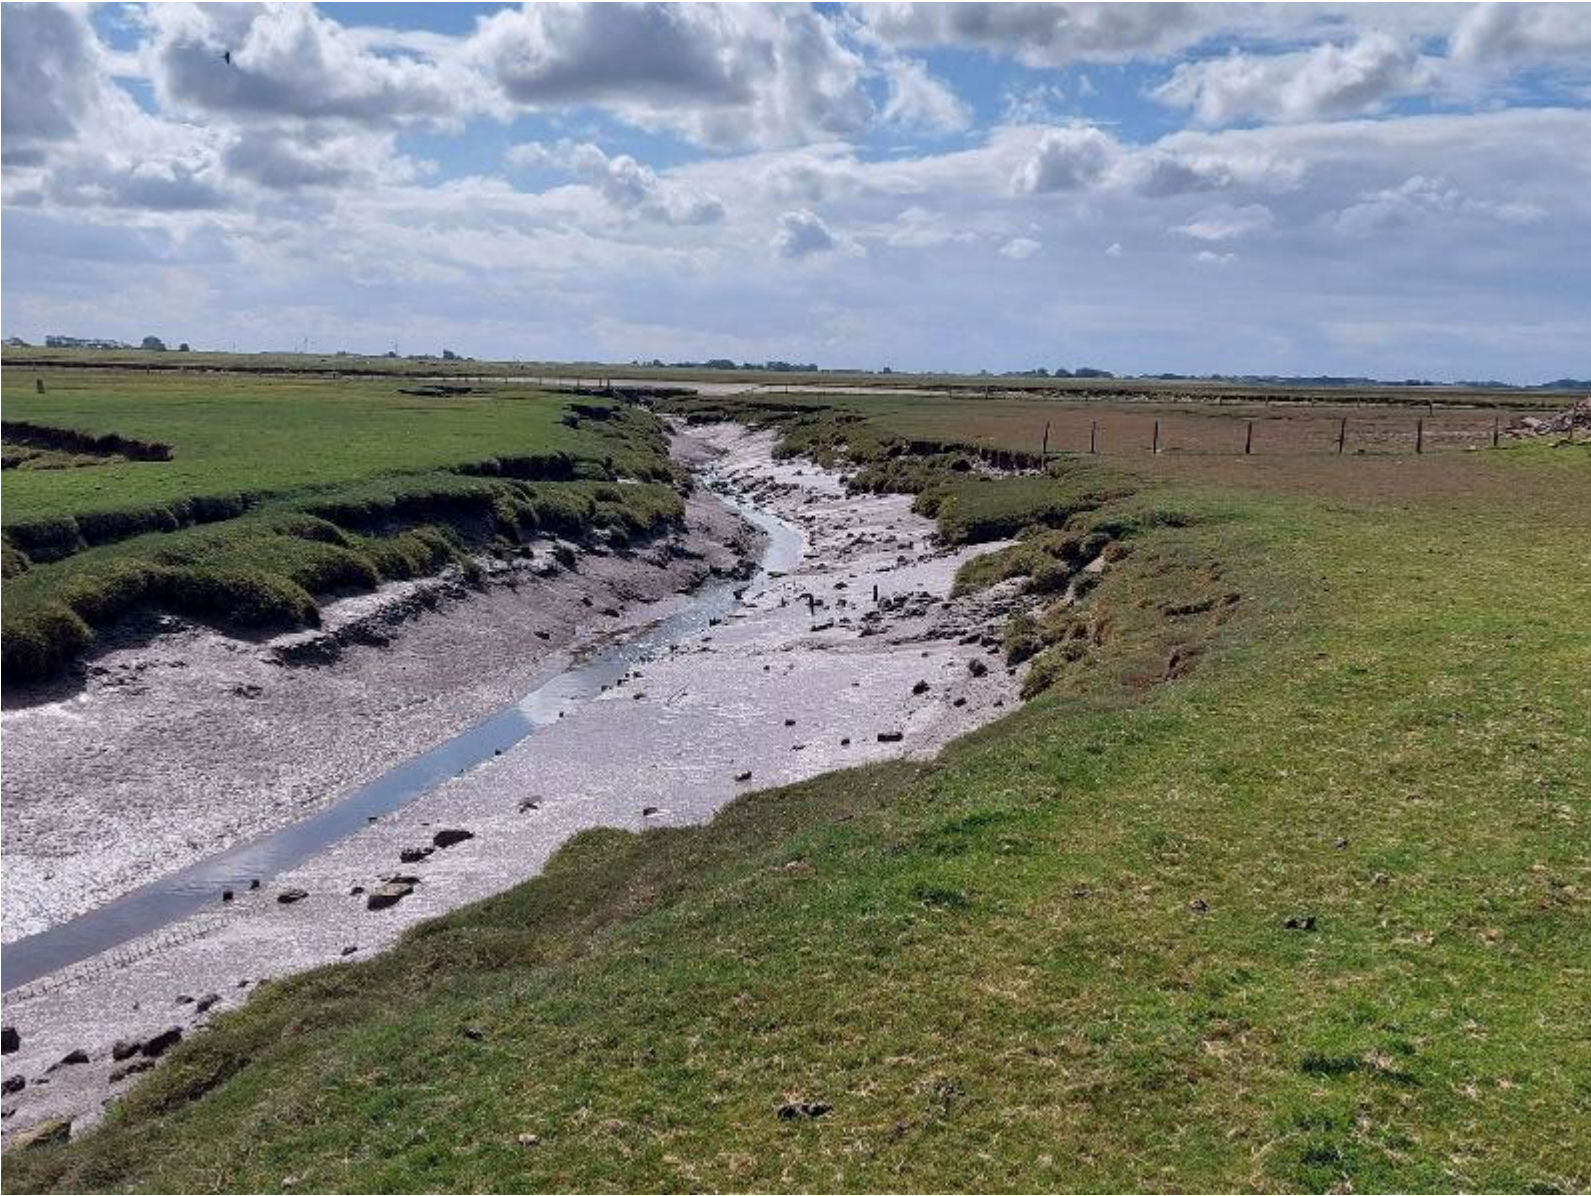
- There has been recent historic (1960s) straightening of the Cocker Tidal Channel from its natural meandering alignment to an artificial 'cut'.
- Where this 'new' cut meets the natural Patty's Farm Creek, the larger joint natural channel meanders across Cockerham Sands.
- Where the combined channel incises closely towards shore (notably at Bank End Farm), ongoing erosion of saltmarsh margins has caused some past local concerns about flood risk.
- There has been extensive recent historic (1981) reclamation of saltmarsh at Cockerham Sands through land claim at Pilling to Cockerham Marsh.
- Cockerham Marsh SSSI (designated solely for natterjack toads) is now in an 'unfavourable declining' status as a consequence of this reclamation.
- Natural sediment deposition in Morecambe Bay can cause siltation and blockage of land drainage sluice gates and outfalls and backing-up of water.

Intersection between Cut and Natural Channel from Bank End Tidal Flap

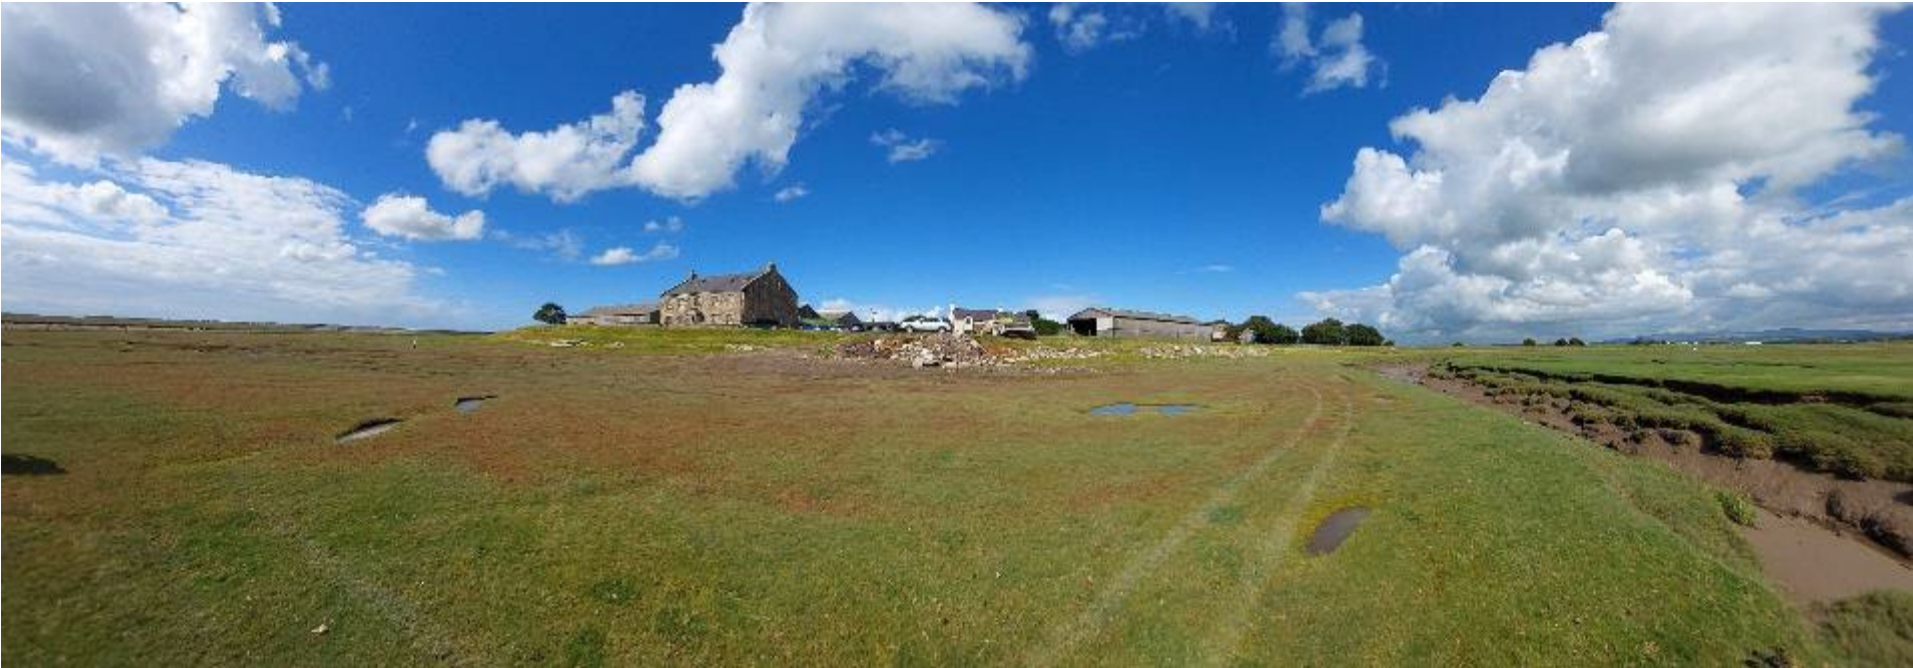
Saltmarsh fronting Bank End Farm
