COASTAL NFM: BEACH NOURISHMENT

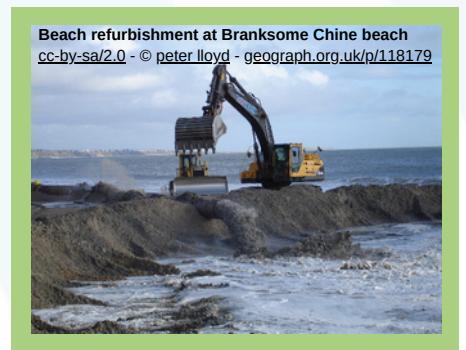
Dredging

Material is dredged from the sea bed and pumped to shore along with large amounts of water. As the dredged material is pumped onto the beach the water drains away leaving the sand behind.

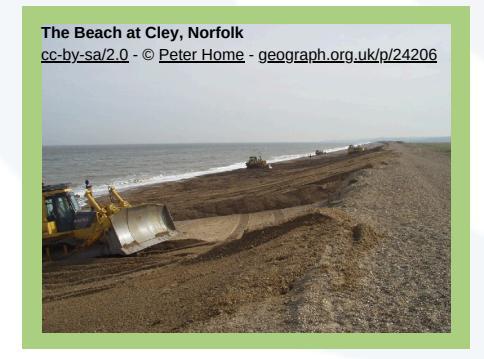
Reprofiling

This involves the reshaping of the beach by moving material by machine from areas of accretion to areas where erosion has taken place.

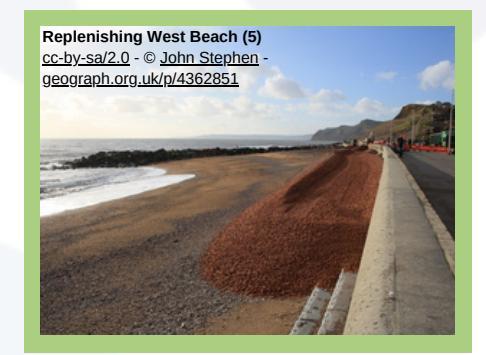
Transported

Dredged material from other areas or gravel/sand that has been quarried on shore can be transported to site by truck and placed where it is required.

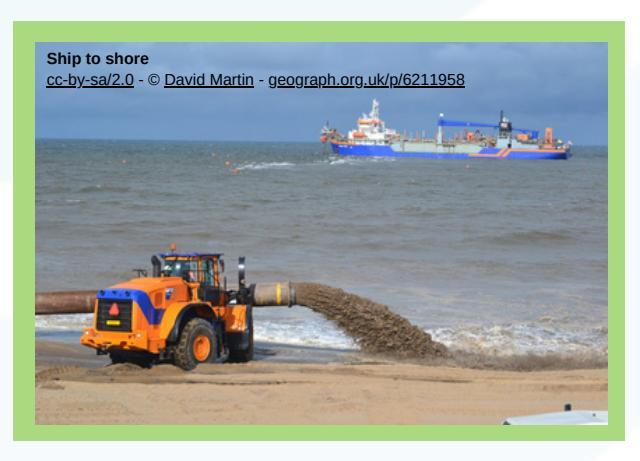
Lincolnshire Beach Nourishment

To replace the eroded material, Team Van Oord use a Trailing Suction Hopper Dredger to suck up sand 12 miles off shore. The material is then brought close to shore and pumped through large pipes onto the beach where it is reprofiled by a bulldozer and excavator, this process is repeated twice per day at high tide.

Each year approximately 400,000m³ of material is replenished along the coast using GPS to achieve the required design level. The replacement material also provides a buffer to the hard engineered coastal defences reducing the possibility of them becoming undermined by the effects of scour.
