# COASTAL FLOOD DEFENCES: REVETMENTS

## Case Study: Fairhaven and Church Scar Sea Defence Project

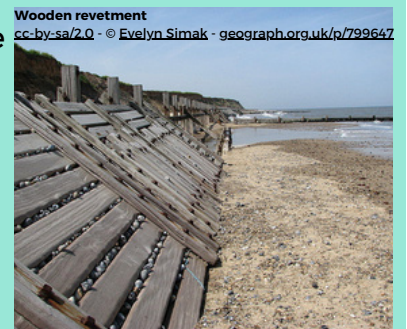
Wooden revetment  
cc-by-sa/2.0 - © Evelyn Simak - geograph.org.uk/p/799647

Revetments are sloping structures built on embankments or shorelines, along the base of cliffs, or in front of sea walls to absorb and dissipate the energy of waves in order to reduce coastal erosion. They can be made of concrete, stone, asphalt or wood, and the height of the revetments is designed to stop waves overtopping the defence. Revetments can be both permeable and impermeable; the permeable revetments are generally built from rock or concrete armour, gabions, and timber. They reduce the erosive power of waves by dissipating their energy as they reach the shore. Impermeable revetments are continuous sloping defences made of stone or concrete which act as a fixed line of defence and are designed to act as a barrier against high tides and storm surges.
