COASTAL NFM: BEACH NOURISHMENT

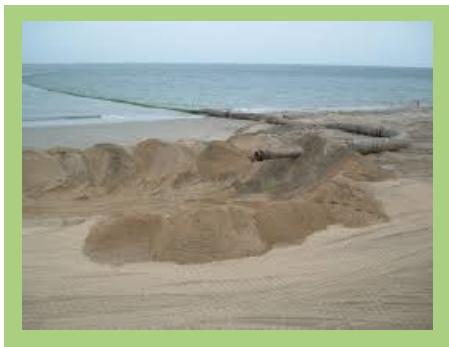
Dredging

Material is dredged from the sea bed and pumped to shore along with large amounts of water. As the dredged material is pumped onto the beach the water drains away leaving the sand behind.

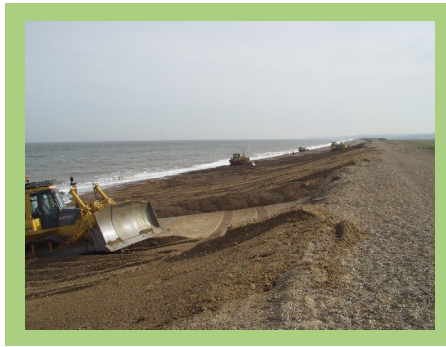
Reprofiling

This involves the reshaping of the beach by moving material by machine from areas of accretion to areas where erosion has taken place.

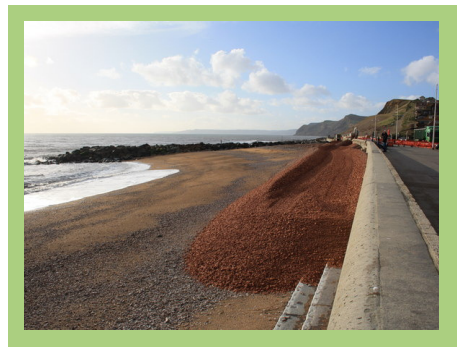
Transported

Dredged material from other areas or gravel/sand that has been quarried on shore can be transported to site by truck and placed where it is required.

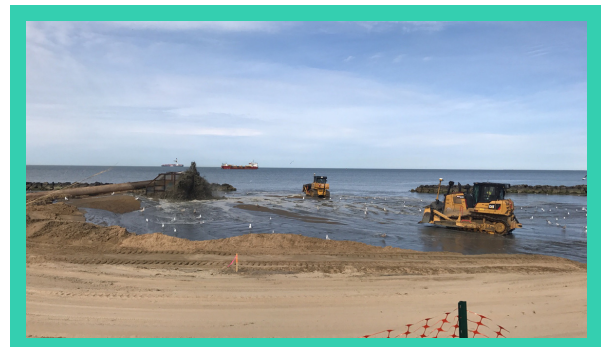
Lincolnshire Beach Nourishment

To replace the eroded material, Team Van Oord use a Trailing Suction Hopper Dredger to suck up sand 12 miles off shore. The material is then brought close to shore and pumped through large pipes onto the beach where it is reprofiled by bulldozer and excavator, this process is repeated twice per day at high tide.
