COASTAL NFM: BEACH NOURISHMENT

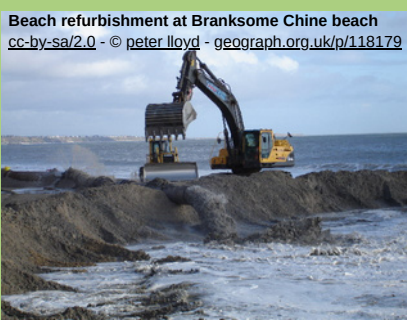
Material is dredged from the sea bed and pumped to shore along with large amounts of water. As the dredged material is pumped onto the beach the water drains away leaving the sand behind.

Beach refurbishment at Branksome Chine beach
cc-by-sa/2.0 - © peter lloyd - geograph.org.uk/p/118179

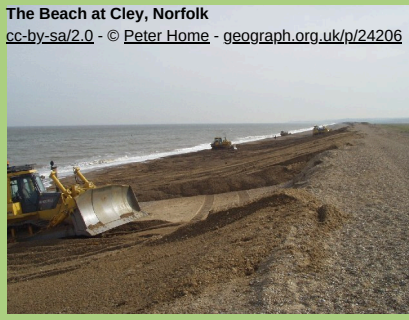
This involves the reshaping of the beach by moving material by machine from areas of accretion to areas where erosion has taken place.

The Beach at Cley, Norfolk
cc-by-sa/2.0 - © Peter Home - geograph.org.uk/p/24206

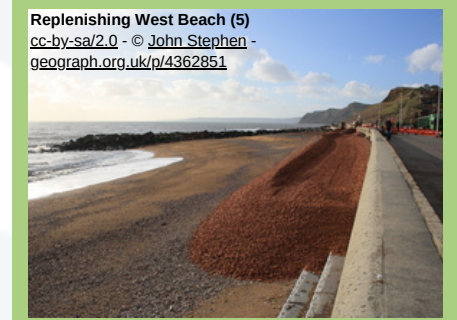
Dredged material from other areas or gravel/sand that has been quarried on shore can be transported to site by truck and placed where it is required.

Replenishing West Beach (5)
cc-by-sa/2.0 - © John Stephen - geograph.org.uk/p/4362851

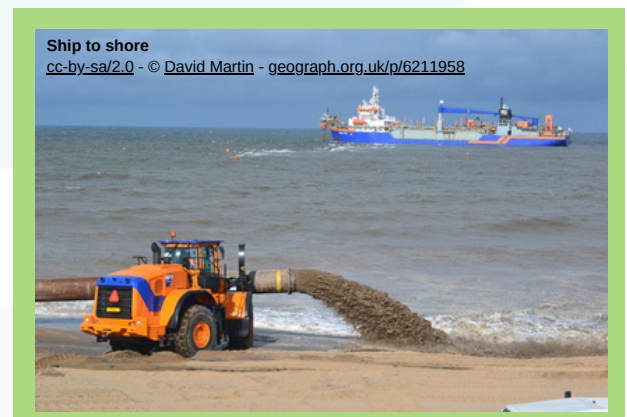
To replace the eroded material, Team Van Oord use a Trailing Suction Hopper Dredger to suck up sand 12 miles off shore. The material is then brought close to shore and pumped through large pipes onto the beach where it is reprofiled by a bulldozer and excavator, this process is repeated twice per day at high tide.

Ship to shore
cc-by-sa/2.0 - © David Martin - geograph.org.uk/p/6211958

Each year approximately 400,000m³ of material is replenished along the coast using GPS to achieve the required design level. The replacement material also provides a buffer to the hard engineered coastal defences reducing the possibility of them becoming undermined by the effects of scour.
