COASTAL FLOOD DEFENCES: GROYNES

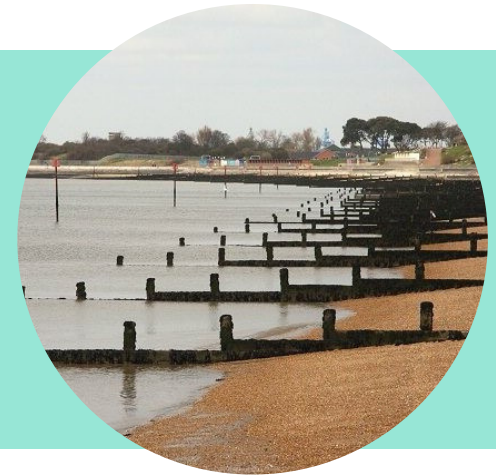
Groynes are low lying wood or concrete structures which are situated out to sea from the shore. They are designed to trap sediment, dissipate wave energy and restrict the transfer of sediment away from the beach through long shore drift. Longshore drift is caused when prevailing winds blow waves across the shore at an angle which carries sediment along the beach. Groynes prevent this process and therefore, slow the process of erosion at the shore. They can also be permeable or impermeable, permeable groynes allow some sediment to pass through and some longshore drift to take place. However, impermeable groynes are solid and prevent the transfer of any sediment.

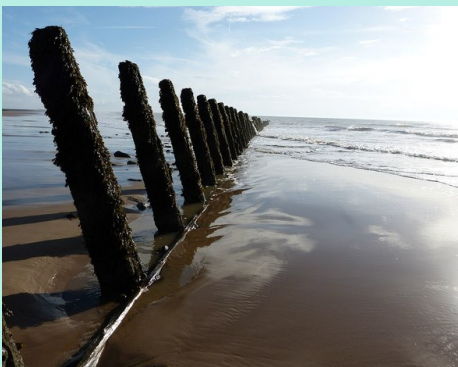
Case Study: Walney Island, Cumbria

Walney Island is a narrow island off the west coast of England, which forms a part of Barrow-in-Furness. The island is home to 13,000 residents and is approximately 11 miles in length and covers 5 square miles. The island is relatively narrow at points, with the narrowest section being 250 metres wide. The west coast of the island is exposed to the Irish Sea and the east coast has many low lying wet marshlands. Exposure to high tides and storm surges has caused progressive coastal erosion over time as well as extreme flood events. Often, these flood events have been capable of breaching the narrowest parts of the island, separating the south of the island from the north and at times, this has cut off access to more rural communities and businesses. In order to reduce the flood risk and limit the amount of coastal erosion, wooden groynes have been built along the coastline. It is hoped that these defences will also prevent the island being divided during high tides.
