COASTAL FLOOD DEFENCES: GROYNES

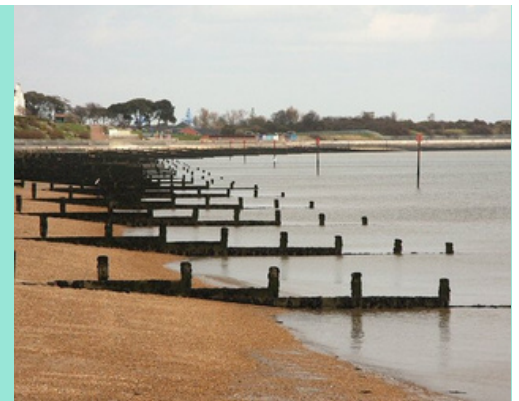
Dovercourt groynes
cc-by-sa/2.0 - © Bob Jones - geograph.org.uk/p/748828

Groynes are low lying wood or concrete structures which are situated out to sea from the shore. They are designed to trap sediment, dissipate wave energy and restrict the transfer of sediment away from the beach through long shore drift. Longshore drift is caused when prevailing winds blow waves across the shore at an angle which carries sediment along the beach. Groynes prevent this process and therefore, slow the process of erosion at the shore. They can also be permeable or impermeable, permeable groynes allow some sediment to pass through and some longshore drift to take place. However, impermeable groynes are solid and prevent the transfer of any sediment.

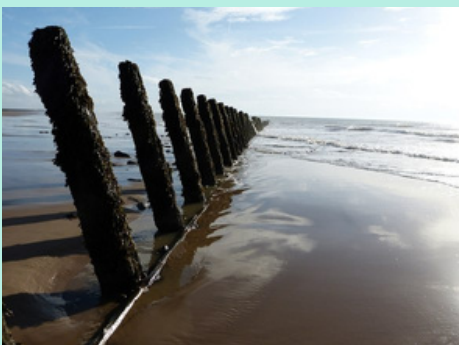
Walney Island Groynes (5) - Northern row in wet sand
cc-by-sa/2.0 - © Rob Farrow - geograph.org.uk/p/3711839

Walney Island is a narrow island off the west coast of England, which forms a part of Barrow-in-Furness. The island is home to 13,000 residents and is approximately 11 miles in length and covers 5 square miles. The island is relatively narrow at points, with the narrowest section being 250 metres wide. The west coast of the island is exposed to the Irish Sea and the east coast has many low lying wet marshlands. Exposure to high tides and storm surges has caused progressive coastal erosion over time as well as extreme flood events. Often, these flood events have been capable of breaching the narrowest parts of the island, separating the south of the island from the north and at times, this has cut off access to more rural communities and businesses. In order to reduce the flood risk and limit the amount of coastal erosion, wooden groynes have been built along the coastline. It is hoped that these defences will also prevent the island being divided during high tides.
