The Swan Hotel in Newby Bridge, Windermere

Large brick built hotel
Flooded 2009 & 2015

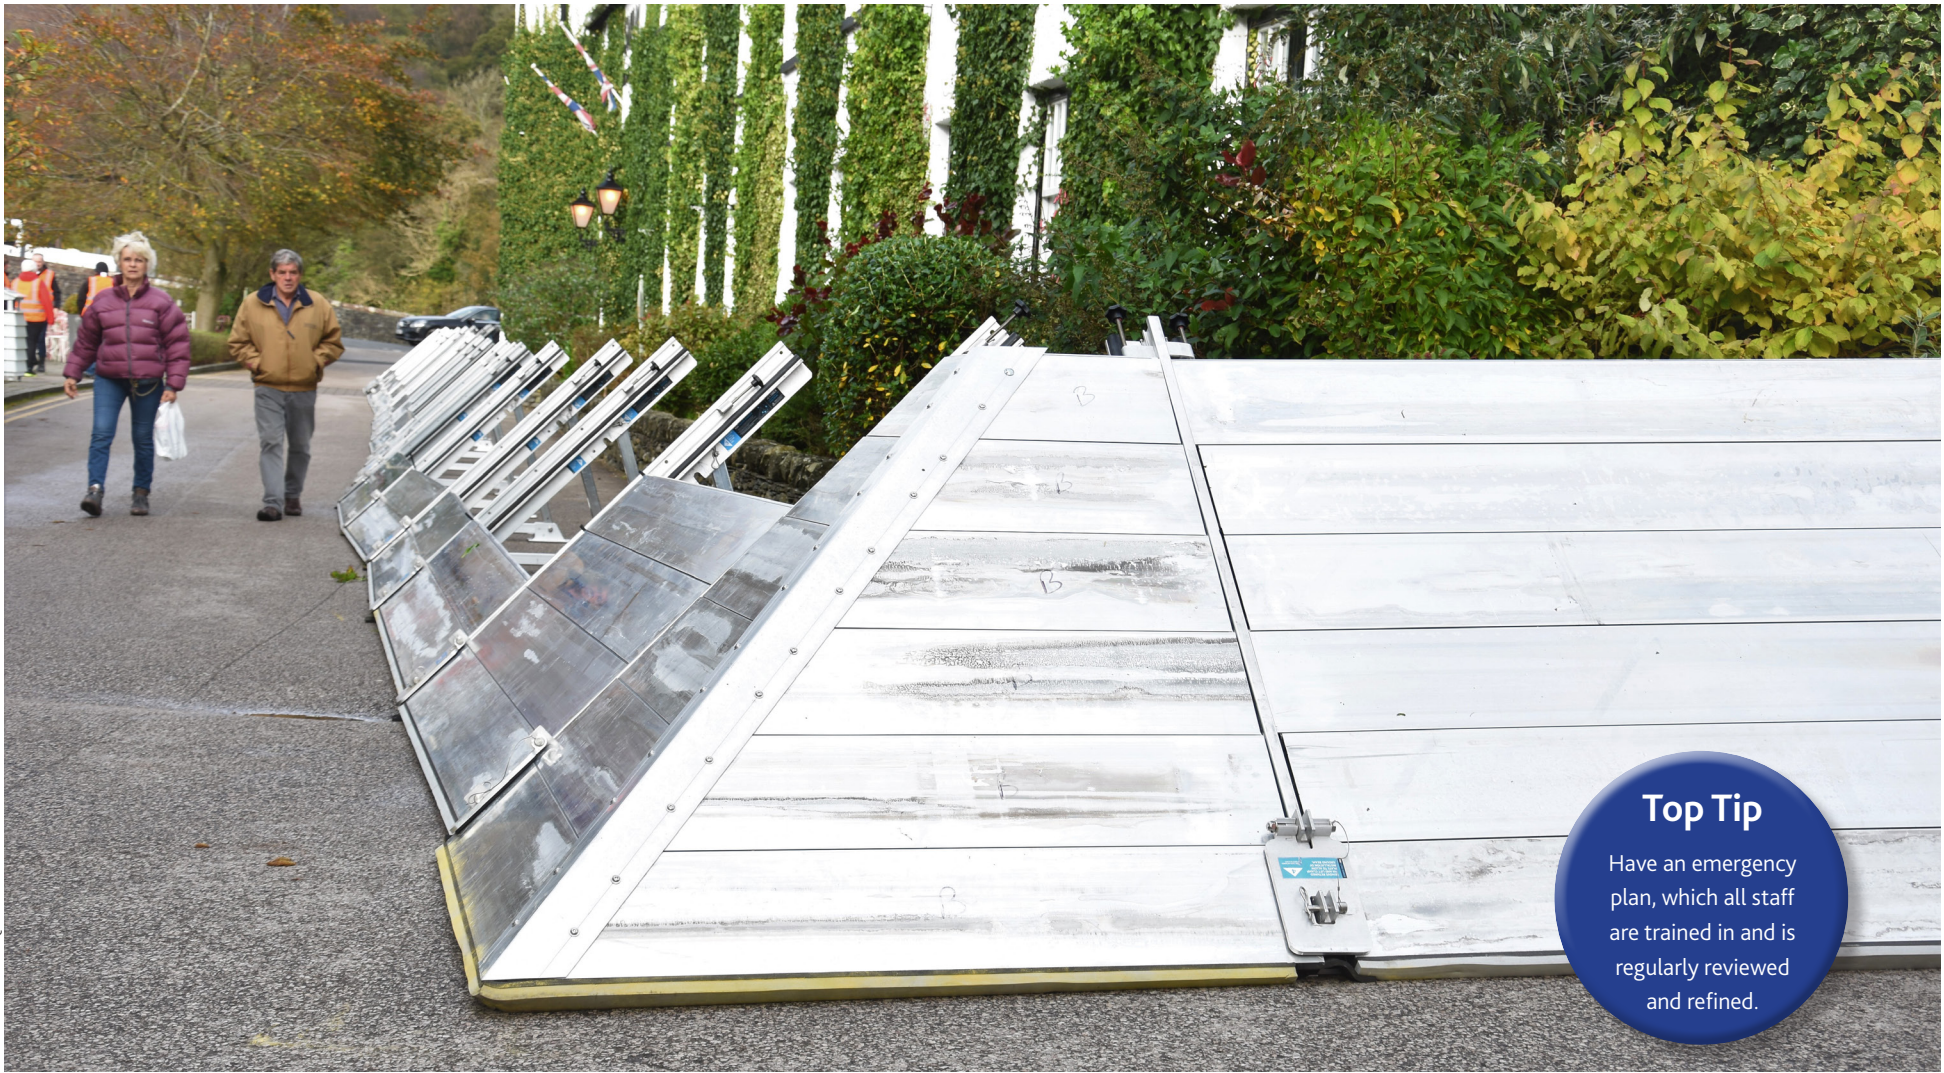
- Rigid temporary barriers are installed around the hotel to a height of 1.2m (4') The hotel has 'Flood Marshals' trained to put the barriers in place, which take 6 people about 1.5 hours.

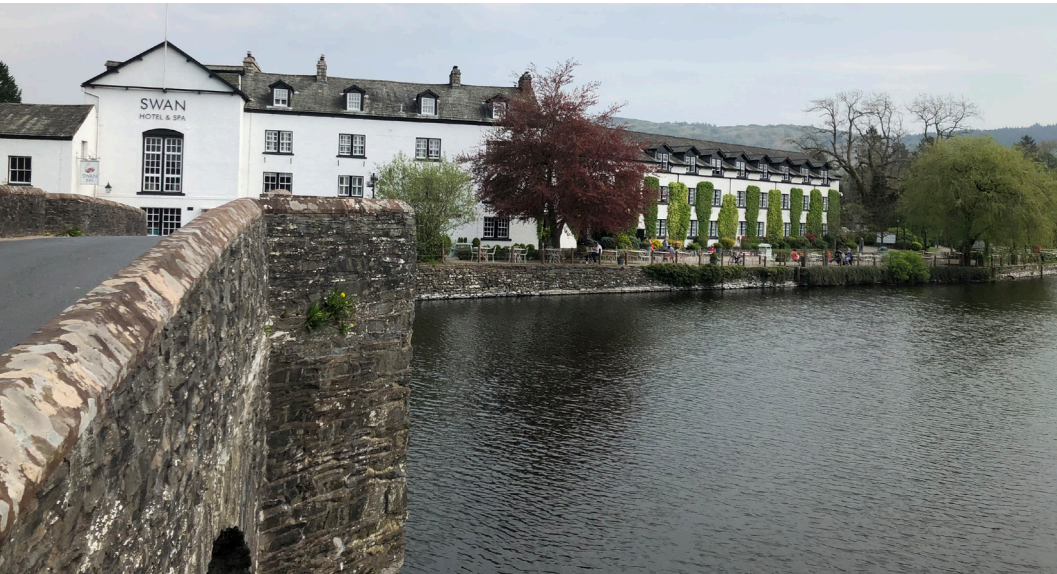
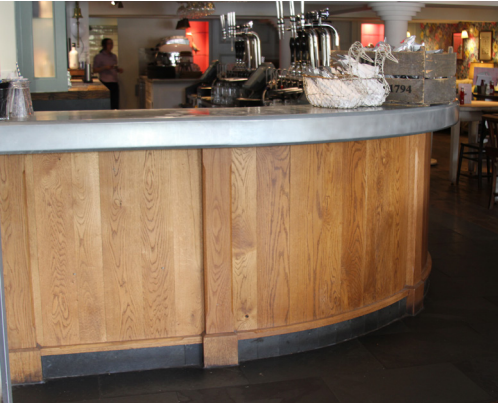
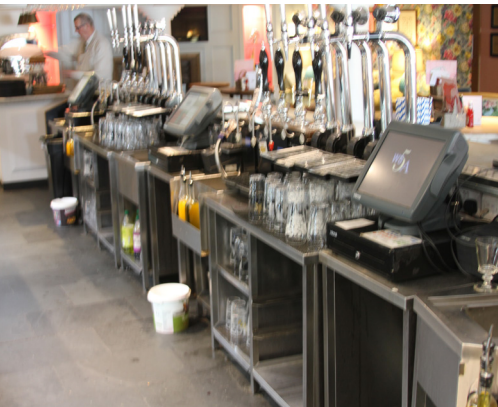
The bar is solid oak with stainless steel fittings and easily removable equipment.

- The hotel has an extensive emergency plan, which all staff are trained in. It is regularly reviewed and refined. They have a 'dry run' every September to practice putting up all barriers.
- The floors all have a resin damp proof membrane beneath them, to prevent the water rising from underneath.
- The bar is solid oak and survived the 2015 flood. It has stainless steel fittings and easily removable equipment.
- The hotel kitchen is in the lowest part of the building. It has resin flooring (that survived the 2015 flood), which has now been extended up the wall to a height of 1 metre. There is washable plaster elsewhere and the kitchen equipment can be moved to a higher level if absolutely necessary.

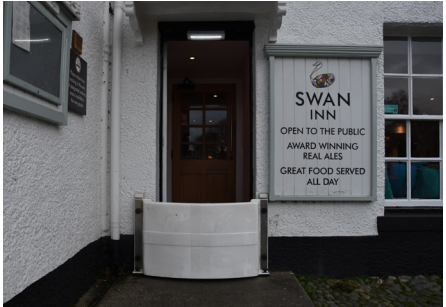
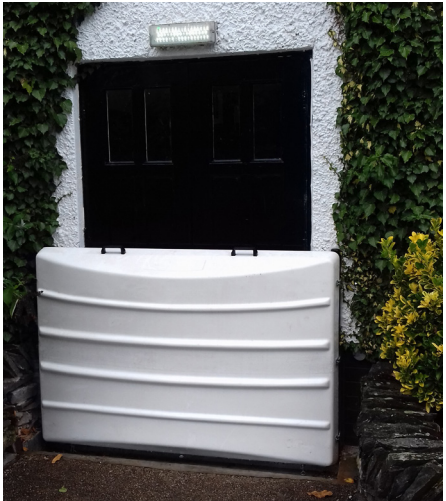
Door guards are fitted to external doors as a 'belt a braces' option.

- Door guards are fitted to external doors as a 'belt a braces' option.
- Non-return valves to all drains.
- Sump and pump fitted to the lift shaft (which flooded in the last flood).
- Smart airbricks to prevent water getting under the floors, as happened before.
- Several puddle pumps.
- Generators to power pumps and emergency lighting.

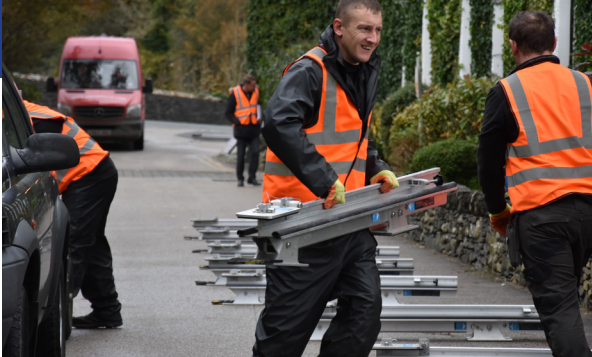
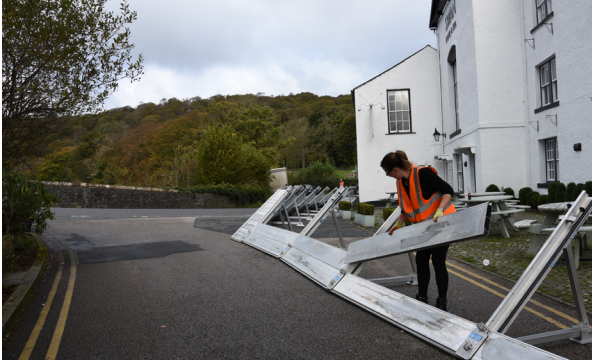
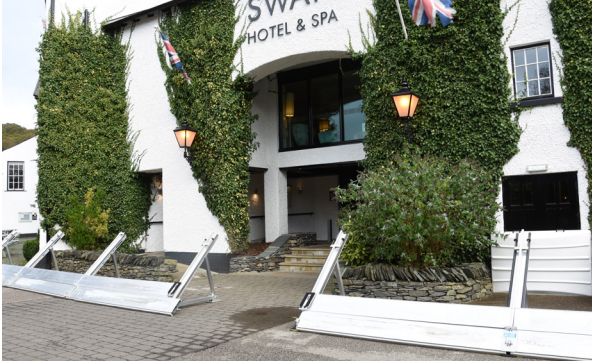
Rigid temporary barriers are installed around the hotel to a height of 1.2m (4'). The hotel has 'Flood Marshals' trained to put the barriers in place, which take 6 people about 1.5 hours.

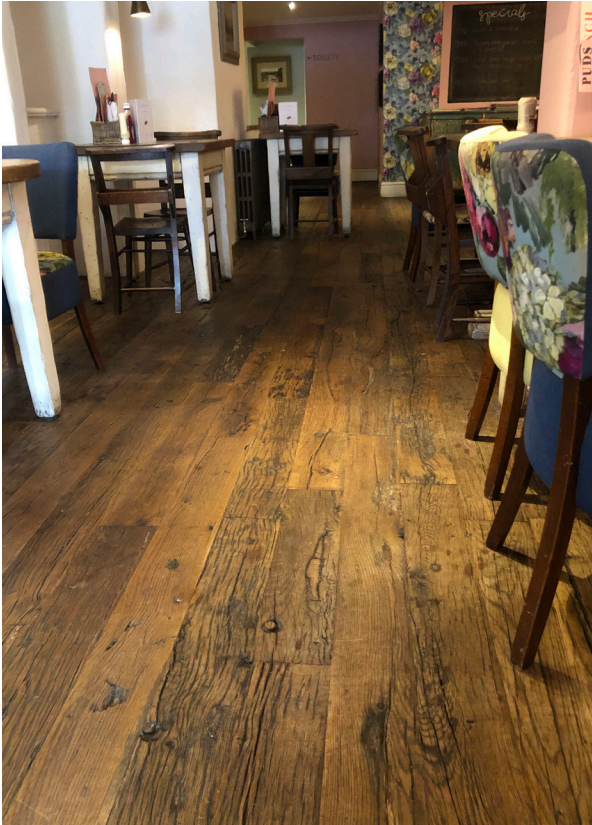
The floors all have a resin damp proof membrane beneath them, to prevent the water rising from underneath.
