# Kendal Flood Risk Management Scheme

Gooseholme Common progress as of 30<sup>th</sup> September 2024

# Kendal Flood Risk Management Scheme – Gooseholme Common update for week of 30<sup>th</sup> September 2024

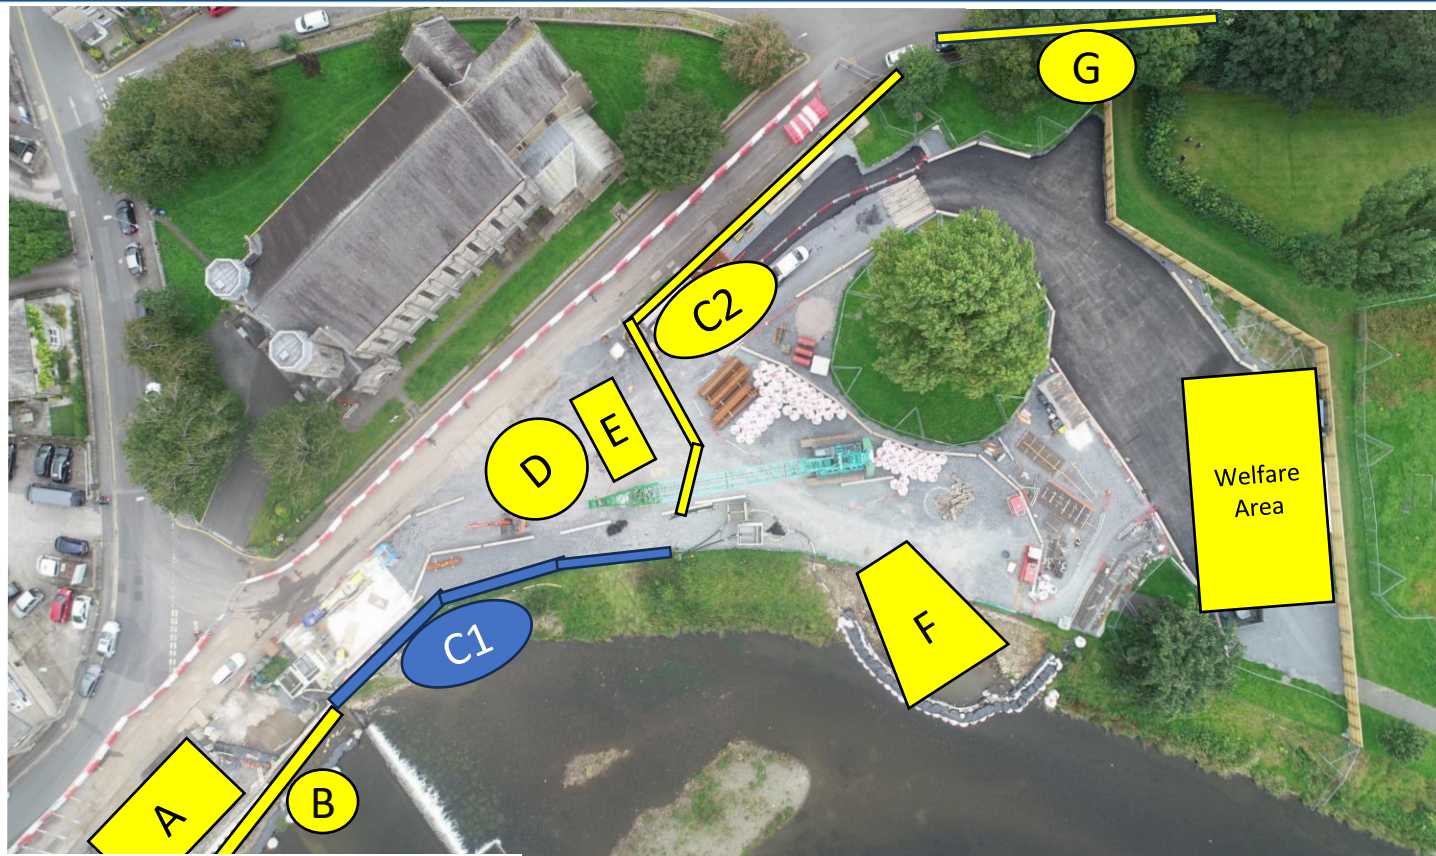
A – Motor Control Centre Building

B – Glass Panel Flood Wall

C1 – Flood Defence Wall

C2 – Flood Defence Wall

D – Wet Well Shaft

E – Valve Chamber

F – Outfall

G – Kerbing Construction

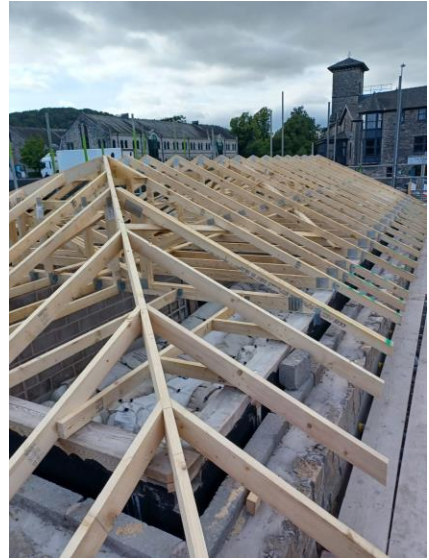
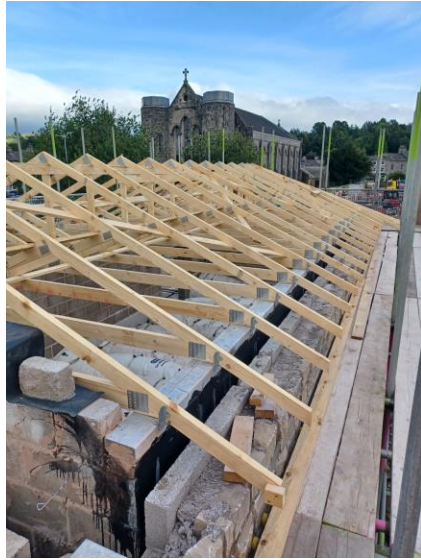
Motor Control Centre Building – Housing for all the electrical equipment for the Stock Beck pumps

**Motor Control Centre Building (MCC)** – The construction of the MCC building has been progressing well with the majority of the stone facing now complete. The roof trusses are now in place with tiling started and continuing this week. Preparations are also being made to accommodate the installation of bat boxes.

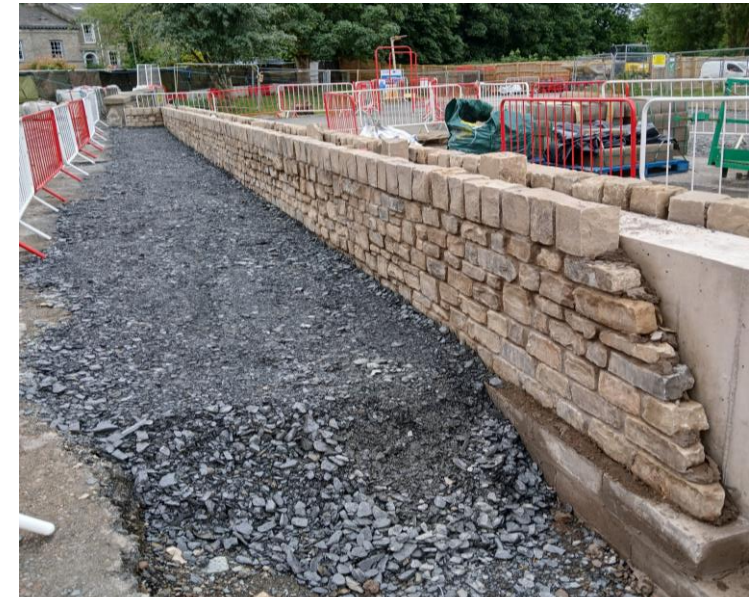
Floodwall along St Georges walk in Construction

**Flood Wall** – A 21m stretch of flood wall is almost complete along St George's Walk. The next stage is for the wall to pass alongside the valve chamber once the area has been backfilled and reinstated.

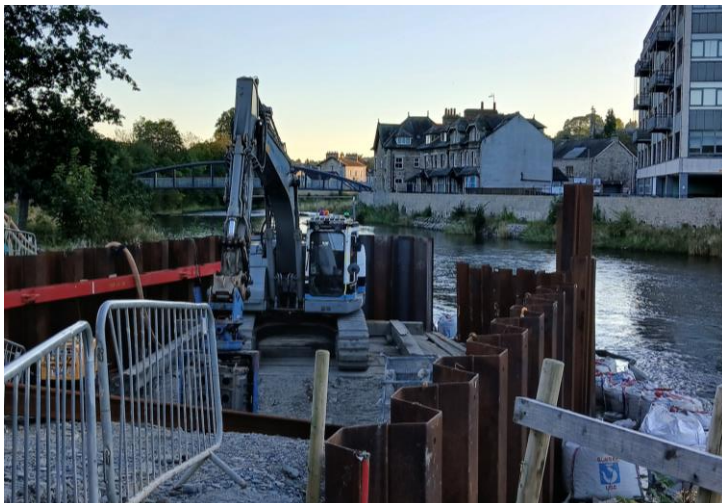
Outfall – The new outfall of Stock Beck into the River Kent.

**Stock Beck Outfall** – Piling to seal the cofferdam has now been complete however, some pumping maybe required as and when necessary to remove any excess water from the sealed area. This week we will continue to excavate and level out the base of the area, so we are able to begin the works to the headwall. A metal frame will also be installed to keep the piled area secure and reinforced.

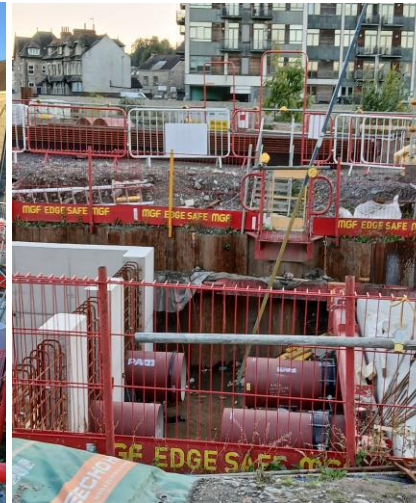
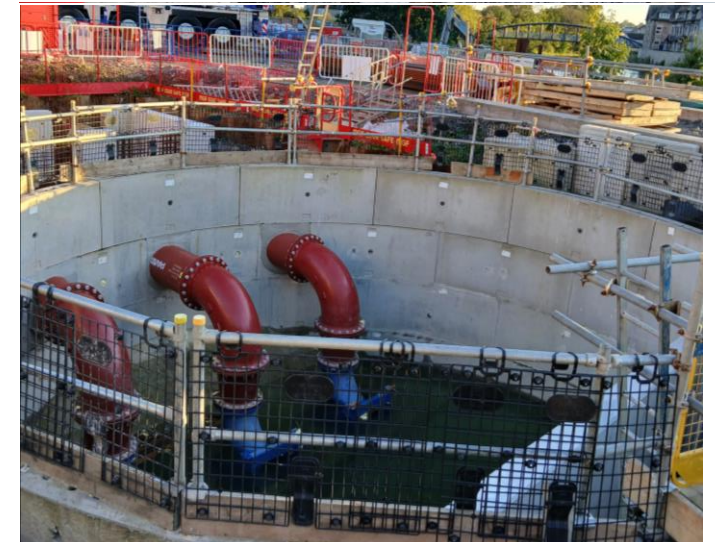
Wet Well Shaft – Underground housing of the 3 pumps for Stock Beck

**Wet Well** – All work we can possibly conduct for the Wet Well has been complete, further works to the wet well won't begin until the sewer diversion is complete due to the close proximity of these works.
