# PROPERTY FLOOD RESILIENCE CASE STUDY: HEST BANK

## Overview

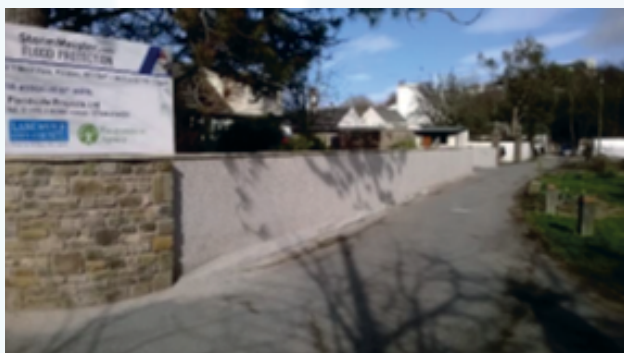
## NEW FLOOD WALL AROUND PROPERTIES

- 1x flood wall was constructed in front of two properties
- 9x flood gates installed.
- 1x non- return valve has been fitted to a drain
- 1x garage door barrier
- 5x surface water pumps were issued to compliment the measures.

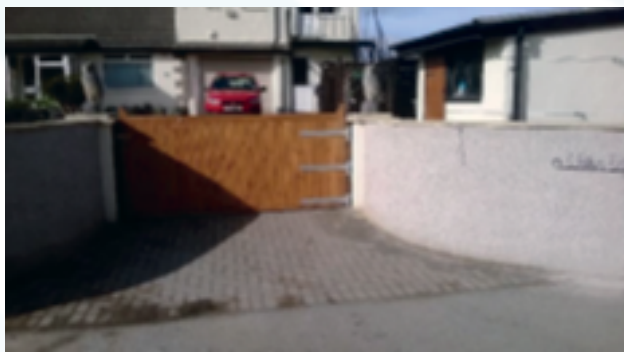
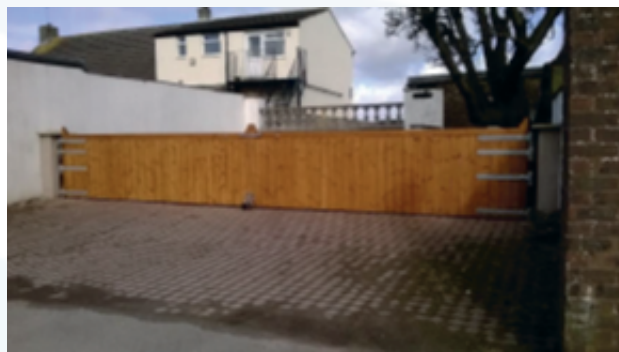
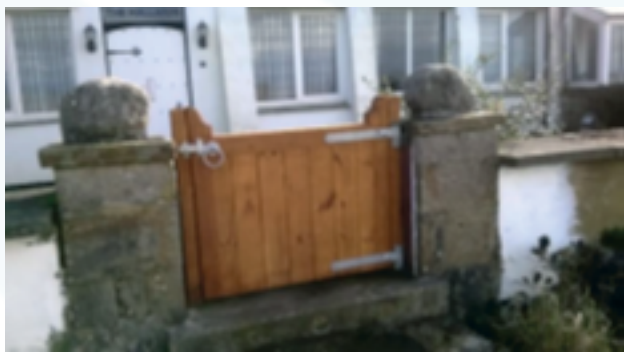
## FLOOD GATES OF VARIOUS TYPES

The residents are really pleased with the new flood measures and feel much safer now. It is now their responsibility to keep the gates maintained and to make sure that they are kept shut whenever they get a flood warning. The manufacturer provided a pack which details how the gates should be maintained.
