# STORM DESMOND: 10 YEARS ON

In December 2015, Storm Desmond brought record-breaking rainfall to the North West, flooding towns, homes and businesses. Ten years on, recovery has led to stronger defences, natural flood management, property flood resilience and improved community preparedness.

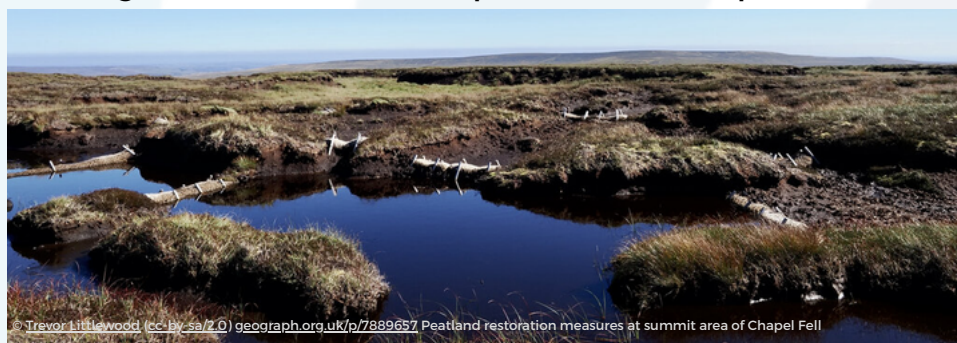
- **Thirlmere Catchment:** Peatland restoration and woodland planting to slow runoff.
- **River Kent and Swindale Beck:** Leaky woody dams and pond storage upstream of Kendal.
- **Cairn Beck:** 8 new leaky dams, modification of 15 earlier leaky dams, 3 new ponds (holding ~116 m<sup>3</sup>), 1.63 km of hedgerows and 1.7 km of riparian buffer strips.

After Storm Desmond, NFM was used to reduce flood risk by slowing water, storing it upstream, reconnecting floodplains, planting tree and restoring peatlands, helping communities manage future extreme rainfall.

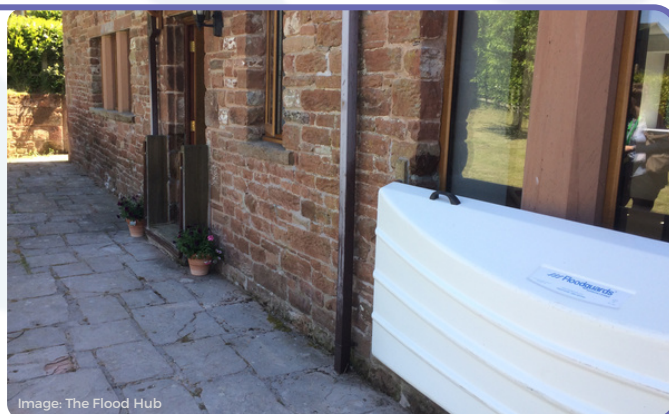
### Edenside Barn PFR Case Study

- A model property demonstrating PFR in a rural, flood-prone area along the River Eden.
- Retrofit funded by homeowner investment and guidance/support from Cumbria County Council.
- Measures include internal flood barriers, water-resistant plaster and flooring, raised electrics and external landscaping to divert water.
- Used to showcase effective flood resilience techniques for other homeowners in the area.
